Monitoring the Hygrothermal Performance of Strawbale Walls

John Straube and Chris Schumacher

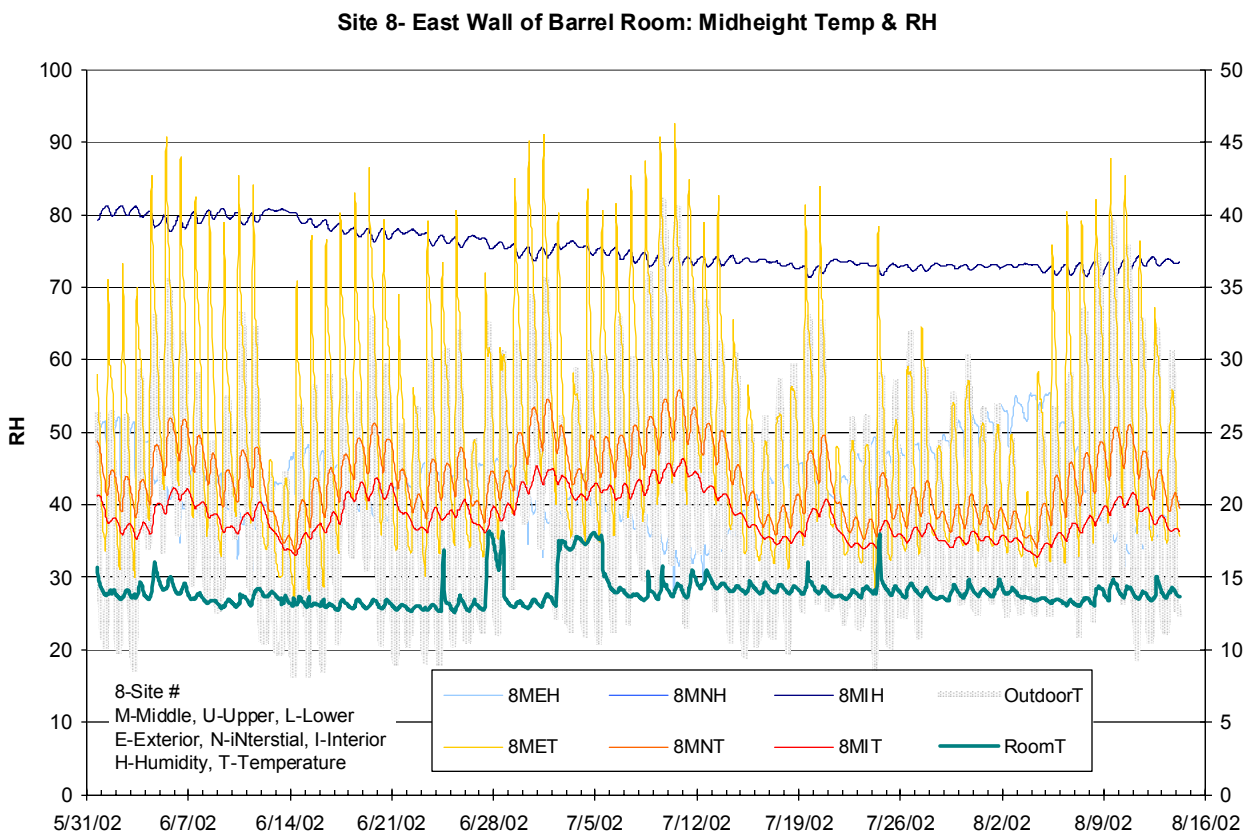
Figure 3.1: RH and T within Site 8, East Wall of Barrel Room

The relative humidity is high near the inside surface, but dropped slowly over the period (likely construction moisture leaving) to around 75%RH over the period. The middle of the bale and the exterior RH are both low, around 45 to 55%RH.

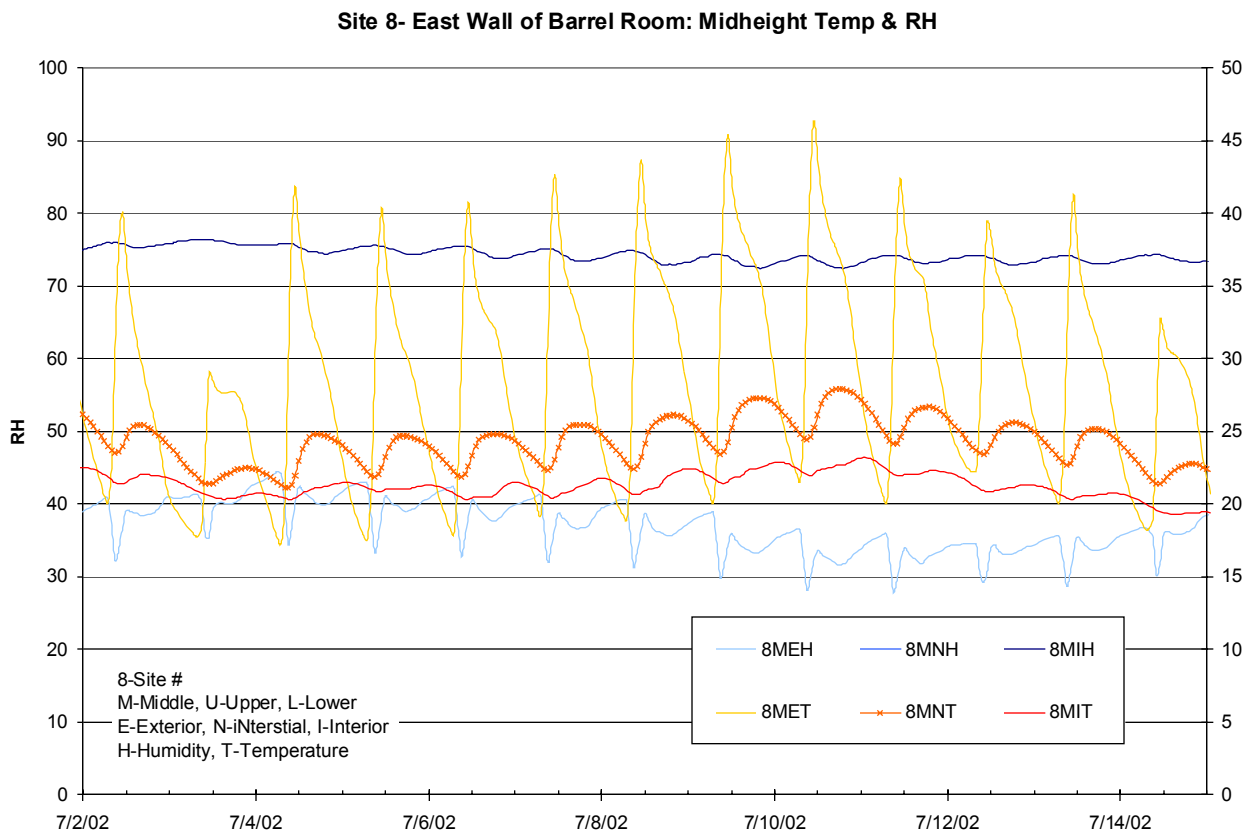
Figure 3.2: Detail View of Site 8

The temperature behind the exterior stucco of the wall (8MET = MiddleExteriorTemp) at mid-height often rises quickly in the morning, peaking at around 40 °C at 11:00 am. This is clearly caused by the morning sun, which is shaded on this wall by noon. The exterior temperature peaks later in the day (4 or 5 pm) and is usually lower. The temperature at the interior plaster (MIT) is much cooler and more stable, hovering near 20 °C (68 F) and varying by only about 3 °C over the period. Daily variations of the interior plaster is only on the order of 1°C. The middle-of-bale temperature tends to

vary between 20 and 25 °C. The wall remains above the exterior and interior temperatures because of solar exposure.

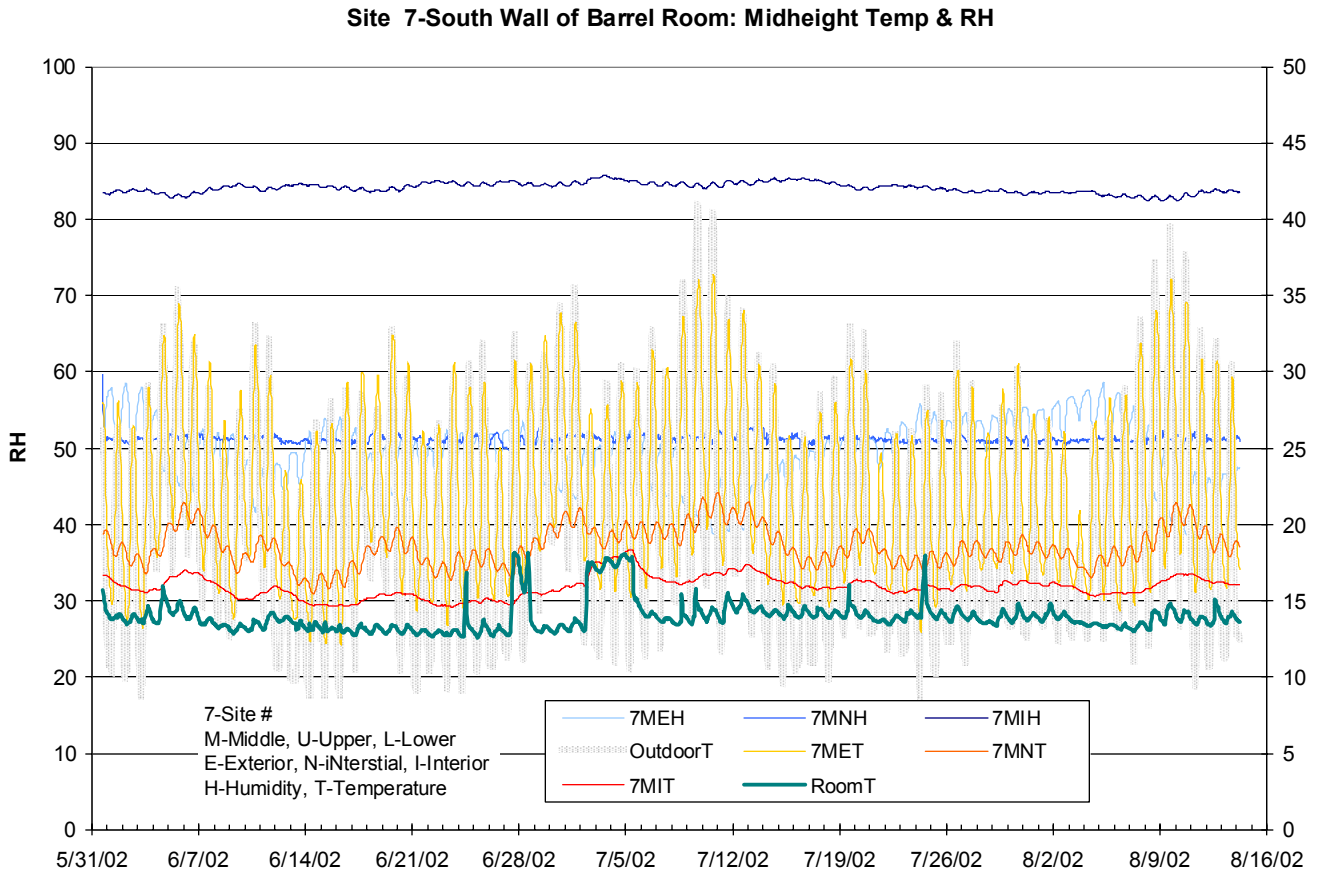
Figure 3.3: RH and T of South Wall of Barrel Room

The shading and high angle of the sun on the south side apparently avoids direct sun exposure on the exterior at mid height over this period since the 7MET (mid-height, exterior, temperature) sensor remains below the exterior temperature and peaks at a slightly later time (5 or 6 pm)(Figure 3.3). The exterior and mid-bale RH are slightly higher at this site than the east side but remain below 55%RH for the most part.

The cooler interior temperatures (they are more than 5 F cooler than the east side, likely because of the sheltering effect of the barrels) however, resulted in a higher than desirable RH just behind the earth plaster of 85% over the period of this graph. The RH dropped during the winter, but the plot in the Appendix shows that the RH is rising again toward

the end of the period. Since all three locations are showing the same response, this means that the interior RH of the barrel room should be reduced.

The second most important moisture load is relative humidity. In the case of the barrel room, the high interior RH places the walls at high stress. Because of the monitoring, it is known that the wall RH is being maintained, just, within the safety levels. (In most buildings, interior RH of much less than 50%RH should be maintained when it is cool outside, and even lower when it is cold outside.) In the case of the subject building, careful monitoring and control should be used to keep the RH in the Barrel Room at or below a daily average of 80% RH, since the south wall is exhibiting slightly high readings.

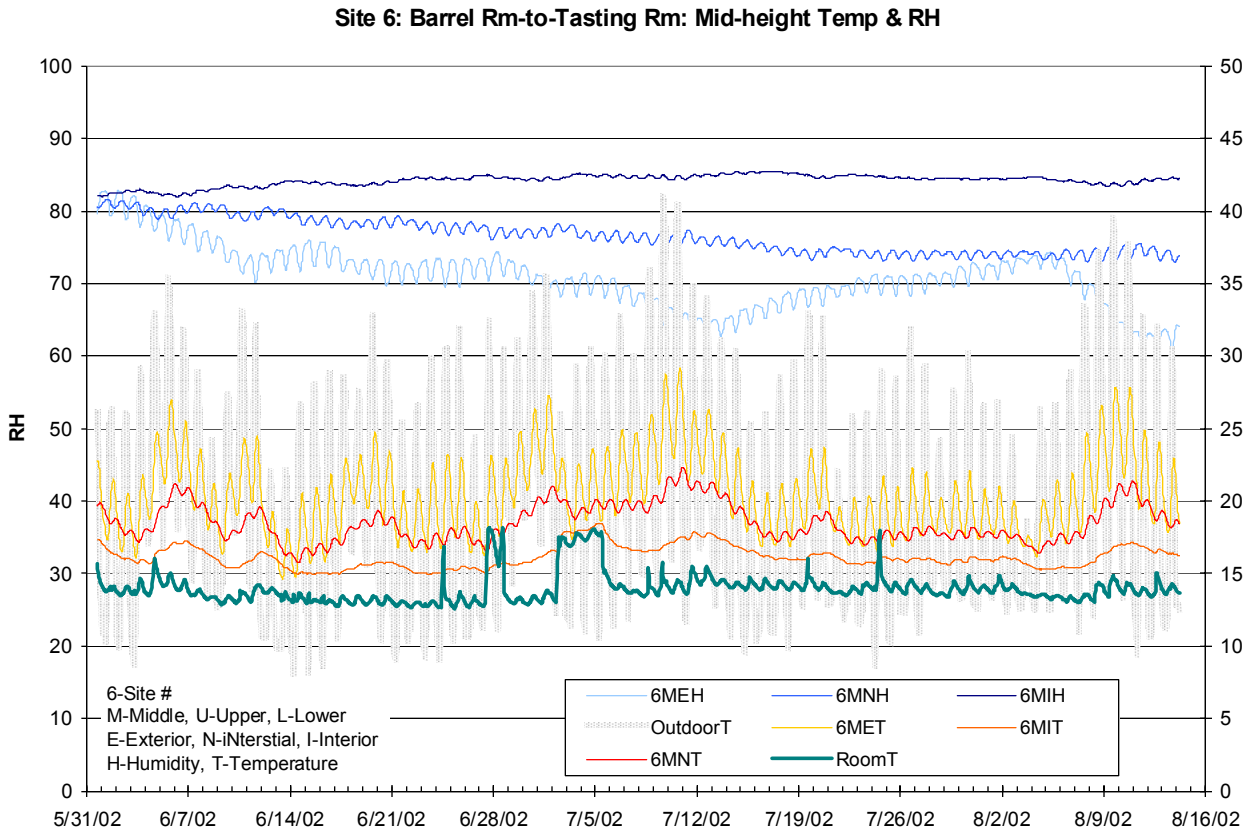
Figure 3.4: RH and T Within Wall Separating Tasting Rm and Barrel Rm

Site 6 (Figure 3.4) examines the unique wall that separates the barrel room from the tasting room. At the end of the study period, both sides are conditioned, whereas at the beginning of the period, the tasting room was a moderated version of outdoor temperature and humidity conditions. The outside temperatures are much lower than sensor stack Site 7 or 8 since the tasting room temperature is moderated. With no large driving temperature difference, the RH within the strawbale is predictably higher. In fact, it is over 85% just below the interior plaster, and around 70% near the tasting room side. Some drying of the tasting room plaster clearly occurred over the summer, but the tasting room side gains moisture as the barrel room RH increases.

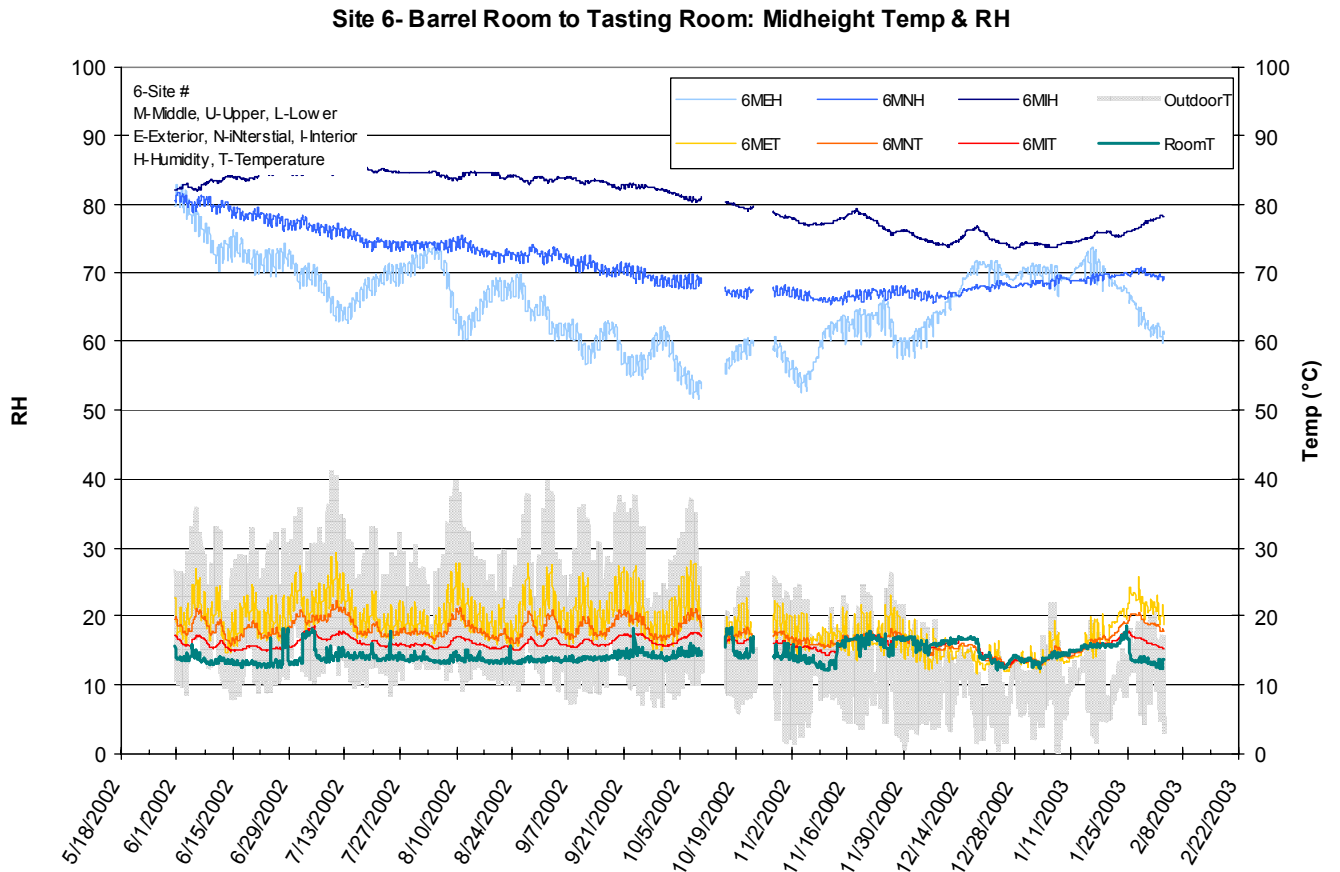
Figure 3.5: Drying out of Sensor Site #6

As the tasting room was conditioned later in the year, and the barrel room RH was controlled, the RH in these walls dropped to safer levels, showing the drying of construction moisture (Figure 3.5). The barrel room side is clearly the side which has the highest RH, since this is the source of the moisture, and the temperature across the wall is uniform. It can also be seen how the temperature variation become much less later in the period as the building interior become conditioned.

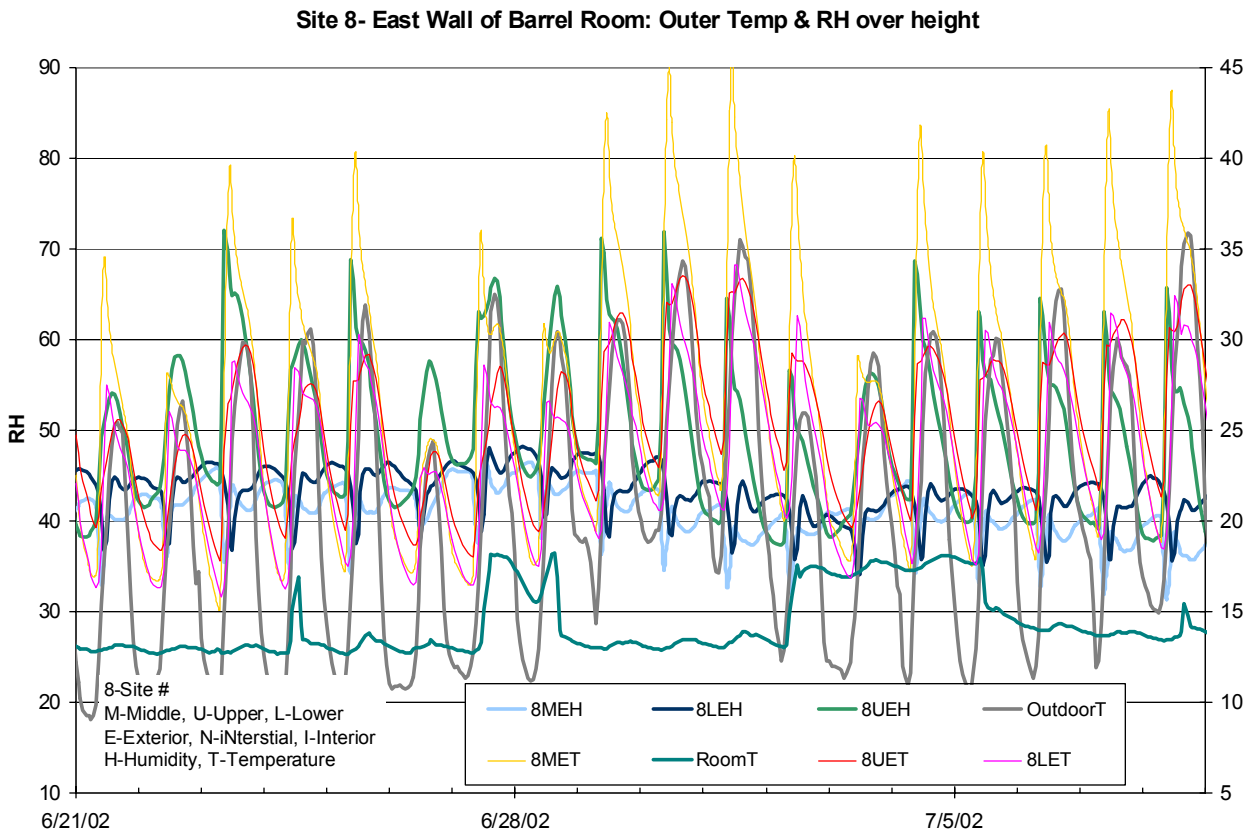
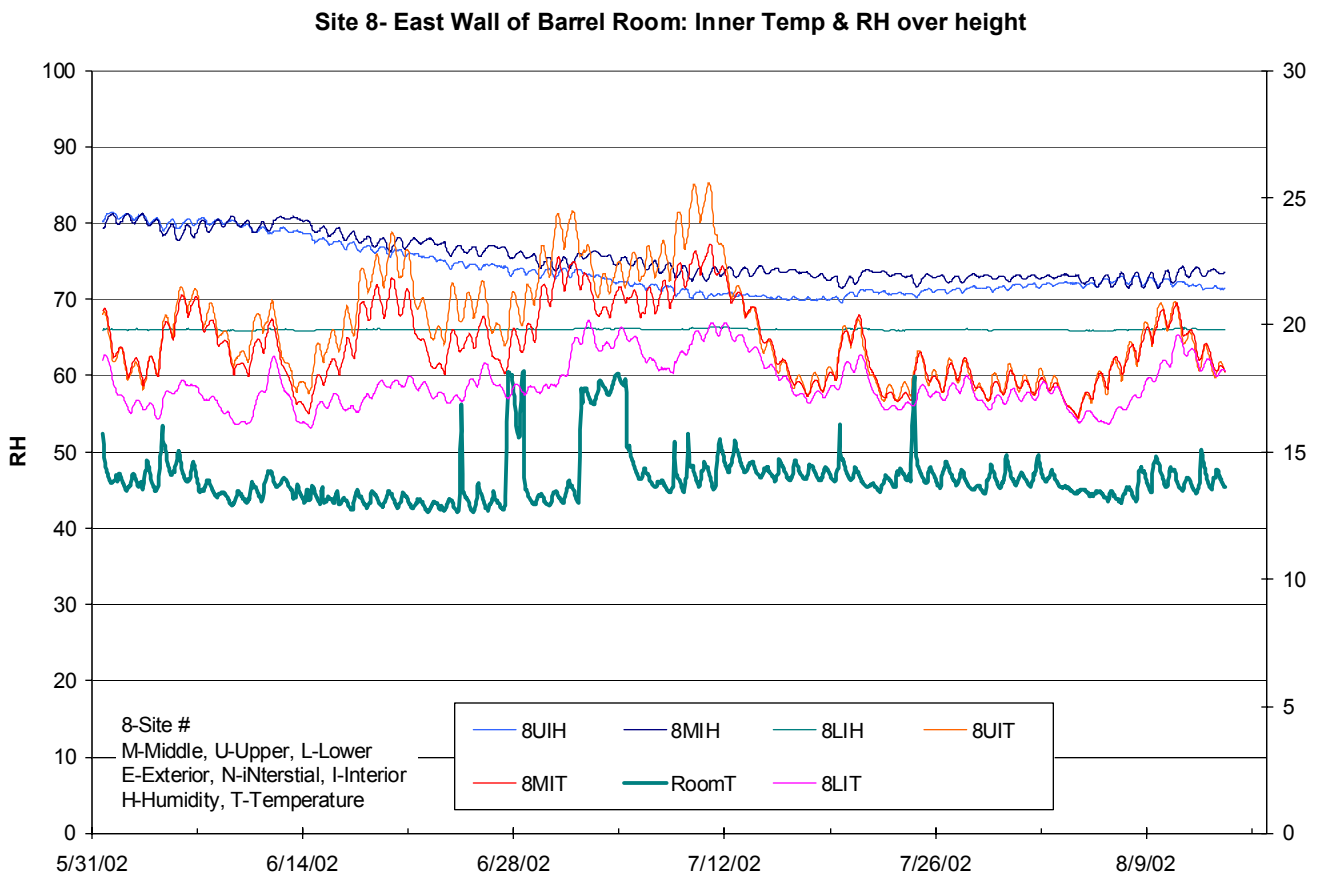
Figure 3.6: Vertical Variations in T and RH at Site 8

Variations over height were investigated in more detail at Site 8 (Figure 3.6, Figure 3.7).

The sensors UIT and MIT and UIH and MIH show that the upper and middle locations read very similar temperatures and RH. This provides some reassurance that the sensors agree with each other. The LIT sensor is somewhat cooler, likely reflecting the heat loss through the concrete slab near grade and the fact that cold air falls on the inside. The LIH sensor is assumed to be damaged since it is unnaturally stable.

Sensors MEH and LEH are almost identical, whereas UEH (the uppermost sensor) is much more variable.

The exterior temperature variation suggests that the mid-height sensor is the warmest while the top and bottom are cooler. The difference is mostly noticed in the peaks. This could be because the top sensor is more protected from the sun by the overhang, and the bottom sensor is connected to the massive and earth-connected concrete footing wall.

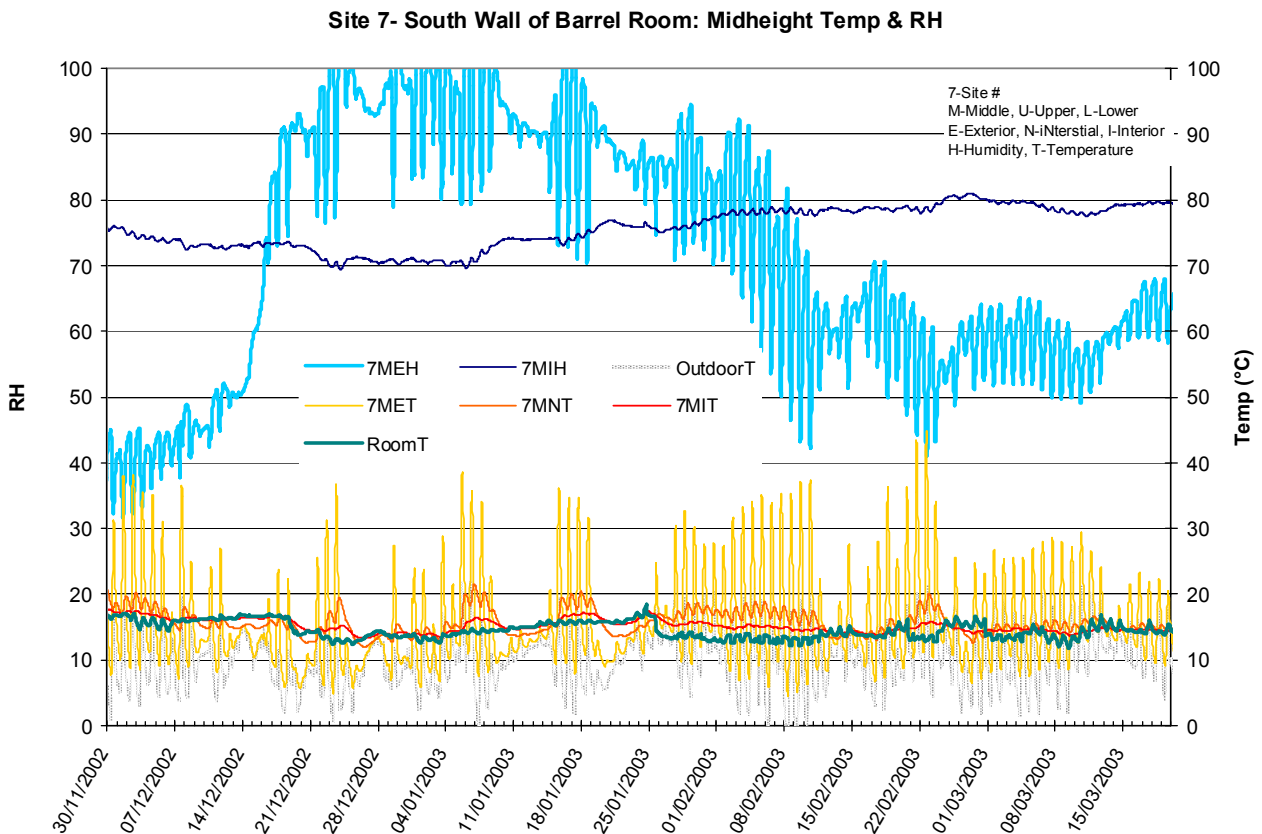
Figure 3.8: Response of Site 7 (midheight) to rain

The walls responded strongly to rain deposition. It is clear that even with the large overhangs some wetting does occur. An example of this performance can be seen at Site 7 (south wall of barrel room) just before Christmas, 2002 (Figure 3.8). The weather plots show heavy rain and winds from the south, and the wall on the south responds dramatically. The RH at the exterior rises quickly to almost 100%, and then drops to below 80% over the next 6 weeks, and returns to equilibrium within about 8 or 9 weeks. The interior RH sensor increased slightly, but almost not noticeably.

The lower sensor on the wall shows essentially the same performance, although the outer RH sensor failed in this case. The middle RH sensor shows that the wall does dry out. The upper sensor does not show this response pattern, since the overhang clearly protects this part of the wall from all rain. Note that all walls exhibit an increase in RH in the exterior sensors during the winter because of the dropping temperatures and increasing exterior RH.

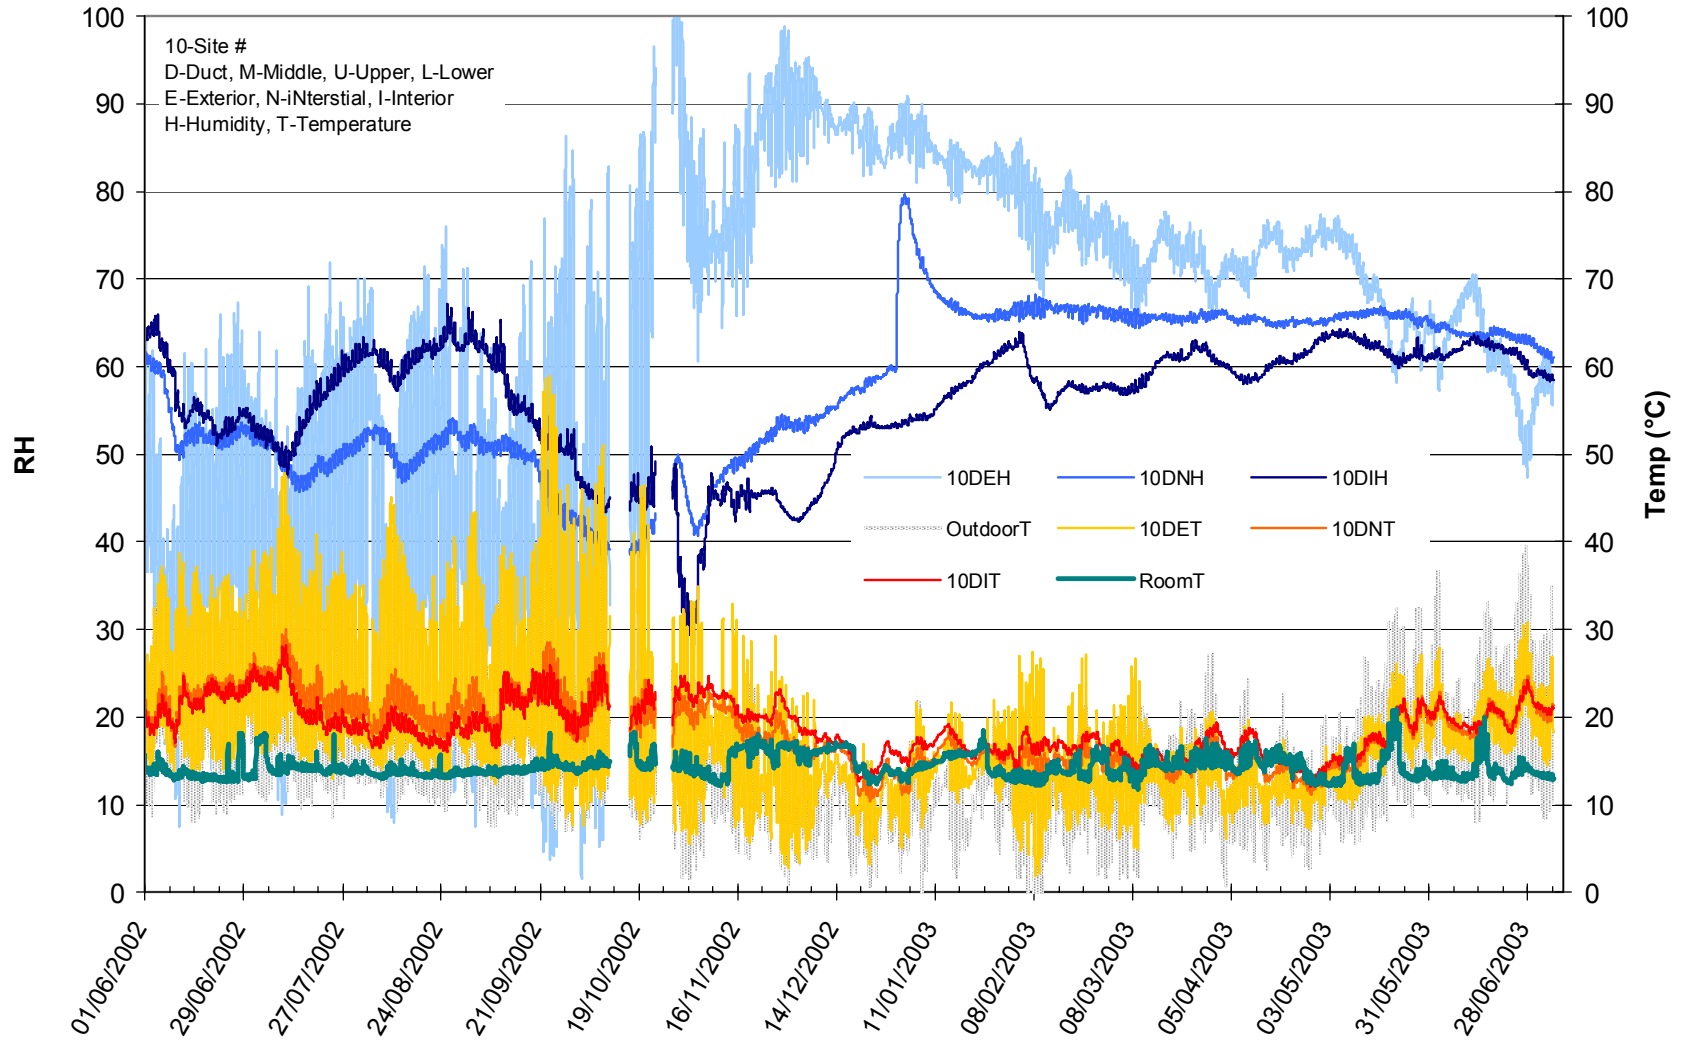
Site 10- Exhaust Duct on Wall of Barrel Room: Temp & RH

Site 10 is an exhaust port on the north side of the barrel room. Wetting from a rain event in November dried quickly, but a second rain event in November slightly rewet the wall again. The wall has dried down, quickly, but shows how exterior moisture can redistribute to the center of the wall as part of the drying process.

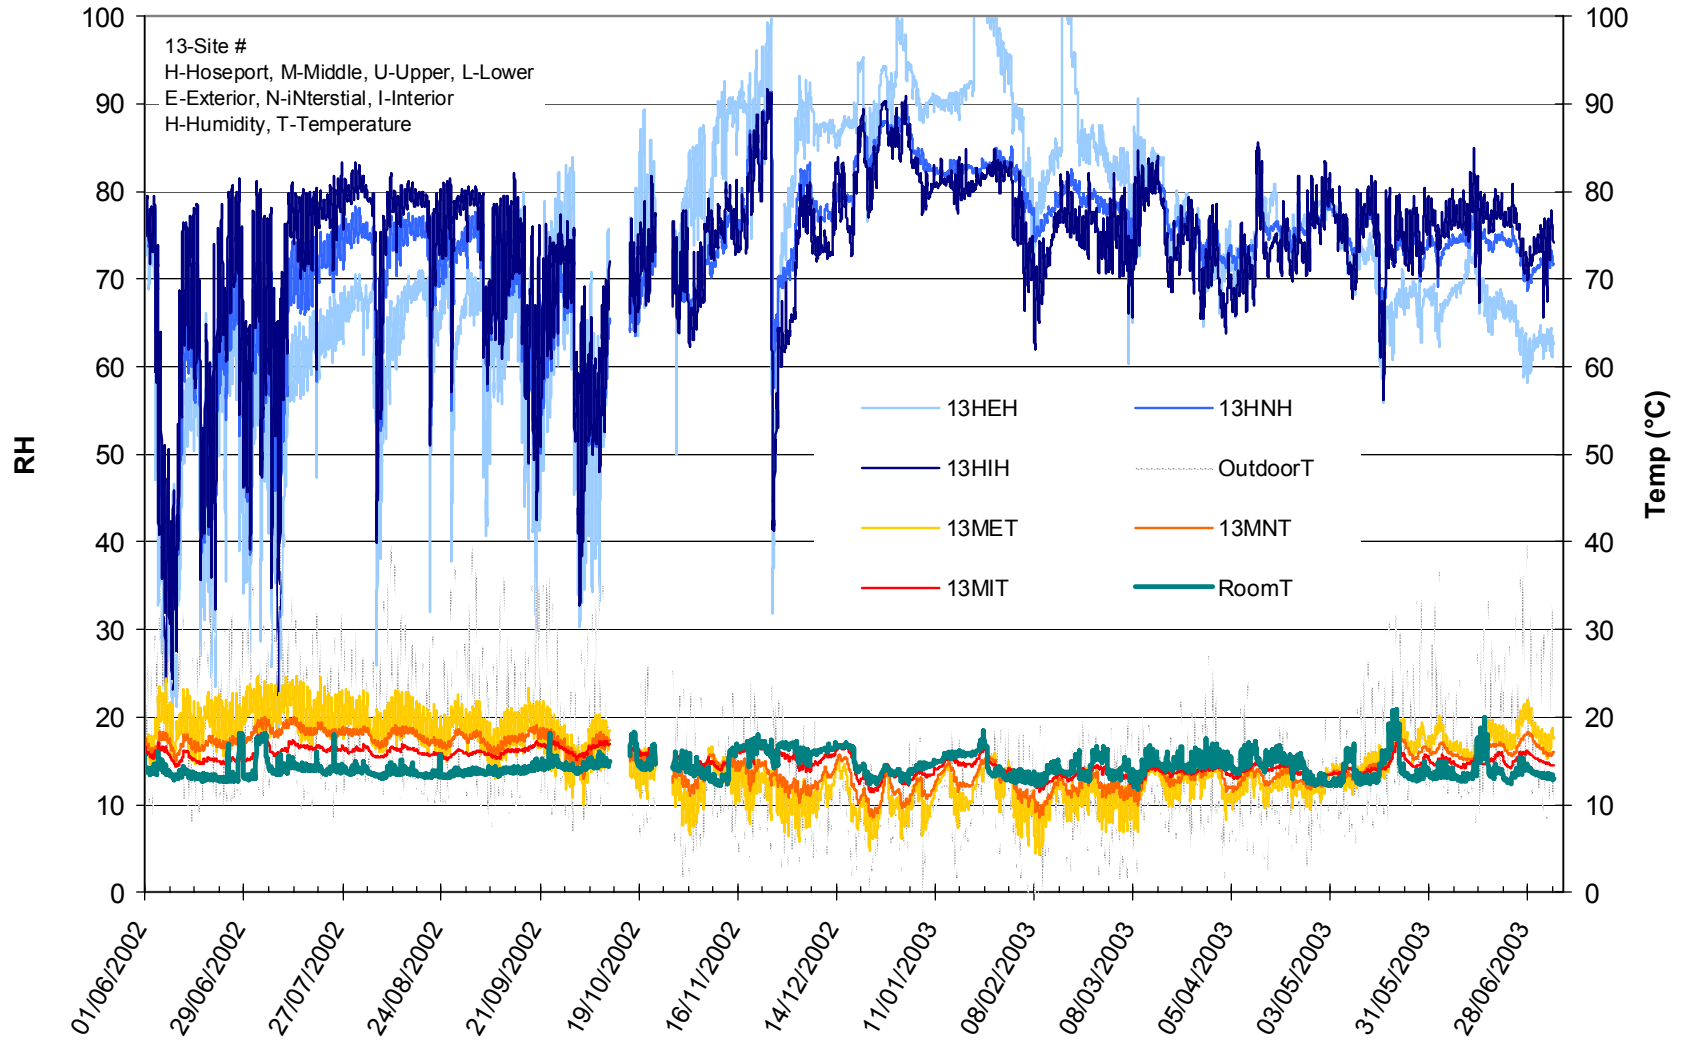
Site 13- Hoseport on South Wall of Barrel Room: Temp & RH

Site 13, the hoseport, shows repeated wetting events during the winter months, and RH values of close to the threshold for much of the monitoring period. Whether this is due to rain collection around the penetration, condensation on the cold metal pipes, leakage from the pipes, or sprayed water from operational activities is uncertain, but the cause should be investigated on site by the building managers. It appears to be slightly drier and more stable over the last 4 months, although why this is the case is unknown.

The hoseport (site 13) showed the consistently highest readings over the winter, but now appears to be drier and more stable. It should be inspected by the building operators.
