IN-PLANE CYCLIC TESTS OF PLASTERED STRAW BALE WALL ASSEMBLIES

**Cale Ash, Mark Aschheim
University of Illinois**

**David Mar
Tipping-Mar + Associates**

Abstract

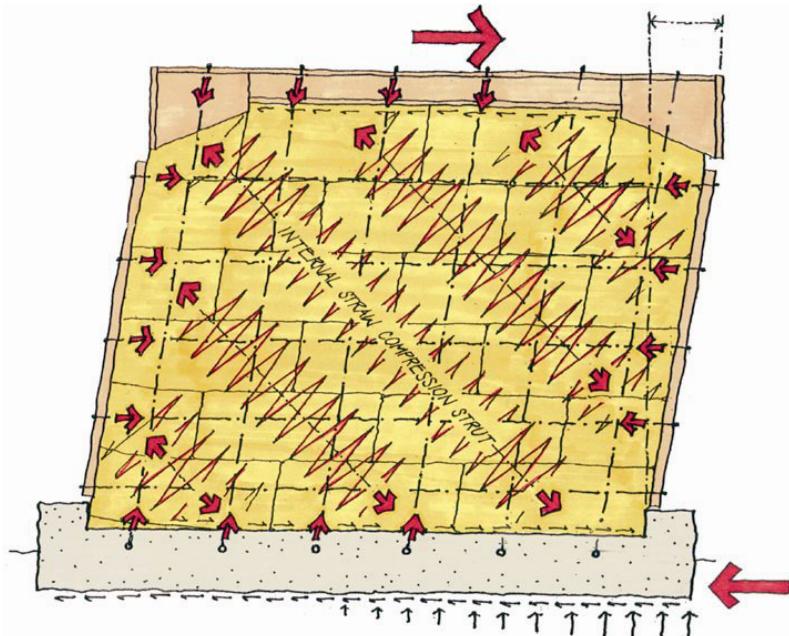
Figure 2.1 – Illustration of possible load path

The straw bale wall assembly represents a composite of elements that work together to resist lateral and gravity forces. One of the basic tenets of earthquake resistant design is to provide a ductile mechanism of resistance to lateral forces. Because the forces “flow” through many individual elements, the provision of ductility requires that brittle elements be provided with sufficient strength to ensure that ductile behavior develops in those elements capable of ductile response. Figure 2.1 illustrates one conception of the flow of forces in a straw bale wall assembly. In this figure, lateral forces applied at the top of the wall are resisted by an internal truss, composed of diagonal compression struts within the plaster skins or the straw bales and tension developed in vertical and horizontal ties in the stucco or plaster skins. Although discrete forces are shown in the figure, the actual forces are understood to be distributed throughout the straw or plaster, or carried by the mesh or twine. For the force flows illustrated in the figure, ductility would be obtained by yielding of the mesh in tension or deformation of the straw bales in compression, provided that other elements have sufficient strength and stiffness to cause the deformations to concentrate in the mesh or the bales.

It is clear that earth plaster and stucco facings are much stiffer than the straw bales themselves, and so if the compression struts in the bales are to be fully mobilized, the facings would have to degrade significantly under previous load reversals. Prior to this degradation, stress will develop throughout the field of each face, and these stresses will redistribute as the facings crack or fail locally due to the development of principal tension and principal compression stresses due to the applied lateral and gravity loads. The best prospects for obtaining “ductile” seismic response appear to be associated with several alternative possibilities: (1) rocking of the wall, (2) flexural yielding of the wall, and (3) development of compression struts in the bales. Rocking of the wall is associated with the opening of a gap at the base of the wall. Tensile reinforcement, if present, will yield and then fracture. Gravity loads, consisting of wall self weight and any load applied at the top of the wall, will provide a restoring moment that resists rocking about the toe of the wall. Flexural yielding at the base of the wall relies upon tensile reinforcement to develop flexural resistance to the applied lateral force. Both flexural yielding and rocking require that the compression zone of the wall not fail and that the shear strength of the wall be adequate. Sources of deformation include flexural yielding, gap opening, and horizontal slip at the base of the wall. The development of a compression strut in the bales normally requires the facings to be heavily damaged or to spall off, while maintaining the integrity of reinforcement and the connections at the top and bottom of the wall.

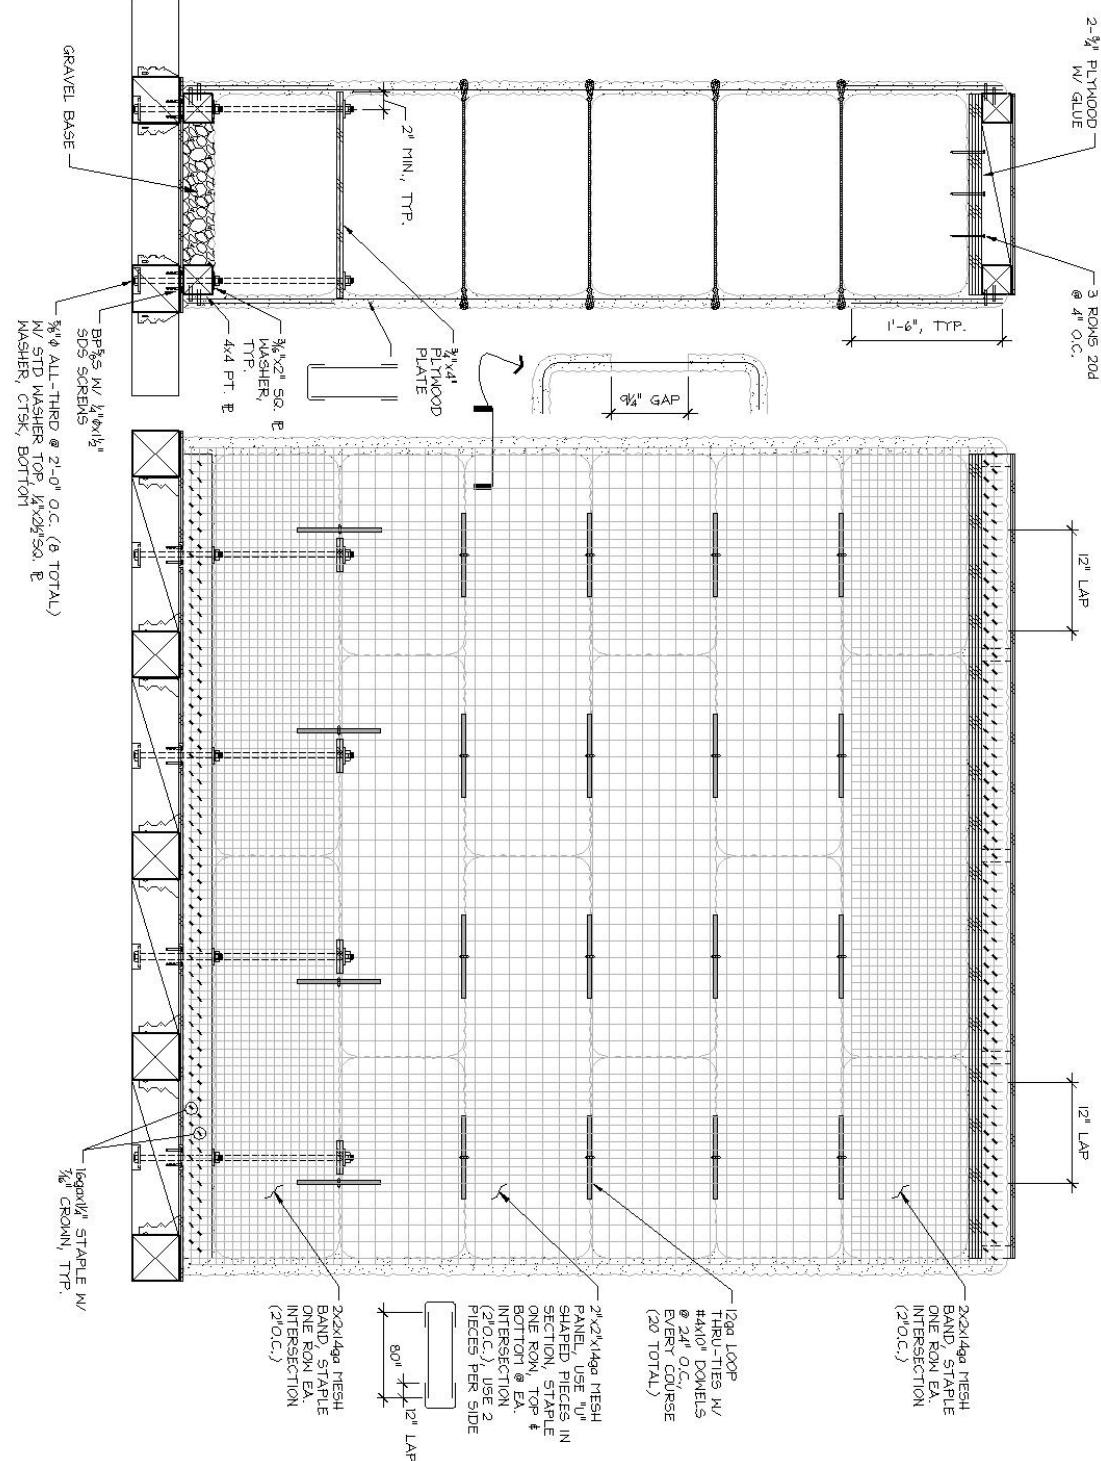
Figure 3.3 – Wall C

EARTH SKINS - HEAVY DETAILING

Six plastered straw bale assemblies were constructed and tested. Internally, each wall was similar, with six straw bale courses stacked in a running bond. Each course was the width of two bales, a nominal 8-foot width per course. The nominal height of each wall, from bottom of bale to top of bale, was also 8 feet. Two different skin materials, earth plaster and cement stucco, and three different levels of reinforcement details were used, representing light, medium, and heavy reinforcement. Reinforcing details were either selected from practical use or modified to obtain a desired result as discussed in Chapter 2. Some details are simple such as several twine tie-downs, while others are more complex such as lapped wire mesh and confined bale courses. Figures 3.1 through 3.6 show construction drawings for each of the six wall specimens.

One of the objectives of this experimental research project was to determine the impact of various reinforcing details and materials. As shown in Figures 3.1 – 3.6, several combinations of reinforcement and configuration were employed in the wall construction. In total, there were four types of skin reinforcing materials used:

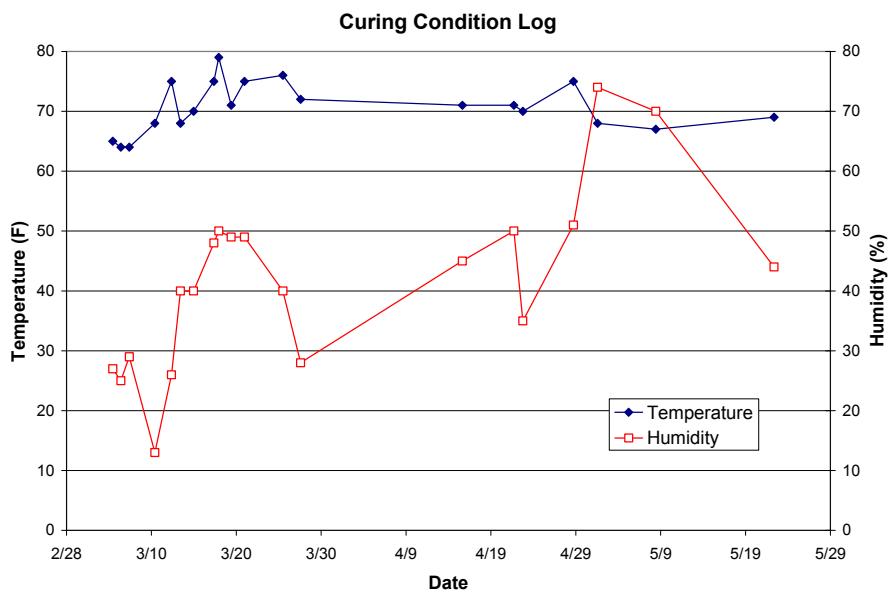
Figure 4.1 – Curing conditions

The earth and stucco plasters were applied to the walls and cured in the same environment as the cube samples. Temperature and relative humidity of laboratory were recorded periodically. The recorded values are shown in Figure 4.1, with a mean temperature of 70.7°F and a mean humidity of 41.7%.

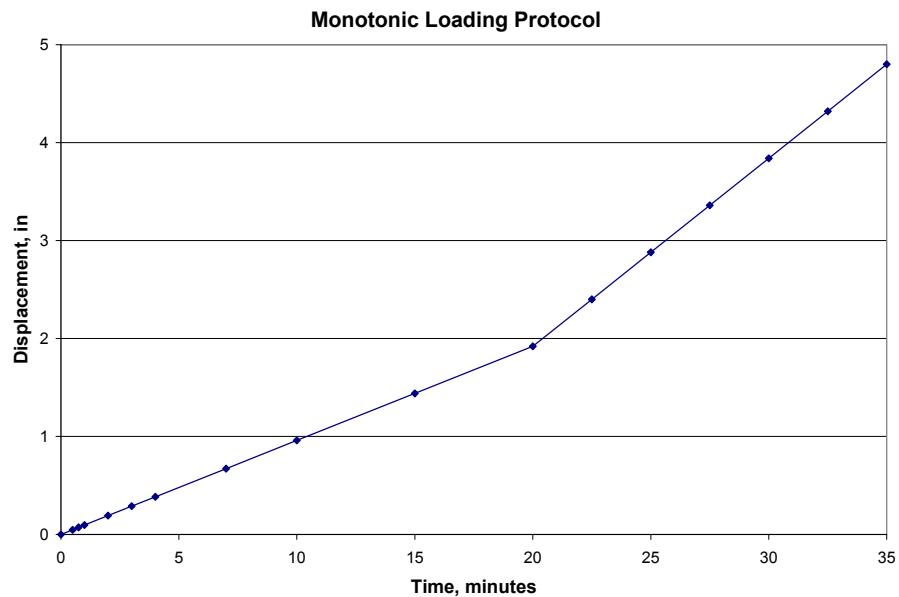
Figure 5.1 – Monotonic loading protocol

All walls with the exception of the lightly detailed earth plaster wall (Wall A) were tested according to the same protocol, described in the following section. Wall A was not intended for seismic resistance but rather for non-seismic applications. Therefore, a cyclic testing protocol was too rigorous. A simple monotonic displacement profile was instead used as shown in Figure 5.1.

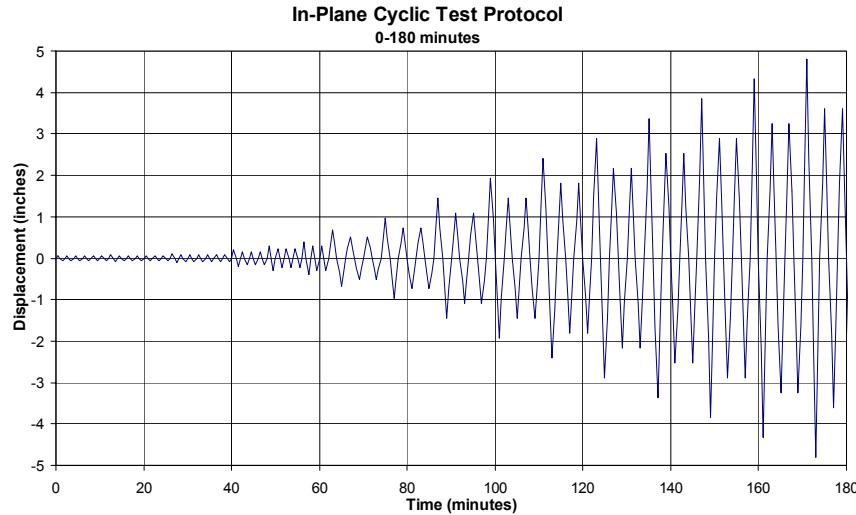
Figure 5.2 – Cyclic test protocol (0-180 minutes)

In order to gain sufficient data on the engineering properties of the other five straw bale wall assemblies tested cyclically, a protocol was desired which would not incur premature damage to the specimen. The protocol shown in Figure 5.2 was modified from an existing one used for testing shear walls and was deemed suitable for this application. Based on research and prior experience, initial yielding was expected to occur at perhaps 0.10% of the nominal wall height of 96". This cyclic displacement of 0.096" was selected as the third load step increment, occurring at 26.5 minutes after the test start. This predicted initial yield drift level was reached on the 14th cycle, providing many cycles of smaller amplitude data on the elastic properties of the tested wall. As shown in Figure 5.2, there are many cycles in the small displacement range to capture

the yielding behavior of the tested wall. Subsequent cycles increase in amplitude, reaching 5% drift (4.80 in) at the end of the protocol.

This protocol has 16 load steps of increasing displacement with trailing cycles after each peak cycle as shown in Table 5.1. After completion of the programmed test protocol, each wall was manually loaded to obtain two cycles of 7.5% drift (7.2 in). This extreme displacement was used to establish the performance of the straw ball wall assembly at high drifts. Higher drifts could not be obtained due to physical limitations of the testing setup.

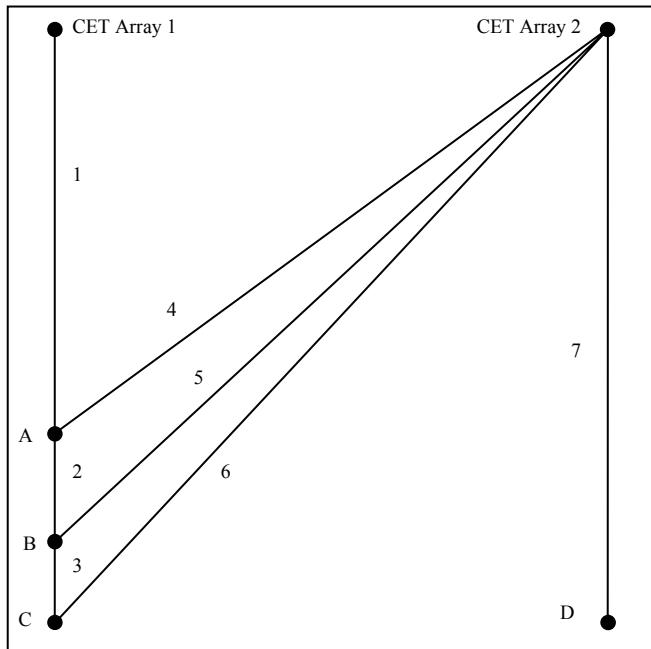
Figure 5.3 – Instrumentation schematic

Additional instrumentation was used to further evaluate the structural response and effectiveness of various details. Cost, complexity, and fidelity are all considerations when designing an instrumentation setup. Prior research and experience combined with some engineering judgment led to the design of the instrumentation shown in Figure 5.3, which uses cable-extension transducers (CETs) for measuring the displacement of Points A, B, C, and D. Each CET converts the extension of a flexible cable into a voltage which is digitally recorded at a rate of 2 hertz. These voltage measurements can be converted to displacement during subsequent data analysis.

In total, seven CETs were used in two arrays. CET Array 1 had three transducers and Array 2 had four (Figure 5.4 shows Array 2 for reference). Each array was attached with the $3/4'' \times 4''$ lag screws fixing the header beam to the loading beam, maintaining a constant distance between the arrays. CETs 1 and 4 measured the spatial displacement of Point A, CETs 2 and 5 measured Point B, CETs 3 and 6 measured Point C and Point D was measured by CET 7 alone. Points C and D were rigidly attached to the 6×6 wood base, with a constant spacing, and measure the overall deformations of the wall. Points A and B were inserted in small holes drilled into the plaster material, and measure interstitial deformations within the wall. Point A was located just below the start of the third bale course and Point B was located just below the second bale course, in order to measure the deformation in each course.

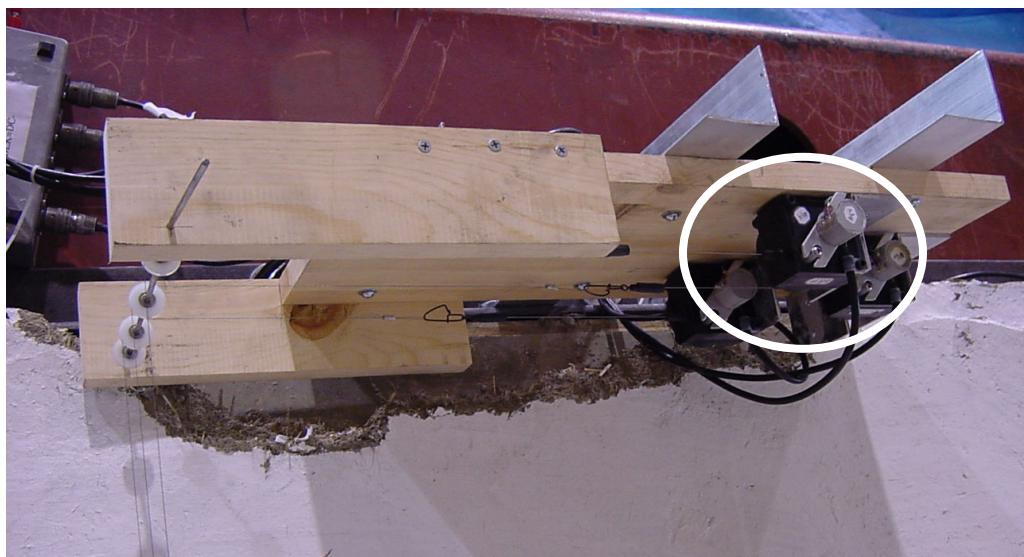
Figure 5.4 – Cable-extension transducer array photograph (transducer circled)

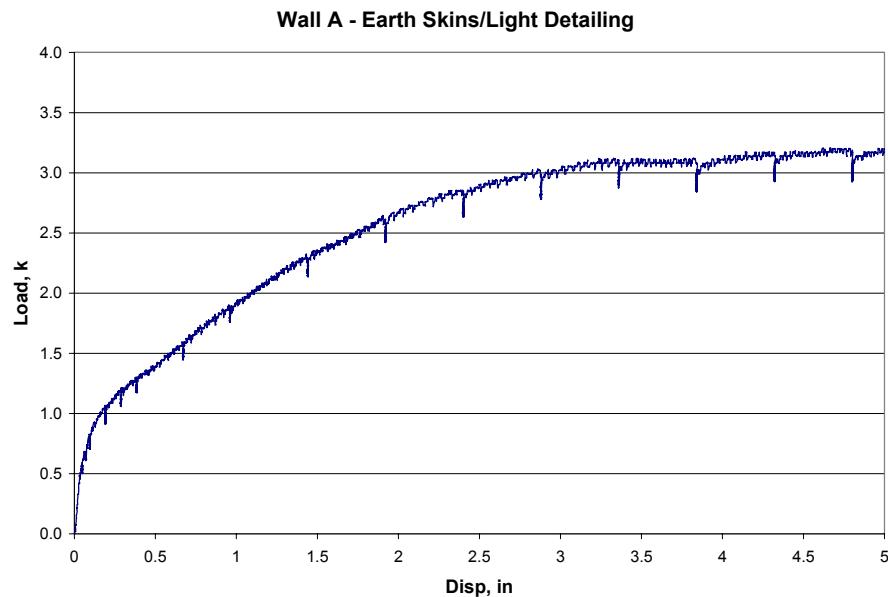
Figure 6.1 – Wall A load-displacement plot

Wall A was not designed to resist seismic actions and was therefore tested under monotonic loading. The loading was carried out at a rate similar to the initial rate of the cyclic protocol, and pauses were taken at each of the peak displacement values given in Table 5.1 to observe and record the progression of damage to the wall. The resulting load-displacement plot is shown in Figure 6.1. One may observe a minor reduction in load at each pause.

The peak capacity of Wall A was 3.2 kips, which was reached at 4% drift (3.84 inches) and was maintained for higher displacements. Non-linear load-displacement response was observed near 0.75% drift and a load of 0.7 kips. However, the load capacity continued to increase up to 3.5% drift and remained constant after this. During loading, the header beam was observed to slip relative to the top course of bales as evidenced by cracking in the plaster returns at the top of the wall as shown in Figure 6.2. At lower displacements (less than 2.4 inches) the failure mode appeared to be dominated by slip of the box beam relative to the top course of bales, corresponding to lateral loads less than 2.85 kips. Above this 2.5% drift level, crushing of the earth plaster in the compression zone commenced as lateral load capacity increased to the maximum value of 3.2 kips. The increase in lateral resistance and shift in location of damage

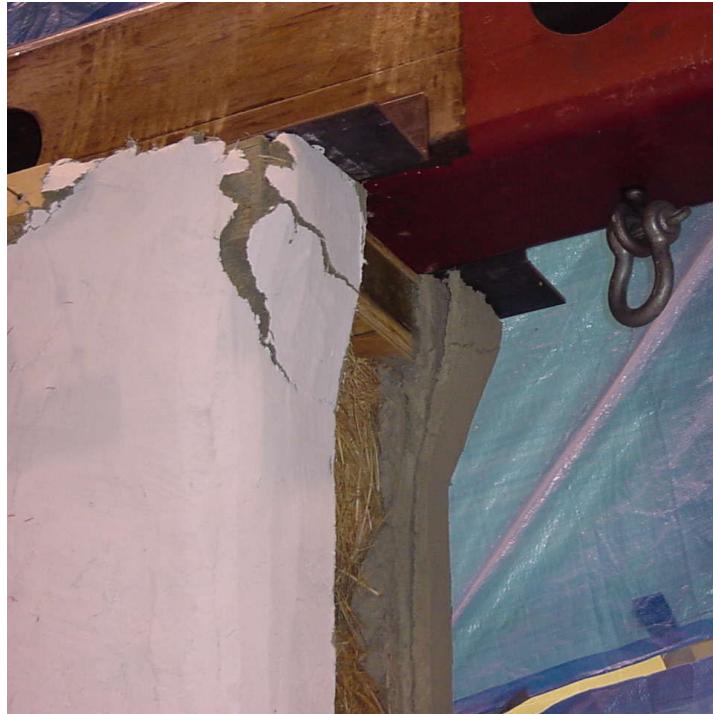
Figure 6.2 – Evidence of header beam slippage in Wall A

suggests that the poly-twine loops around the box beam became engaged after the box beam slipped sufficiently. There was no evidence to suggest the poly-twine failed at any point during the tests, as the poly-twine was found to be taught when inspected at the gaps that opened at the base of the wall during testing.

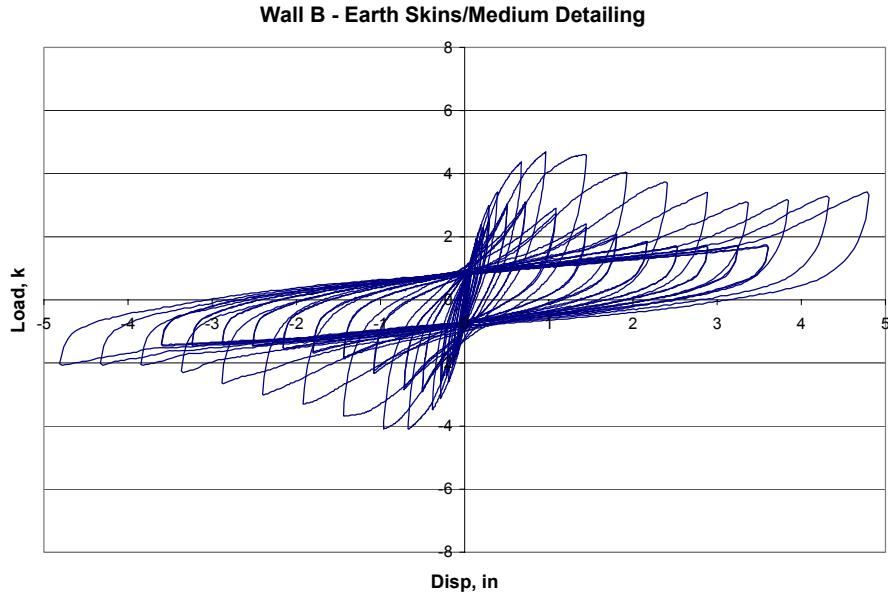
Figure 6.3 – Wall B load-displacement plot

During testing, the predominant failure mode observed was compression zone crushing and base sliding, with the base sliding becoming more pronounced at later stages of the test. The peak capacity of 4.7 kips was reached on the 8th load step, at a drift level of 1% (0.96 inches). Looking at the load-displacement plot in Figure 6.3, the change in the hysteresis loops with increasing displacements suggests that sliding of the wall becomes more significant at higher displacements. Manual measurements taken to assess the sliding behavior indicated 3/4" amplitude (peak to peak) of slip during load step 14 (4% drift), accounting for 20% of the actuator displacement at this amplitude. The higher amplitude cycles were observed to wear down the earth plaster at the base, which gradually reduced it to sand, clay, and straw components, resulting in a corresponding reduction in the height of the wall, due to this wearing and crushing behavior. Often this soil debris served as a wedge to push the plaster out of plane, away from the bales, when the plaster was loaded in compression. As this occurred, the plaster would crush down over the 6×6 ties, thereby creating a form of interlock and shear resistance

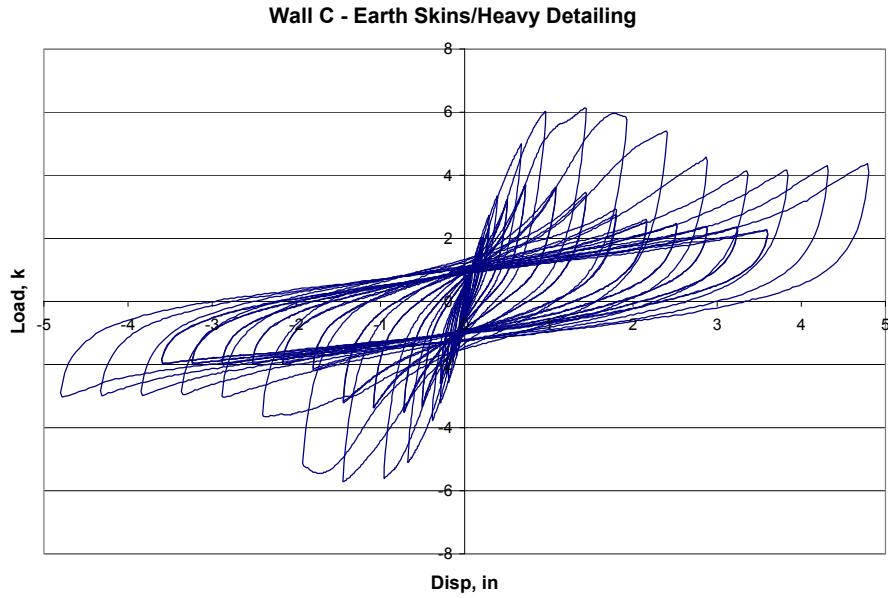
Figure 6.4 – Wall C load-displacement plot

Wall C used a heavy 2"×2" 14-gauge wire mesh with the first course of bales anchored to the base via plywood plates and threaded rods. As shown in Figure 6.4, these modifications resulted in an increase in the lateral strength of this wall relative to that of Wall B, with a peak load of 6.1 kips occurring at 1.5% drift (1.44 inches). At 1% drift, the 6.0 kip resistance was an increase of nearly 30% over the corresponding resistance of Wall B at this drift level.

The overall structural response of this wall was similar to that of Wall B, with predominant failure modes consisting of crushing of the earth plaster and sliding of the wall at its base. The heavier mesh was observed to reduce the slip at the base of Wall C from a peak-to-peak amplitude of 3/4" in Wall B to 1/2" amplitude in this specimen at a drift of 4%. No flexural tension cracks were observed during testing of Wall C, indicating the mismatch of plaster compressive strength to wire mesh tensile strength. Similar to Wall B, this wall also experienced the plaster interlocking with the 6×6 ties at drifts above 3%.

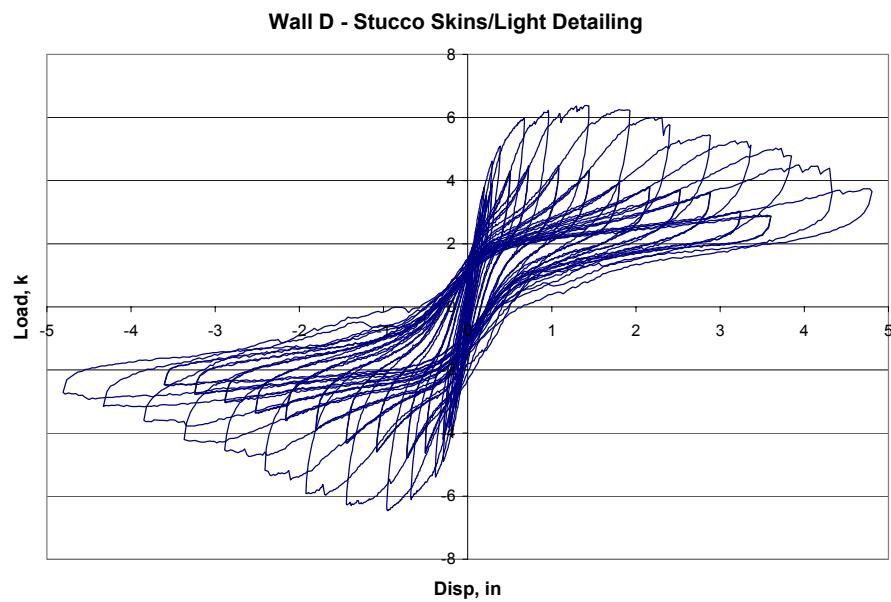
Figure 6.5 – Wall D load-displacement plot

The lightly detailed cement stucco wall used 17-gauge chicken wire mesh as skin reinforcement and to assist stucco placement. Unlike Wall C, this combination of a strong skin and a relatively weak reinforcement led to a different failure mode. The initial stiffness of the walls with cement stucco skins was greater than that of the earth plaster skins. Figure 6.5 shows the load-displacement plot for this test and the pinching nature of the hysteresis loops suggests the presence of the rocking behavior that was visually observed at higher displacements.

The peak load of 6.4 kips was only marginally higher than that observed for Wall C, but the post-peak behavior was dominated by rocking rather than sliding. As higher displacements were reached, two distinct failures were observed at the base of the wall. In some locations the weak mesh was elongated and had fractured, while at other locations the 2×4 sill plate receiving the mesh staples failed in cross-grain bending as shown in Figure 6.6. By the end of the test, the combination of mesh fractures and sill failure had progressed along the full length of the wall, allowing the observed rocking behavior to occur unimpeded. None of the staples anchoring the mesh were observed to fail or pull out.

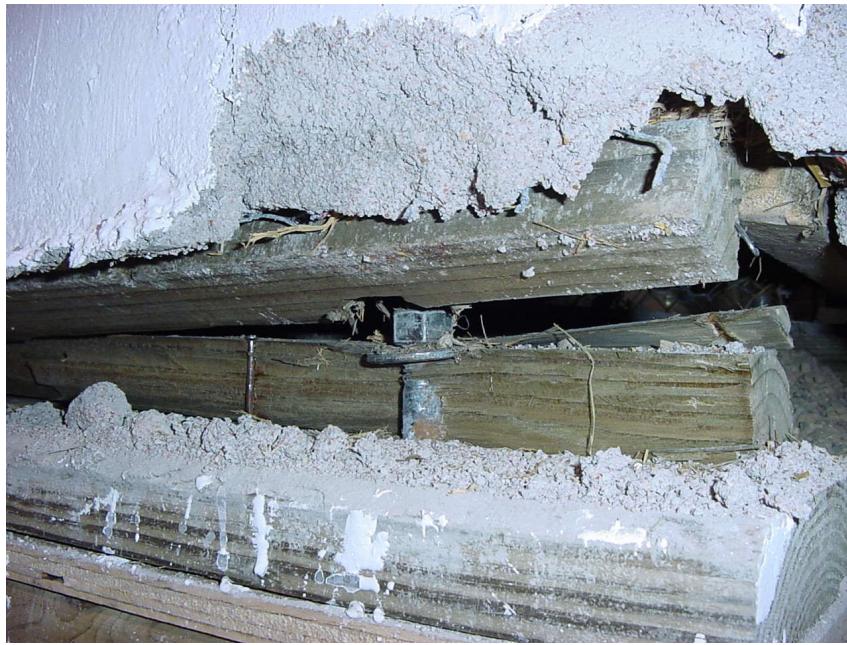
Figure 6.6 – Wall D cross-grain bending failure of sill plate
(Photographed at 5% drift, well after failure had occurred)

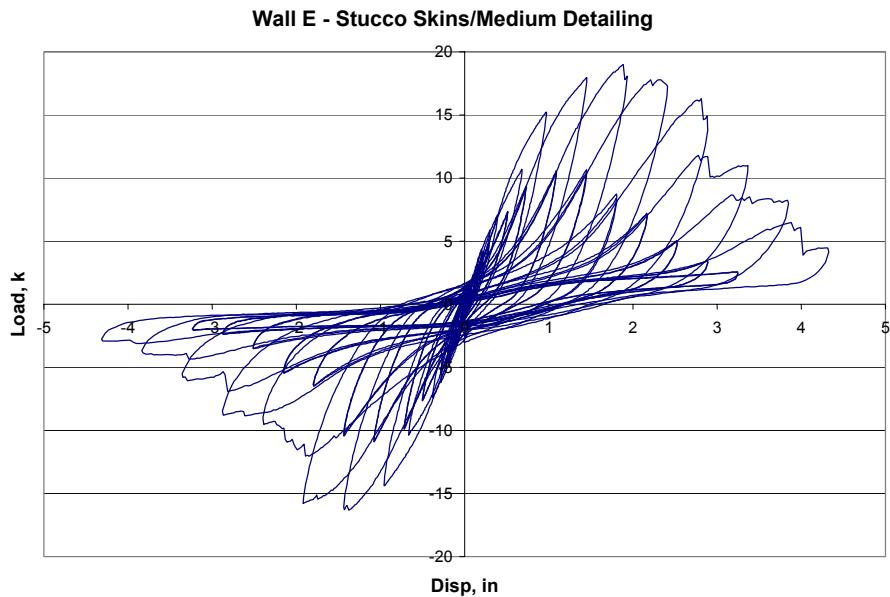
Figure 6.7 – Wall E load-displacement plot

For the medium-detailed cement stucco wall the heavier 14-gauge 2"×2" mesh was used to reinforce the stucco and additional staples were used to attach the stucco to both the sill plate and the header beam. Through-ties running through the thickness of the wall and anchored by dowels in the body of the stucco were installed at every other course, to reduce the likelihood of skin buckling under compressive loading. Instead of the 2×4 sill plate, which failed in Wall D, a 4×4 sill plate was used, and the 4×4 plate was anchored more frequently. The combination of cement stucco skins and heavier wire mesh resulted in an increased lateral strength, having a peak value of 19 kips at 2% drift, as shown in Figure 6.7.

This increase of nearly 200% over Wall D was associated with the development of several flexural cracks within the bottom third of the wall height as shown in Figure 6.8. The ultimate failure mode for Wall E was the loss of tensile capacity of the reinforcing mesh, from both mesh fracture and staple pull out, as shown in Figure 6.9. The mesh fracture was attributed to a combination of tensile elongation and low-cycle fatigue associated with the load reversals, which appeared to work the vertical wires of the mesh. The failures predominately occurred at the staple locations with some failures also occurring at the intersections of the horizontal and vertical wires, where the wires are spot welded together in the manufacturing of the mesh.

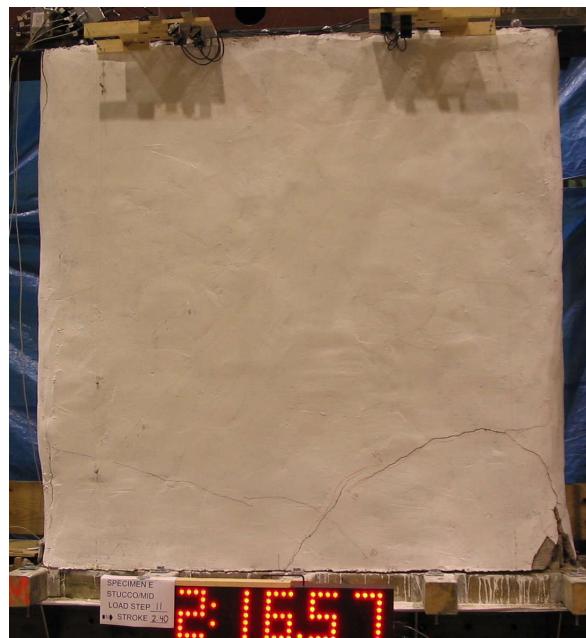
Figure 6.8 – Flexural cracks in Wall E (2.5% drift level)

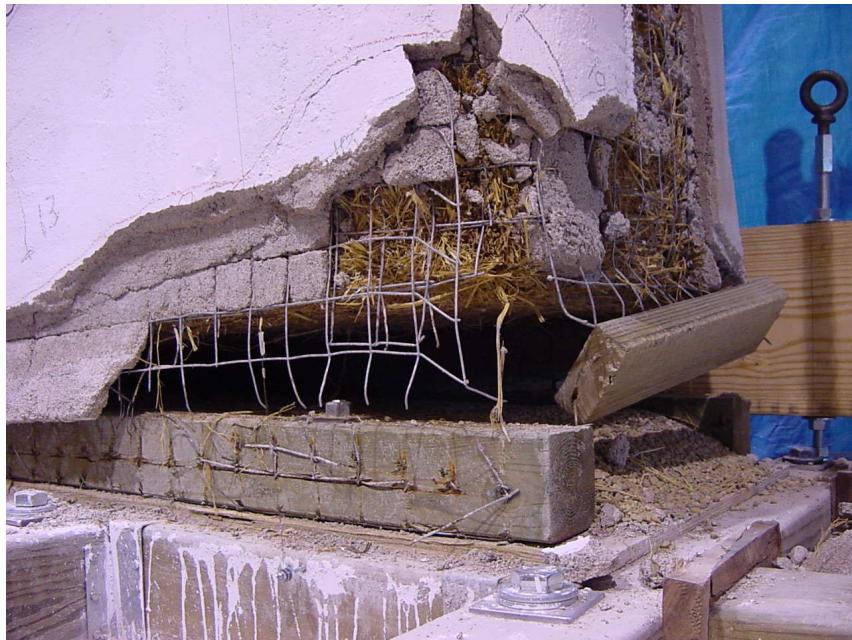
Figure 6.9 – Wall E mesh failure (7.5% drift level)

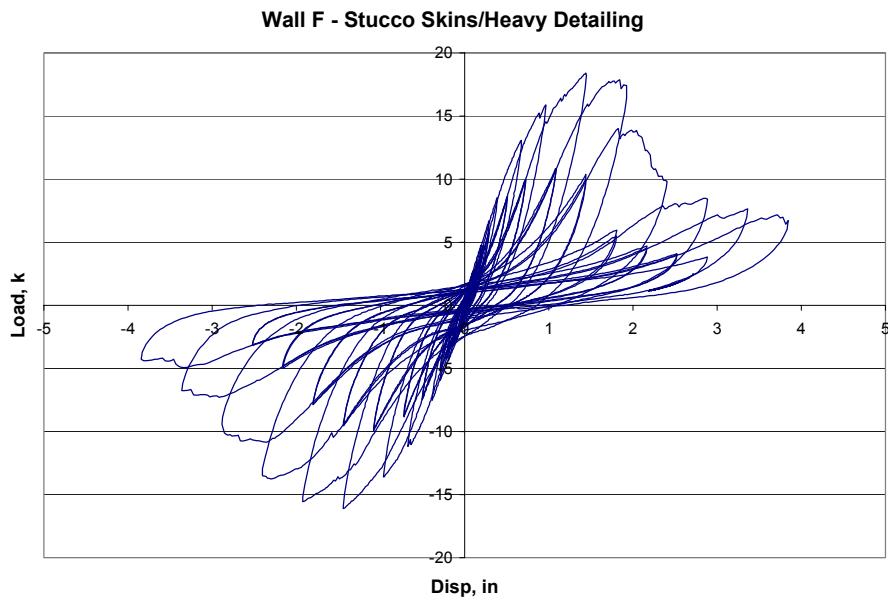
Figure 6.10 – Wall F load-displacement plot

The heavily detailed Wall F added spikes from the header beam, additional cross ties, and confinement to the first bale course to the details of Wall E. Figure 6.10 shows the load-displacement response of this wall. The peak lateral strength of 18.2 kips was reached at 1.5% drift, and the capacity at 2% drift was 17.9 kips. A comparison of Figures 6.7 and 6.10 from Walls E and F, respectively, shows the limited benefit gained from the additional detailing provided in this wall.

The confinement of the first bale course was intended to shift the failure above this level while distributing the yielding of the reinforcing mesh over more of the wall height, aiming to achieve a more ductile behavior. The ultimate failure was indeed observed at this level as shown in Figure 6.11, although there was not an appreciable difference in the ductility or strength of this wall compared to Wall E.

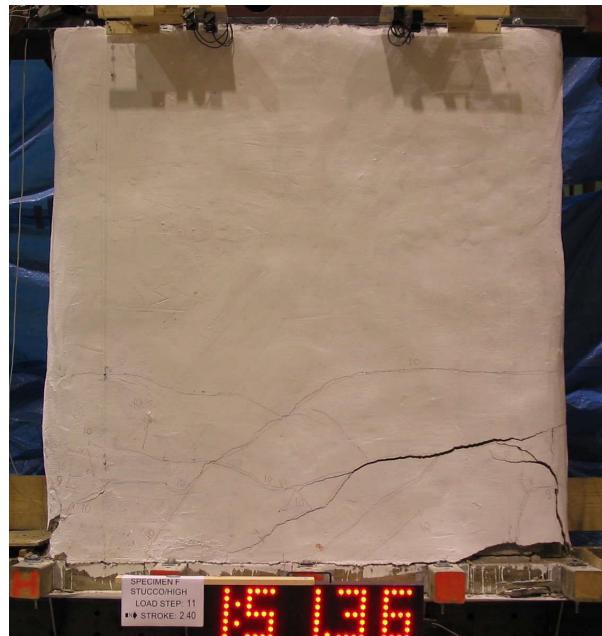
Figure 6.11 – Wall F flexural cracks (2.5% drift level)

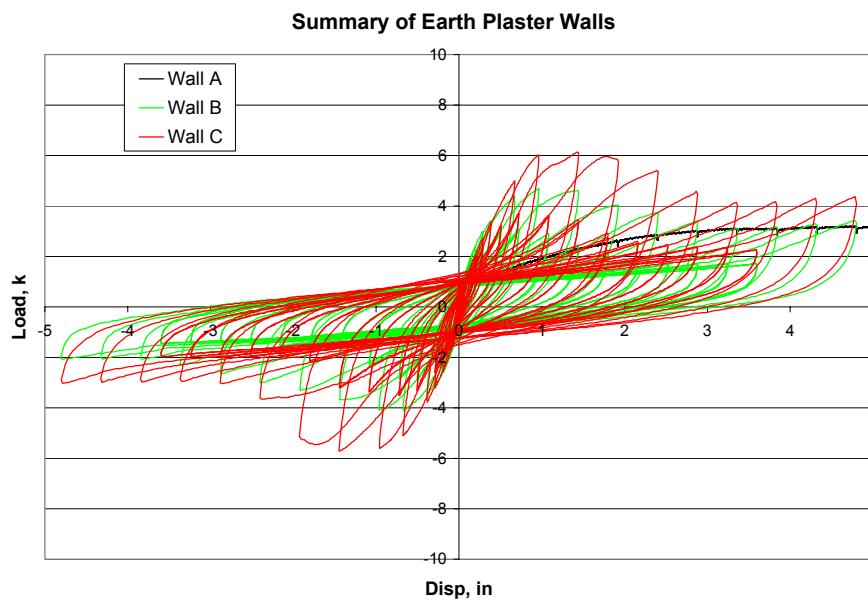
Figure 7.1 – Summary of earth plaster wall tests

A comparison of the three earth plaster skinned walls tested is shown in Figure 7.1. As this plot indicates, the added reinforcement of Wall C did increase the capacity over that of Wall B across the entire displacement range. The monotonically tested specimen, Wall A, had a capacity similar to that of Wall B at higher displacements (over 3 inches) but a lower capacity in the smaller displacement range. All three walls performed acceptably in the higher displacement ranges, with no indications of instability.

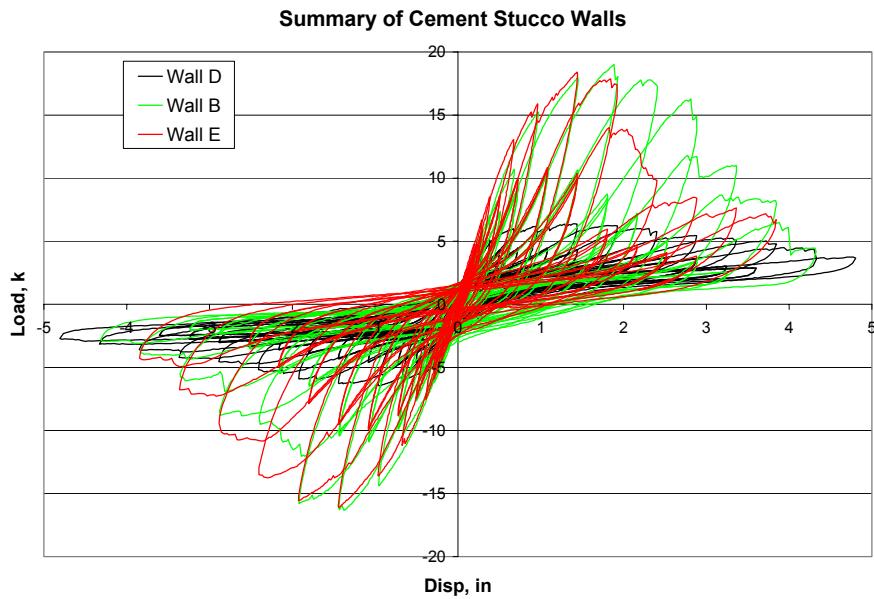
Figure 7.2 – Summary of cement stucco wall tests

Overall, the cement stucco skinned walls had higher capacities than the correspondingly detailed earth plaster skinned walls. As shown in Figure 7.2, both strength and stiffness are increased relative to Walls A, B, and C. The lightly detailed cement stucco specimen, Wall D, had only a small increase in capacity over the heavily detailed earth plaster specimen, Wall C. However, Walls E and F had substantially higher capacities than any of the other four specimens. The individual capacities of these Walls E and F were nearly identical as illustrated by the oft-overlapping curves in Figure 7.2. Similar to the earth plaster walls, all three cement stucco walls performed acceptably at higher displacements. For all specimens, the strength capacities above 4% drift (3.84 inches) were similar.
