**CYCLIC IN-PLANE TESTING OF POST AND BEAM WALLS  
WITH STRAW-BALE IN-FILL AND STUCCO/PLASTER**

Master of Science in Civil Engineering

University of Washington

1999

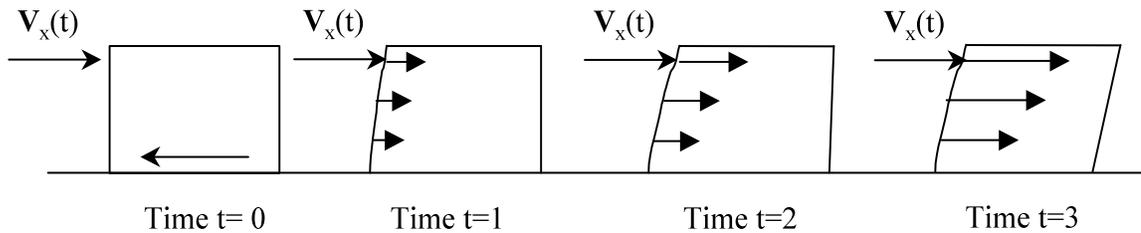
Figure 2: Schematic of Gradual Displacements in a Straw-Bale Wall due to In-plane Loads

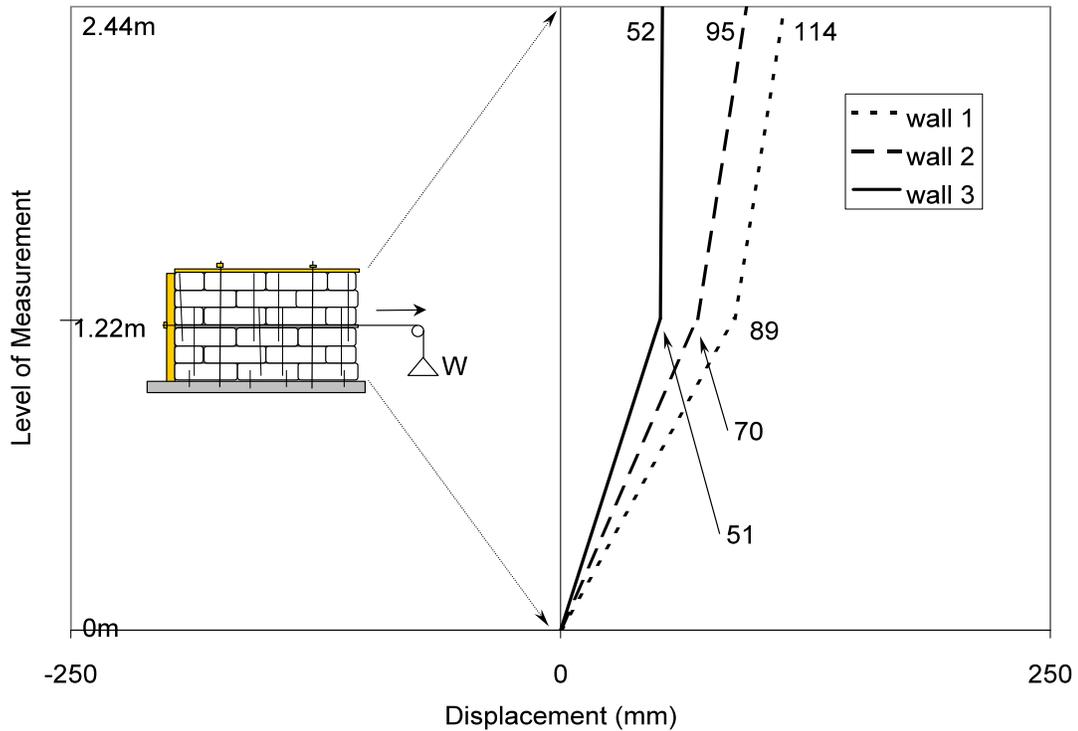
Figure 3: Graphical Representation of Deformation Induced by In-plane Loading on Load Bearing Straw-bale Walls w/out Facings

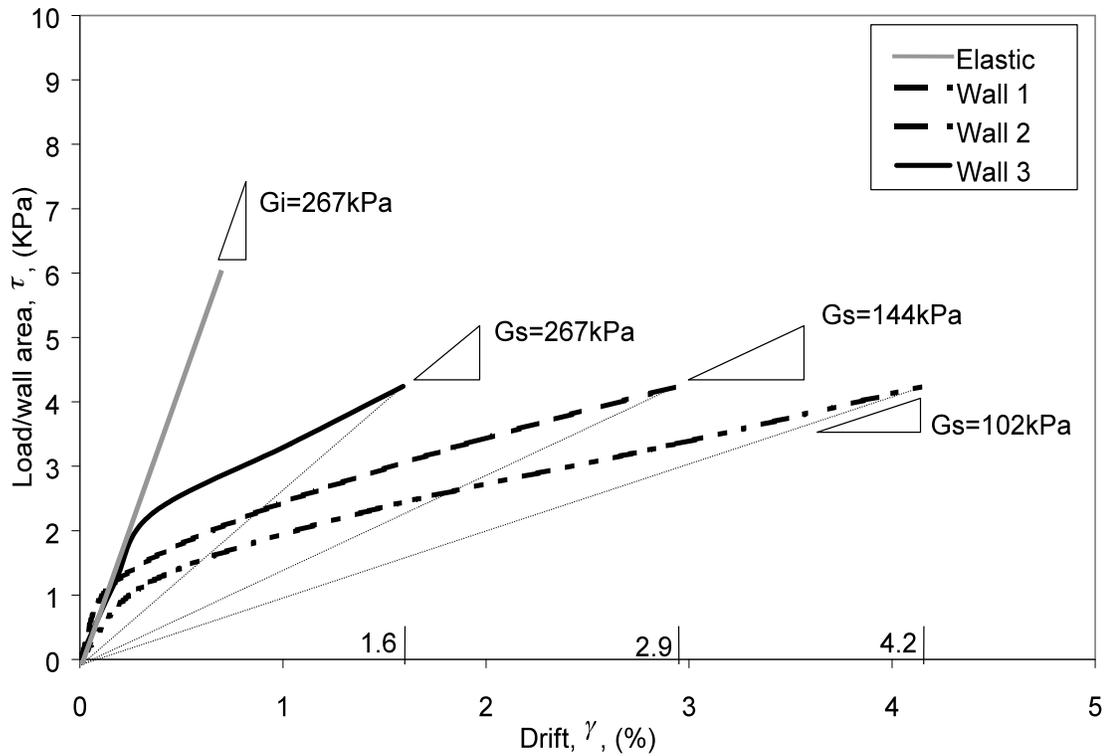
Figure 4 shows a plot of the lateral in-plane monotonic load/area of wall,  $\tau$ , versus drift,  $\gamma$ . The idealized elastic response with initial shear modulus,  $G_i$ , is also presented in this figure to assess the degradation of the secant shear moduli of the walls,  $G_s$ . The secant shear modulus is directly dependent with wall precompression level. The shear stress,  $\tau$ , at which the secant shear modulus is defined is equal to 4.2kPa (0.6kips), and the corresponding drift,  $\gamma$ , of each of the wall units, is presented in Figure 4.

Figure 4: Lateral In-plane Monotonic Load per Area versus Drift

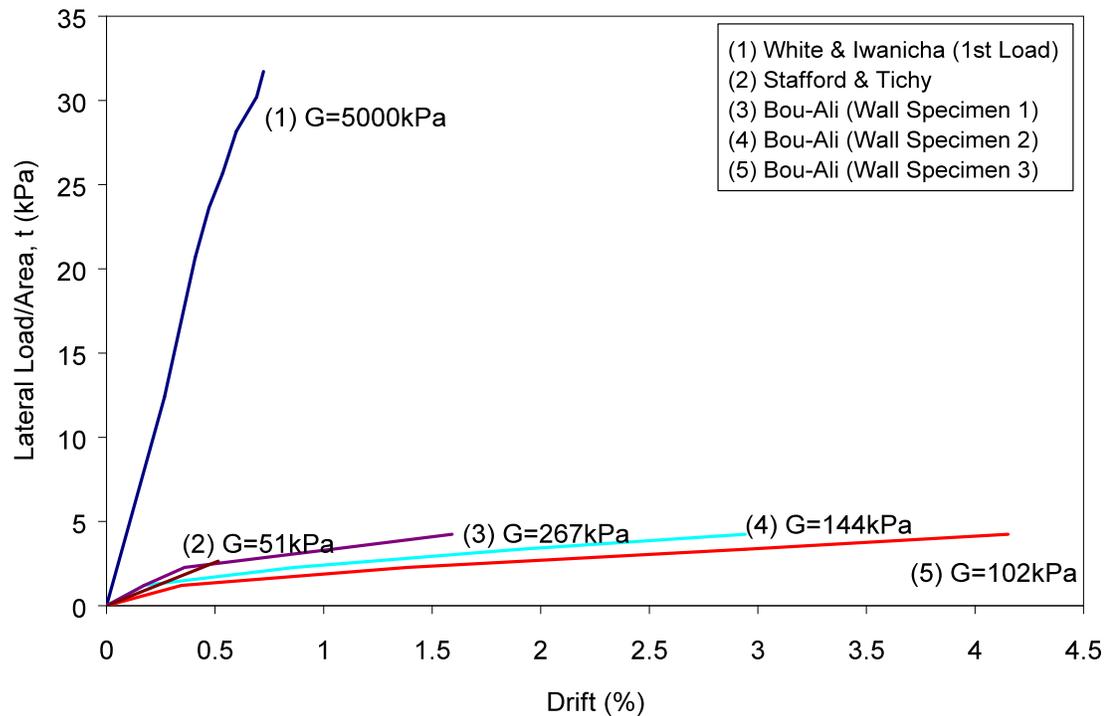
Figure 5: Comparison Lateral In-plane Force Vs. Drift for Previous Studies

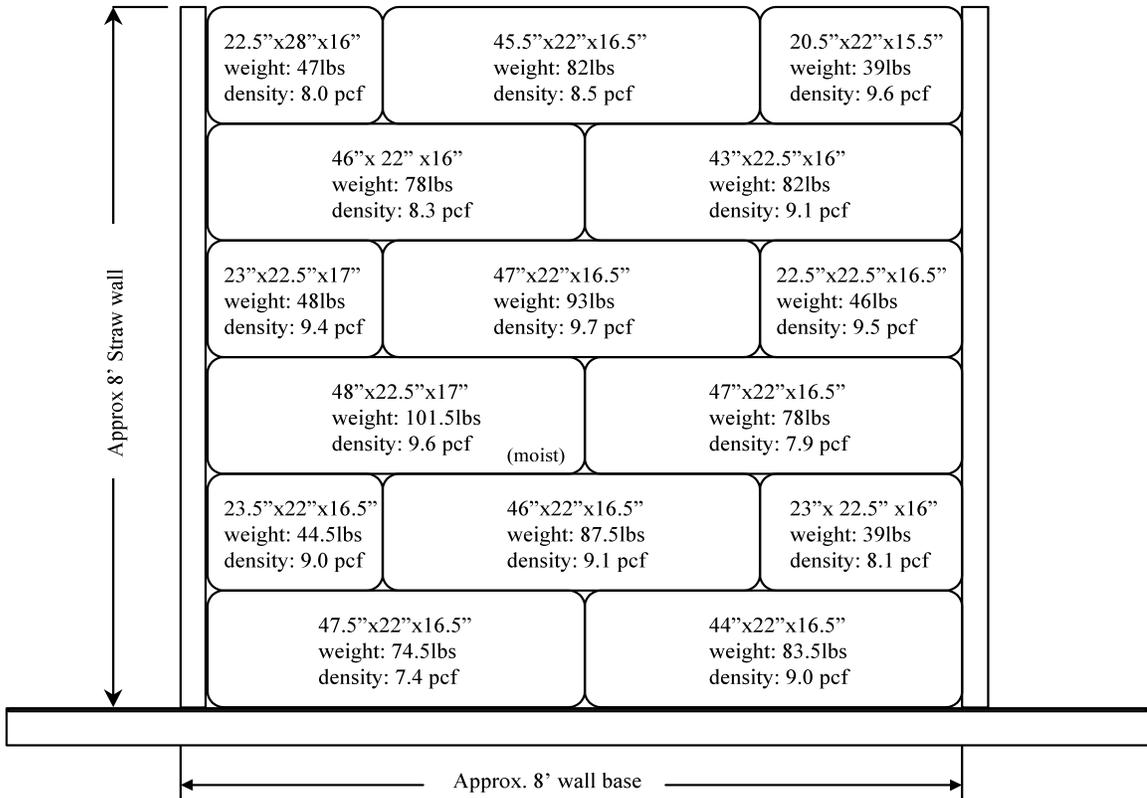
Figures 6 and 7 show an elevation view of the straw-bale in-fill wall, showing the dimensions and density of the bales.

Figure 6: In-fill Wall Elevation Schematic (Three-string Bales)

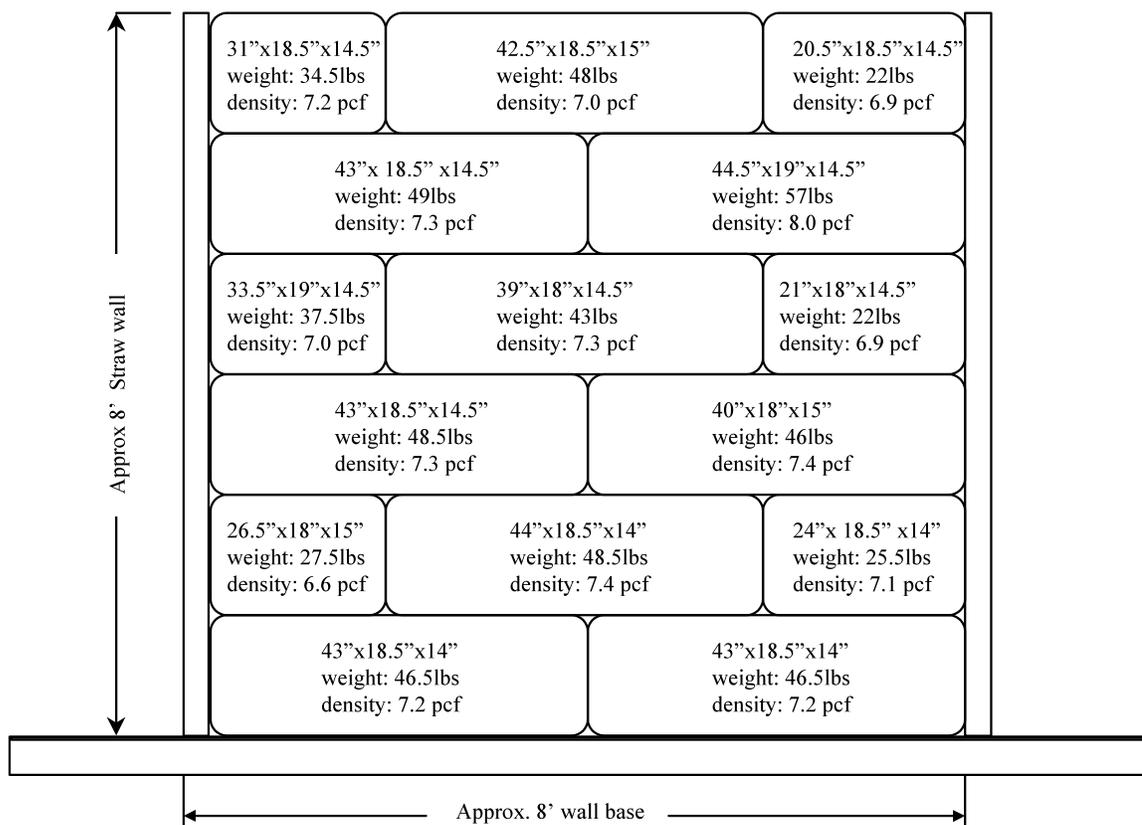
Figure 7: In-fill Wall Elevation Schematic (Two-string Bales)

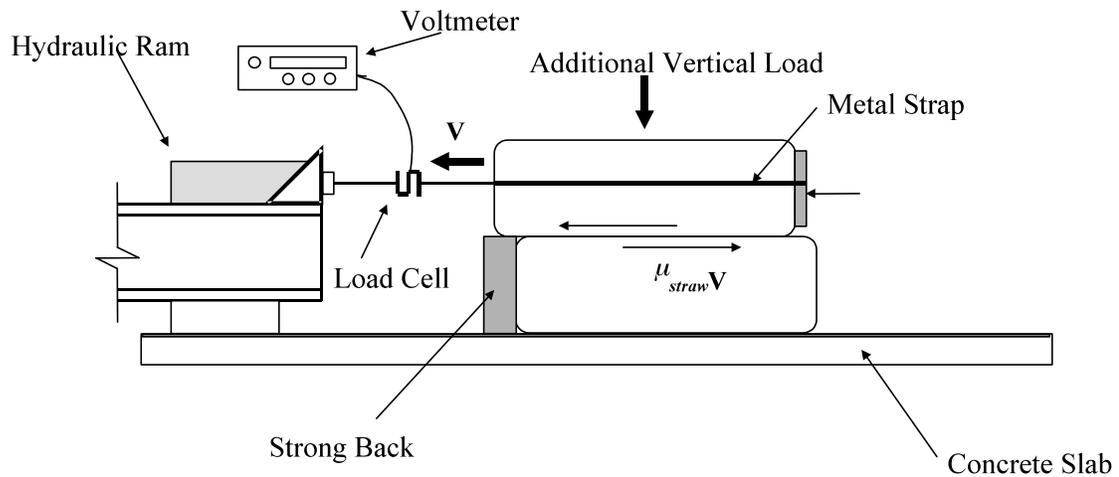
The test setup avoided miscalculations by using a voltmeter (Fluke Inc.) with a maximum voltage reading function. In this manner, the highest voltage differential from the load transducer cell was recorded and stored. The friction coefficient of straw, ( $\mu_{straw}$ ), was found experimentally as  $\mu_{straw}=0.615$ . Figure 8 shows a schematic of the test setup, while Figure 9 shows the scatter of voltage maxima scaled to represent the loads. Table A1 in Appendix A tabulates the actual data obtained from the test.

Figure 8: Test Setup for Determination of Coefficient of Friction,  $\mu_{straw}$

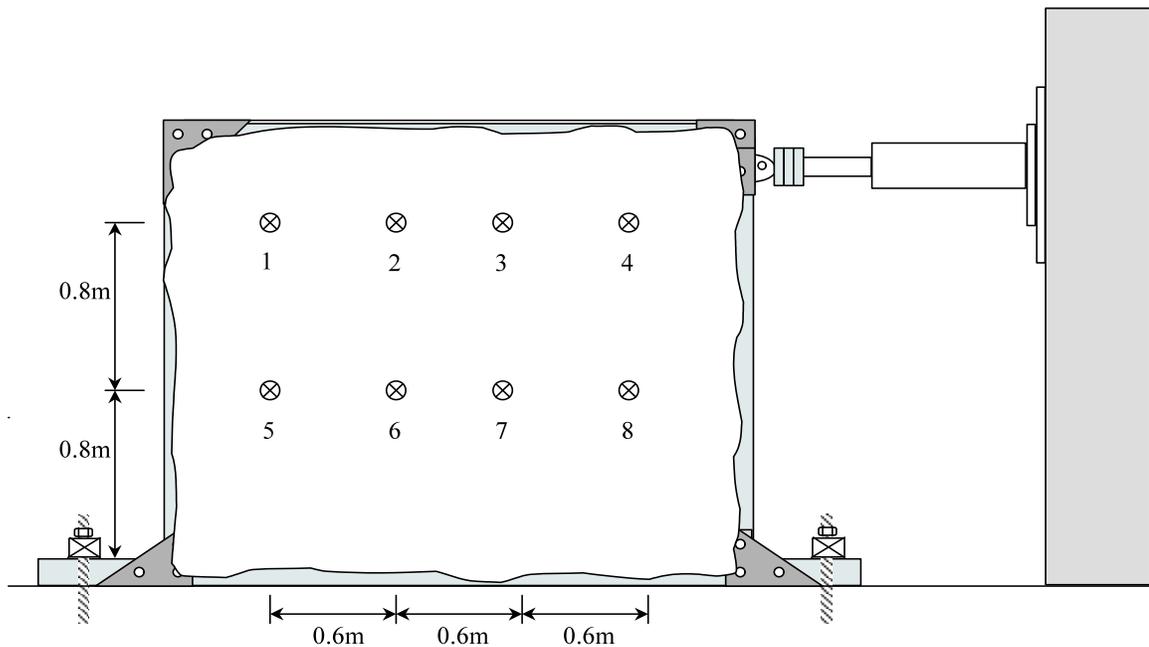
Figure 10: Elevation Schematic of Test Unit

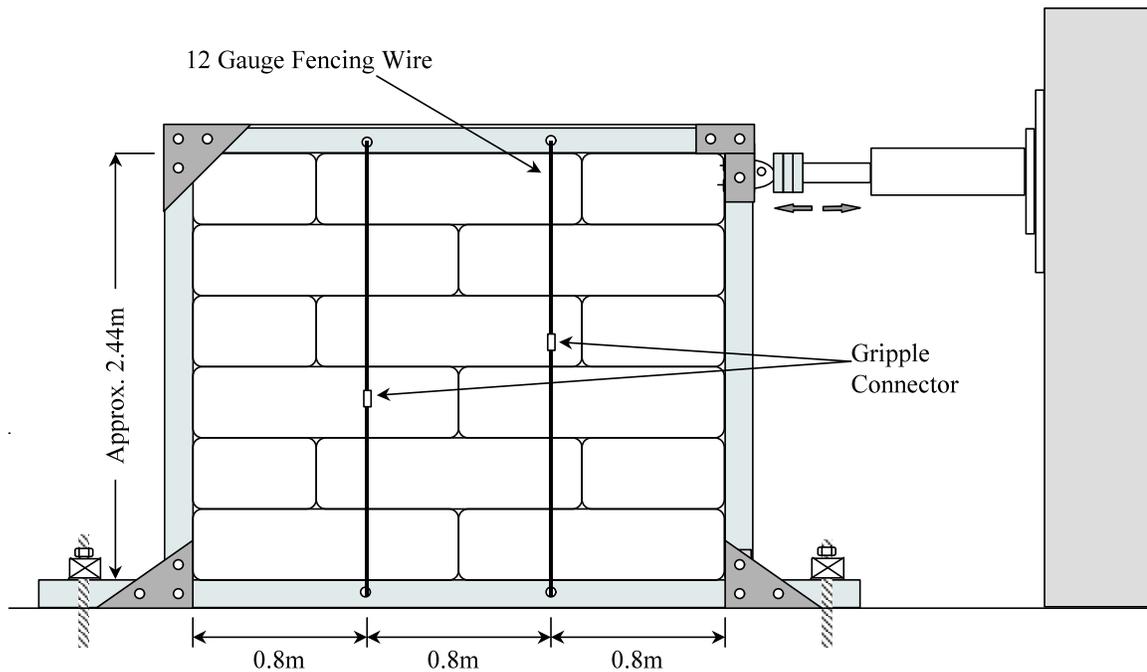
The weight of the roof box beam, approximately 333.6N (75lbs), was the second form of pre-compression applied to the in-fill wall following the “stomping” procedure after each course was laid (King 1996, Stafford and Tichy 1996). A12-gauge heavy fencing tie wire (Kiwi Fence Systems Inc. PA) ran from the base box beam and over the roof box beam and fastened to the other end by means of a gripple wire splicer (Griipple Ltd. Sheffield, England). Three of these tie wires were used, and each side was tensioned with approximately 1.1kN (250lbs) of force, applied by means of a tensioning tool compatible with the gripple splicer. Figure 11 shows the placement of these wires with respect to the rest of the wall. The rated strength of the tie wires used is to 2.2kN (500lbs). With these wires tensioned in place, the total precompression applied to the straw-bales was approximately 1.4kN (575lbs).

Figure 11: Schematic of Precompression Tie Wire Placement on Straw-Bale In-fill Wall

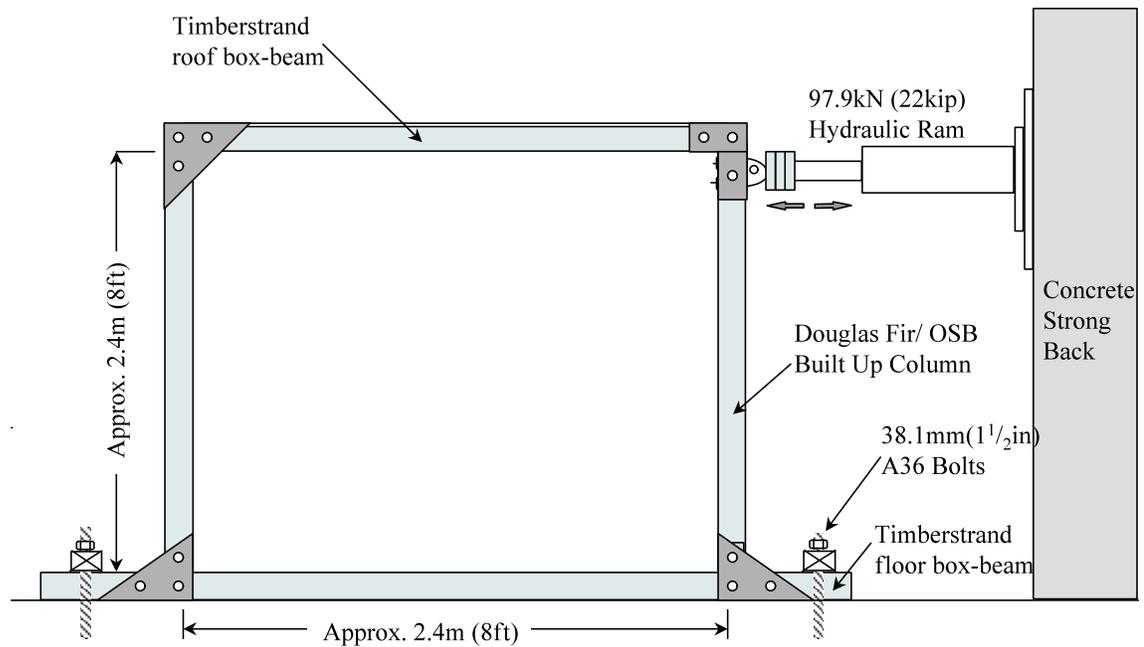
This chapter describes how the test wall units were constructed, the setup and the limitations of both. Straw-bale in-fill wall units, with elevation dimensions 2.44m (8ft) long by 2.44m (8ft) high were constructed for this study. Each wall had stucco on one side and gypsum plaster on the other side to model the exterior and interior. The wooden post and beam sizes were representative of actual non-load bearing designs. Figure 9 shows an elevation schematic of the post and beam test frame used. The connections between the posts, floor and roof beam were designed to act as pinned connections so they would not contribute to the lateral force resistance of the wall models.

Figure 12: Schematic of Post and Beam Test Frame (Elevation)

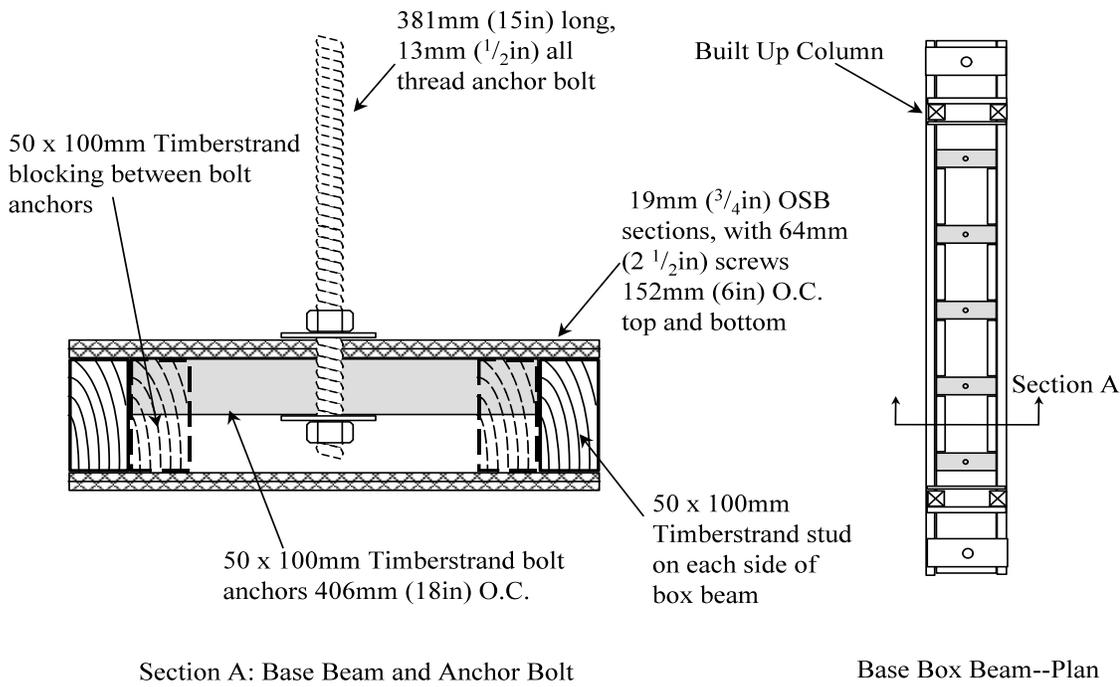
The base and roof box beams were made of timberstrand lumber. The box-beams were made of two 3.67m (12ft) long, 50 by 101mm (2 by 4in) timberstrand lumber stud sections laid on edge and confined on top and bottom by 19.05mm ( $\frac{3}{4}$ in) thick, 558.8mm (22in) wide Oriented Strand Board, or OSB, sections. These OSB sections were secured with wood screws to the timberstrand lumber studs at 152.4mm (6in) off-centers. For the base beam box, 50 by 101mm (2 x 4in) timberstrand lumber section, 381mm (15in) in length, were used as bolt anchors to the 12.7mm ( $\frac{1}{2}$ in) diameter all-threaded mild-steel rods protruding out from the OSB and into the first course of straw-bales as reinforcement. A total of 5 all-threaded rods used as reinforcement for the bottom course of straw-bales. The 5 bolt anchors were secured to the 3.67m (12ft) perimeter studs by means of wood screws, and in between them, shorter timberstrand lumber blocks were screwed on the inside of the 3.67m (12ft) studs for added bending capacity. Figure 13 shows a plan view of the base box beam with a typical cross section and Figure 14 shows an elevation cross section of the base box beam with the reinforcement placing for the bottom course.

Figure 13: Cross-Section Schematic of Base Box Beam (1)

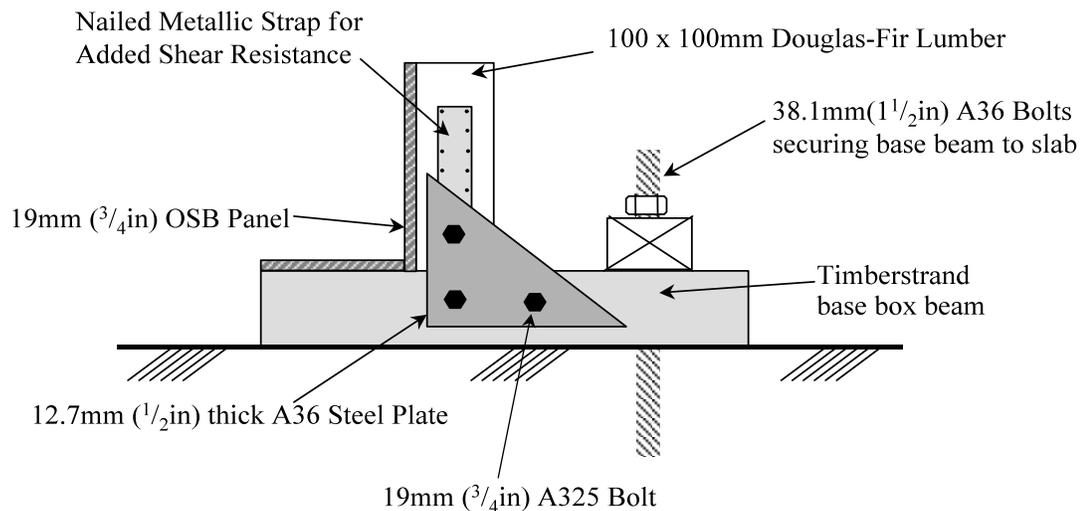
Seismic pin connections consisting of A36 steel plates A325 bolts were designed to allow frame rotation, enabling more representative data of the wall capacity without any additional resistance to be obtained. Each connection consisted of two 12.7mm ( $\frac{1}{2}$ in) plates, and three 152.4mm (6in) long, 19.1mm ( $\frac{3}{4}$ in) diameter bolts. The bolts were placed in double shear, with the threads in shear planes, and were hand snug tightened. Two bolts secured the connection rigidly to the timberstrand lumber base box beam and the third one was connected it to the column member to represent a pin connection. In this fashion, the third bolt allowed the second member to rotate freely with respect to the first. Figure 15 shows a detail of one of the base beam/column connections.

Figure 15: Detail of Seismic Connection for Base Box Beam and Built-Up Column

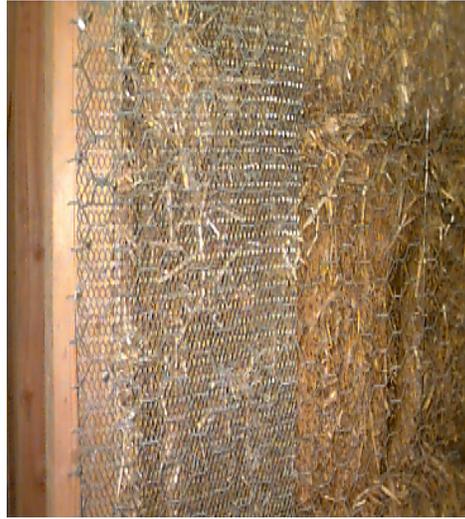
Expanded metal lath, shown in Figure 16, was used at the ends of the each wall and also fastened to the perimeter with roofing nails. The lath was also tied to the wire mesh as needed. The lath was 610mm (24in) wide and ran the entire height of the wall. It was observed that the mesh and lath tended to bow away by as much as 102mm (4in) from the wall, particularly in the middle. Tie wires passing through the bales secured the lath and mesh from one side of the wall to the lath and mesh of the other, assuring the reinforcement remained stayed in the range of 12.7mm to 19.05mm ( $\frac{1}{2}\text{in}$  to  $\frac{3}{4}\text{in}$ ) away from the straw. Four tie wires were passed through each course of bales, totaling 24, and were tied using pliers.

Figure 16: Facing Reinforcement

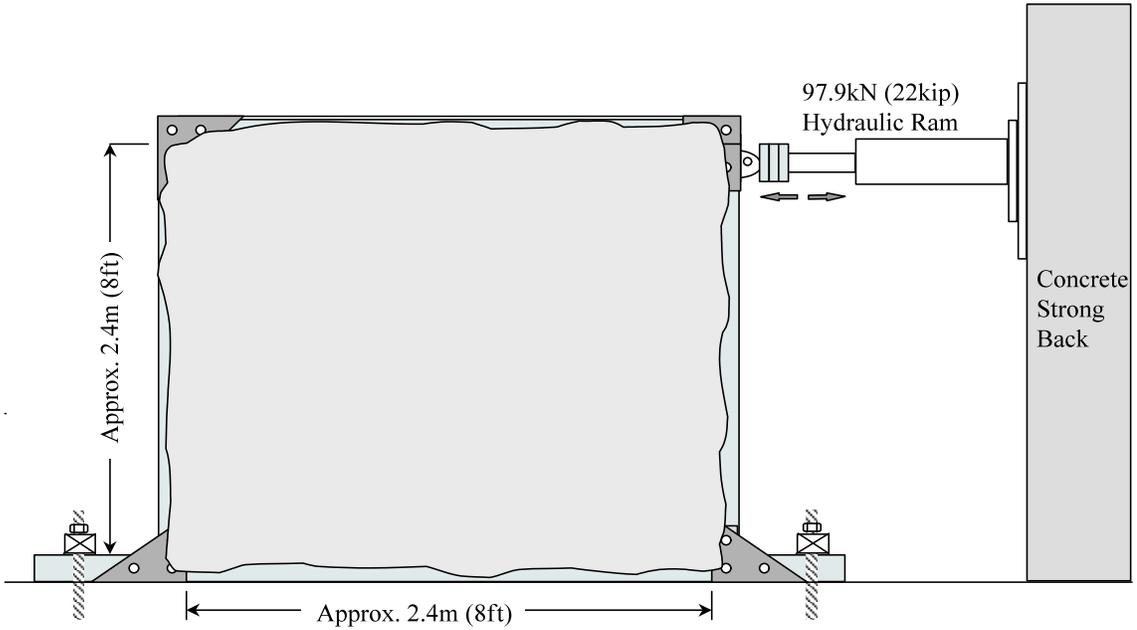
The usual third coat was not applied because it is generally used for aesthetic purposes (Such as for giving the wall a specific color or texture) and too thin, providing no structural contribution. The facings were allowed to cure for 10days before loading the wall units. No moisture enhancing procedures were used during curing. An elevation schematic of the wall constructed as described is shown in Figure 17. Figure 18 shows a cross section of the three string straw-bale wall with the facings applied to it and Figure 19 shows a cross section of the two string straw-bale wall with facings.

Figure 17: Elevation Schematic of Wall with Facings

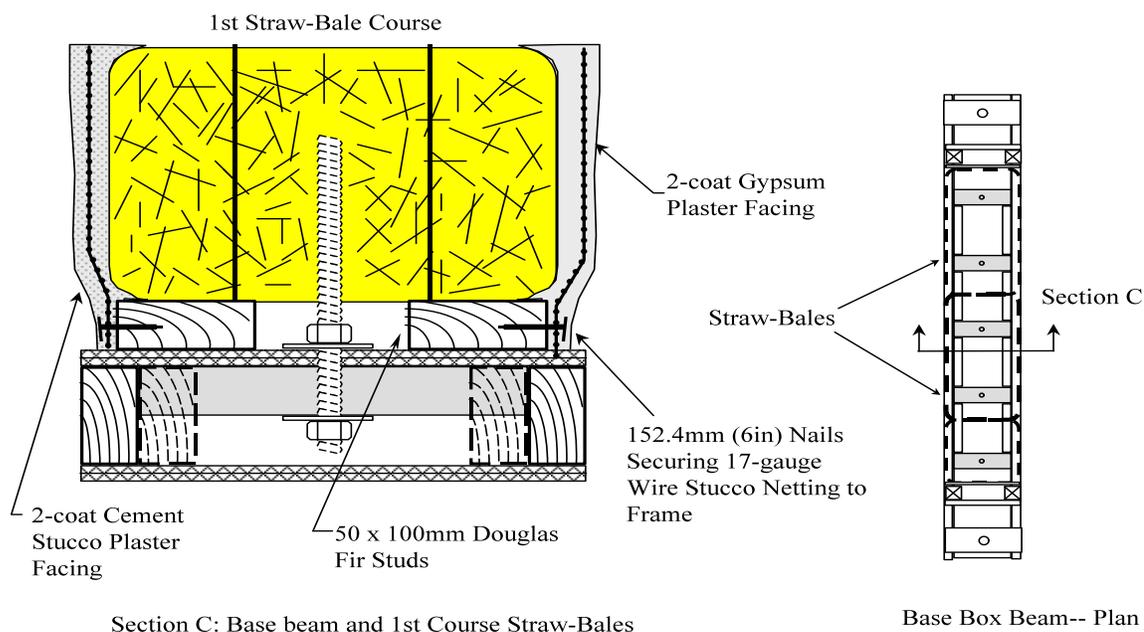
Figure 19: Typical Cross Section of Two String Straw-Bale Wall with Facings

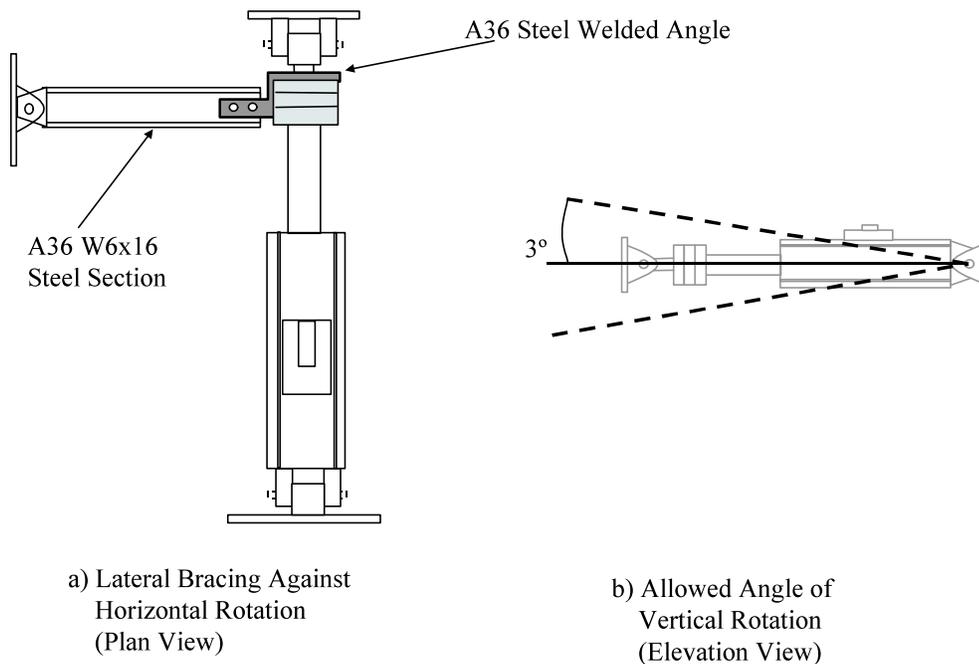
The ram was braced against horizontal rotations, but was allowed to rotate vertically, with a maximum rotation angle of  $\pm 3.0^\circ$  with respect to the horizontal. The angular variations in the load applications were too small to make the load unrepresentative of an earthquake shear. The deformation of the wall height was controlled by the displacement capacity of the ram piston: The maximum reduction in wall height, as the frame deformed into a parallelogram, was restricted to 12.7mm (0.5in) by the maximum angle of vertical rotation of the hydraulic actuator. Figure 21a shows a schematic of the horizontal bracing used, while 21b shows the vertical rotation permitted.

Figure 21: Lateral Bracing Against Horizontal Rotation and Allowed Angle of Rotation

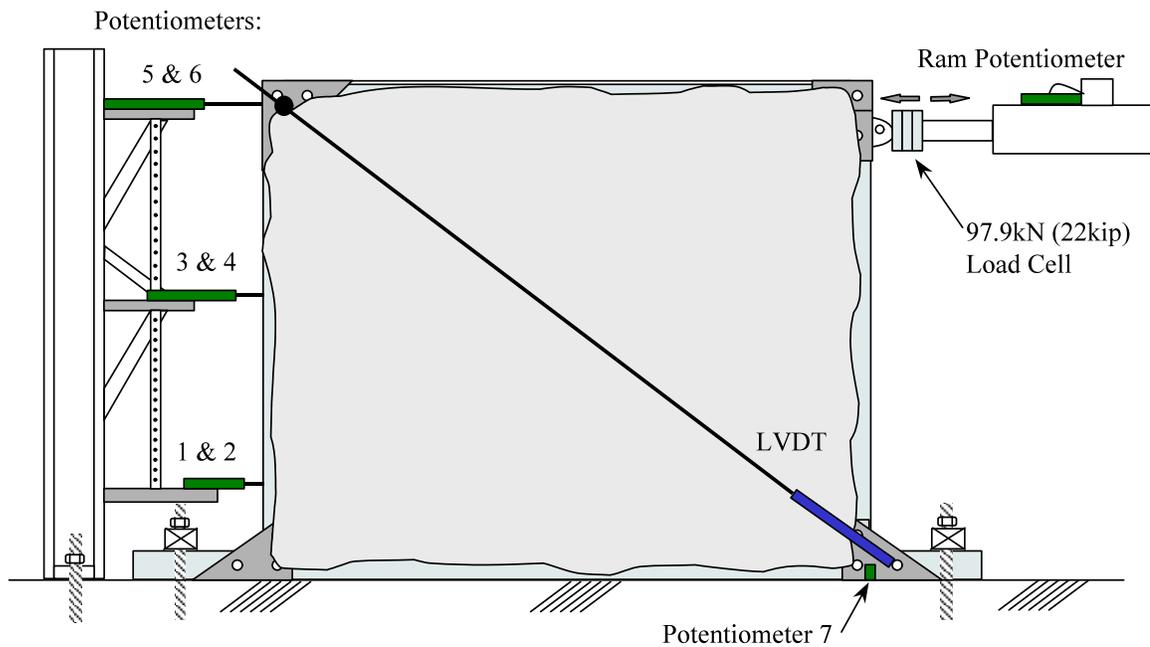
Voltage-differential instruments were used to measure deformations of the wall units. The instruments used were 7 linear motion position transducers, commonly known as potentiometers, and 1 linear variable differential transformer, known as LVDT. Figure 22 shows the location of the instrumentation used with respect to the wall.

Figure 22: Wall Unit Instrumentation Setup

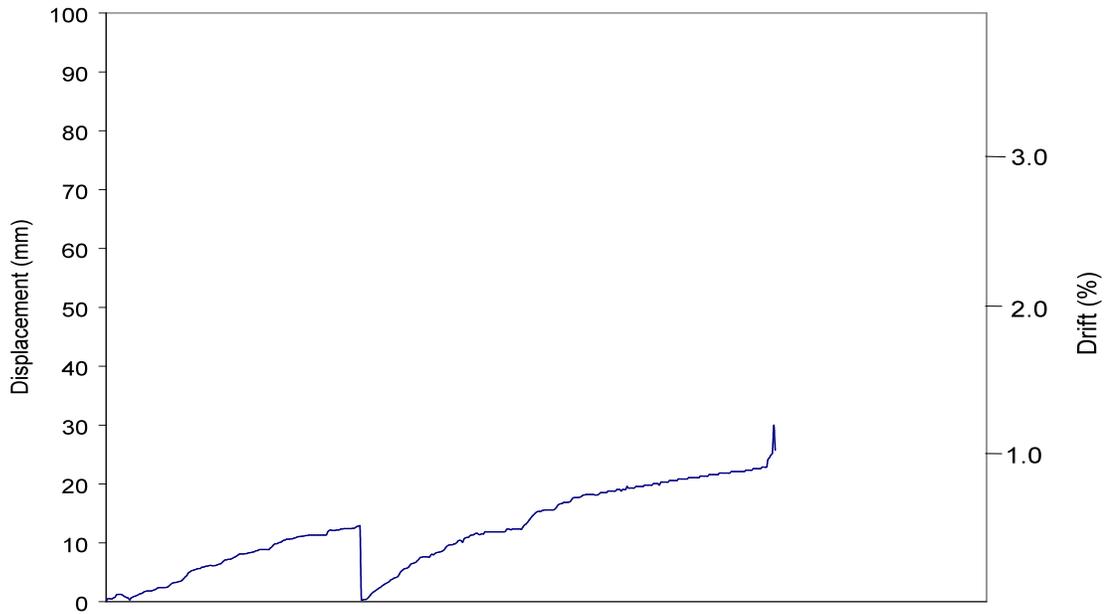
Figure 23 shows the in-plane roof level load applied to wall unit 0. Figures 24 and 25 show the in-plane cyclic roof level load applied to wall units 1 and 2.

Figure 23: Monotonic In-plane Load Regime for Wall Unit 0 (Three-string bales, no facings)

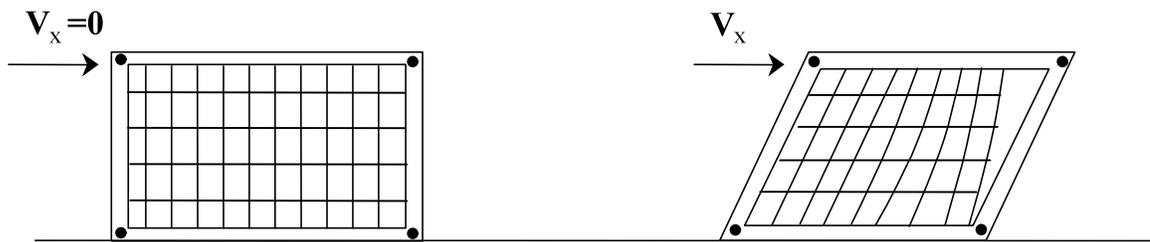
The column element where the load was applied pushed on the straw-bale vertical plane at that end, and deformed it with a straight-line geometry. The vertical plane of the wall opposite the load application deformed with the curve like shape. This observed behavior is represented by the schematic in Figure 26.

Figure 26: Predicted Behavior of Post and Beam Straw-Bale In-fill Wall w/out Facings, Subject to Monotonic In-plane Loading

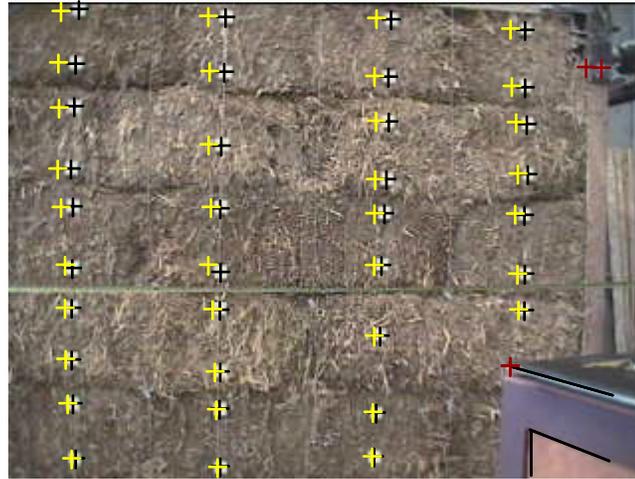
Neither uplift nor slip occurred during Test 0. Position markers were set on each course of straw-bales, and elevation pictures taken before the test and at 2% drift. Superimposing these pictures on one another demonstrates the bulging effect the straw-bale vertical plane farthest from the point of load application, represented by Figure 26. These pictures are shown in Figure 27.

Figure 27: Observed Deformations at 2% Drift, Test Unit 0

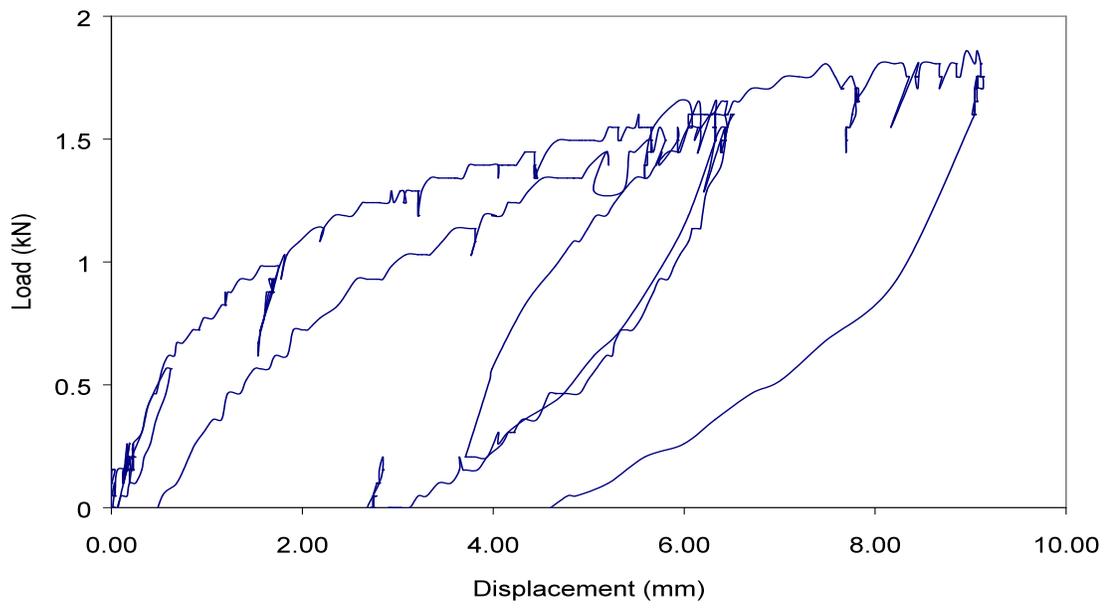
The wall unit had a maximum lateral resistance of approximately 1.9kN (427lbs), at approximately 0.4% drift. The test was halted at this point, as load resistance was constant with increasing lateral strain.

Figure 28: Load versus Displacement, Test Unit 0

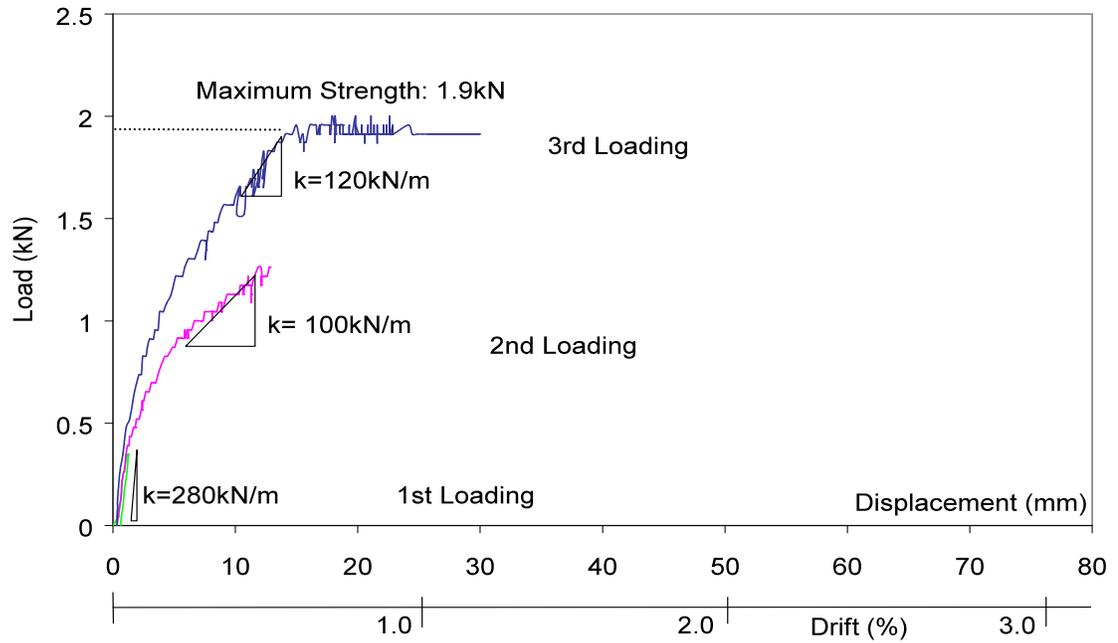
Figure 29: Envelope Curves, Test Unit 0

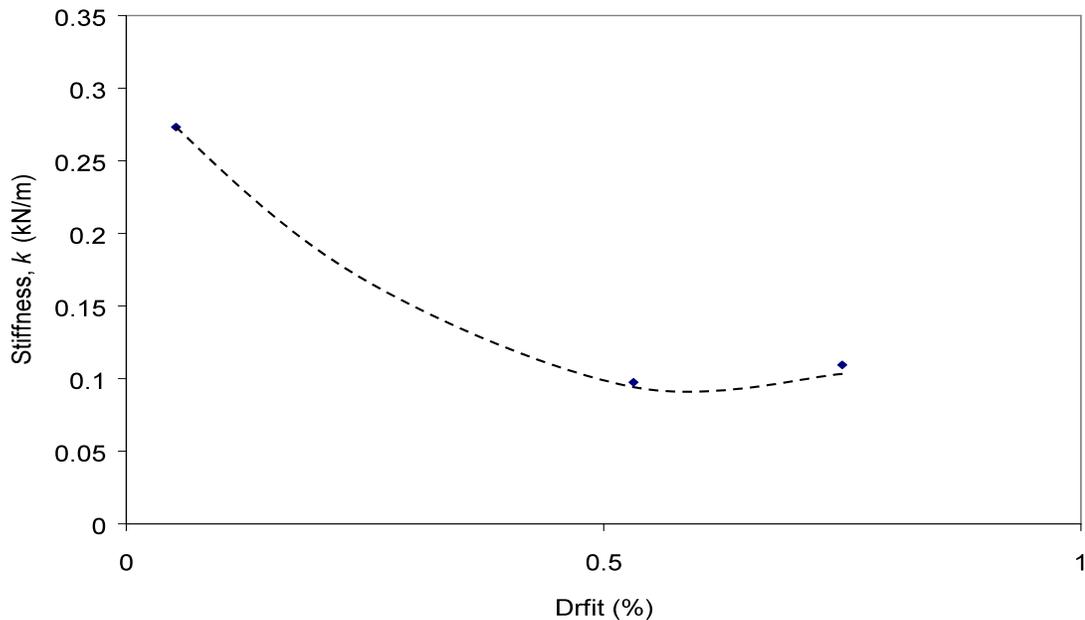
The first loading of Test 0 had a tangent stiffness,  $k$ , of 0.3kN/m (1.6kips/in). The second loading showed a stiffness degradation of 65% from the first loading. A stiffness degradation of 55% is associated with the third loading when compared to the initial stiffness, as seen in Figure 30. Oddly, the stiffness related to the third loading is 17% higher than that of the second loading. Hence, it may be said the unit stiffened at the third loading.

Figure 30: Stiffness Degradation Test Unit 0

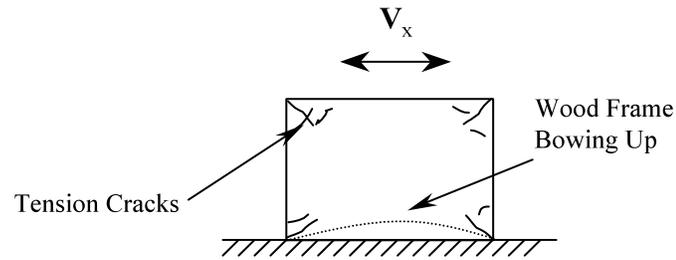
Tension cracks were observed only at the corners of the facings, with some measured uplift as the frame deformed. Figure 31 shows a schematic of the observed behavior of test unit 1.

Figure 31: Schematic of Observed Behavior for Test Unit 1

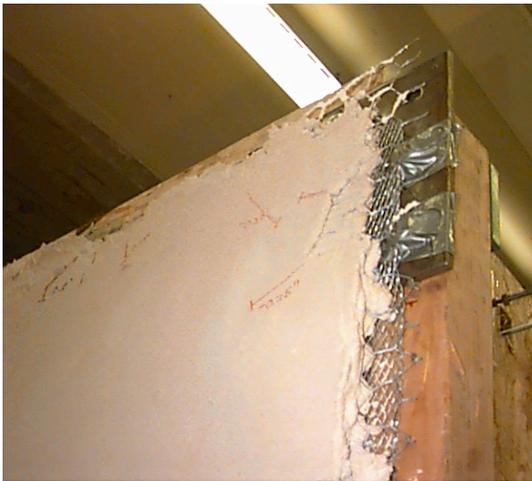
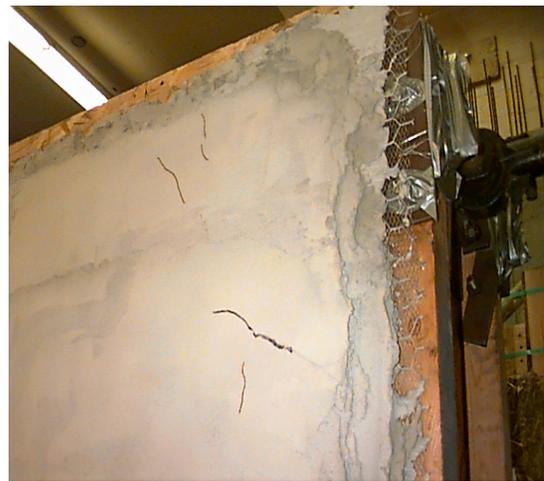
The first diagonal cracks that were observed appeared at the top corners of the wall, approximately at roof displacements of  $\pm 19.05\text{mm}$  (0.75in),  $\pm 0.75\%$  drift, associated to the set of cycles of the loading regime labeled as “initial” in Figure 24, Section 5.3. Figure 32a and b show pictures of the cracks on the stucco and plaster facing at the mentioned drift. No cracks were visible at this drift level on the plaster facing. No diagonal tension cracks appeared at the middle of the wall on either facing at this drift level. Neither uplift nor sliding occurred up to this drift level.

a) Plaster Facing

b) Stucco Facing

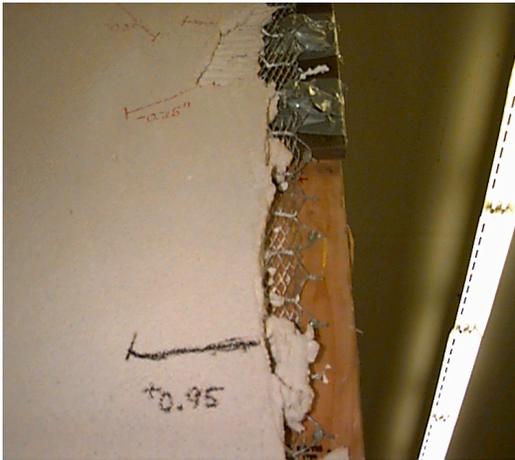
At  $\pm 1\%$  drift, more tension cracks developed on the corners of the stucco facing and the existing ones propagated further, as shown in Figure 33. This drift level is associated with the 1<sup>st</sup> set of cycles of the loading regime (See Figure 24, Section 5.3). At this drift level, a maximum uplift of 8mm ( $\frac{1}{3}$  in) was recorded at the middle of the base box beam. Slip of the wall with respect to the floor slab, approximately 12.7 ( $\frac{1}{2}$ in), was observed, as shown in Figure 34. This was corrected by re-tightening the bolts that held the unit down to the slab. Visual inspection confirmed no further sliding of the unit during the remainder of the tests. Figure 35 is a plot showing the uplift levels at  $\pm 1\%$  drift.

Figure 33: Damage to Test Unit 1 at  $\pm 1\%$  Drift

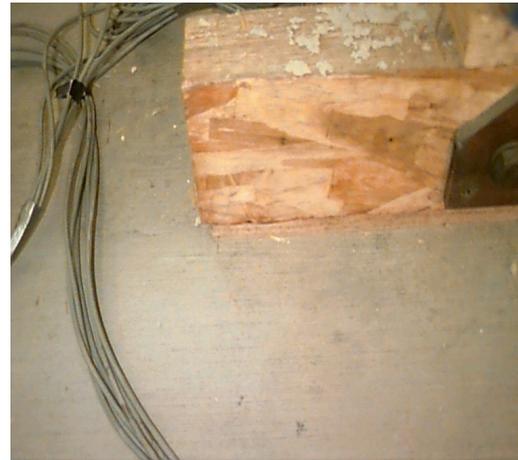
Figure 34: Slip of Unit 1 at  $\pm 1\%$  Drift

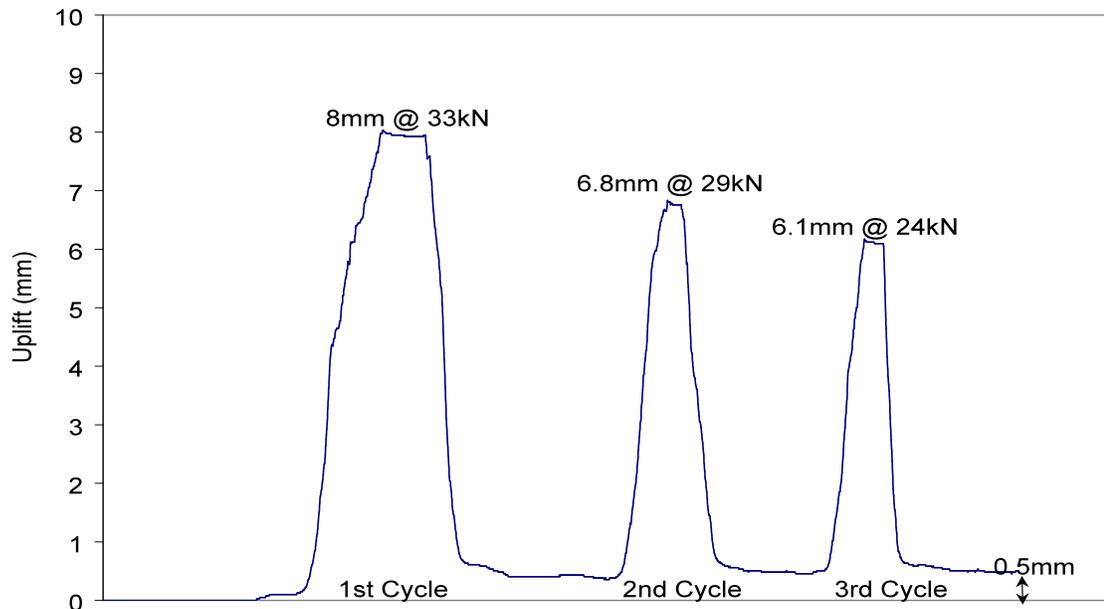
Figure 35: Uplift for Test Unit 1 at  $\pm 1\%$  Drift

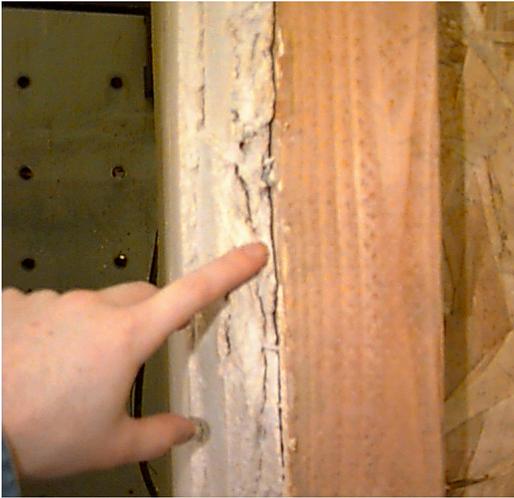
At 1.5 to 2% drift, equal to roof displacements between 38.1 and 50.8mm (1.5 and 2in), separation of the facings from the straw-bale surfaces and frame elements was visible, as shown in Figure 36. This drift level corresponds to the 2<sup>nd</sup> and 3<sup>rd</sup> set of cycles of the loading regime, Figure 24 of Section 5.3. Cracks propagated further at the corners, but no cracks were visible in the middle of either facing, as shown in Figure 37. The plaster facing began spalling at both of the top corners, particularly where the steel connection plates were located. The uplift recorded at the middle of the base box beam is shown in Figure 38. No further slip of the wall with respect to the floor slab was observed at this drift level.

Figure 36: Facing Separation at  $\pm 1.5$  to 2% Drift

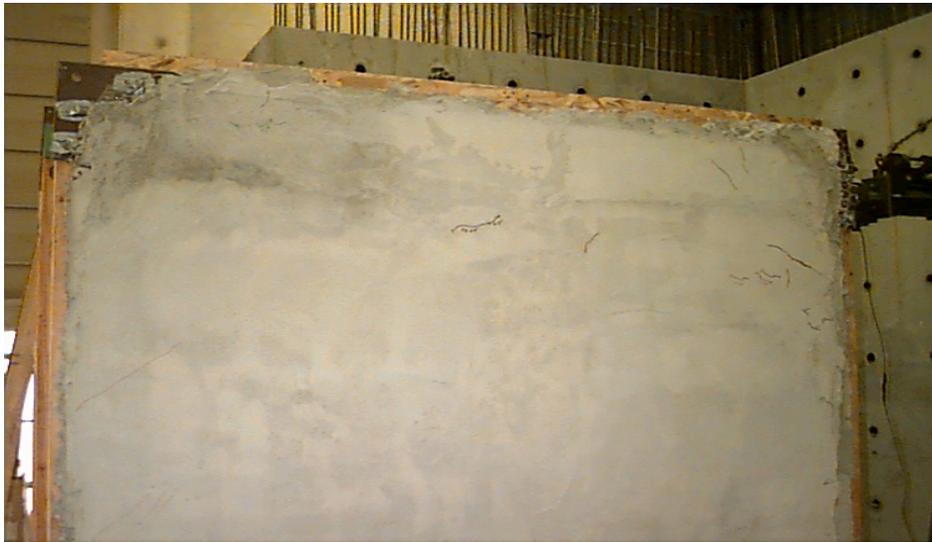
Figure 37: Damage to Stucco Facing, Test Unit 1, at  $\pm 1.5$  to 2% Drift

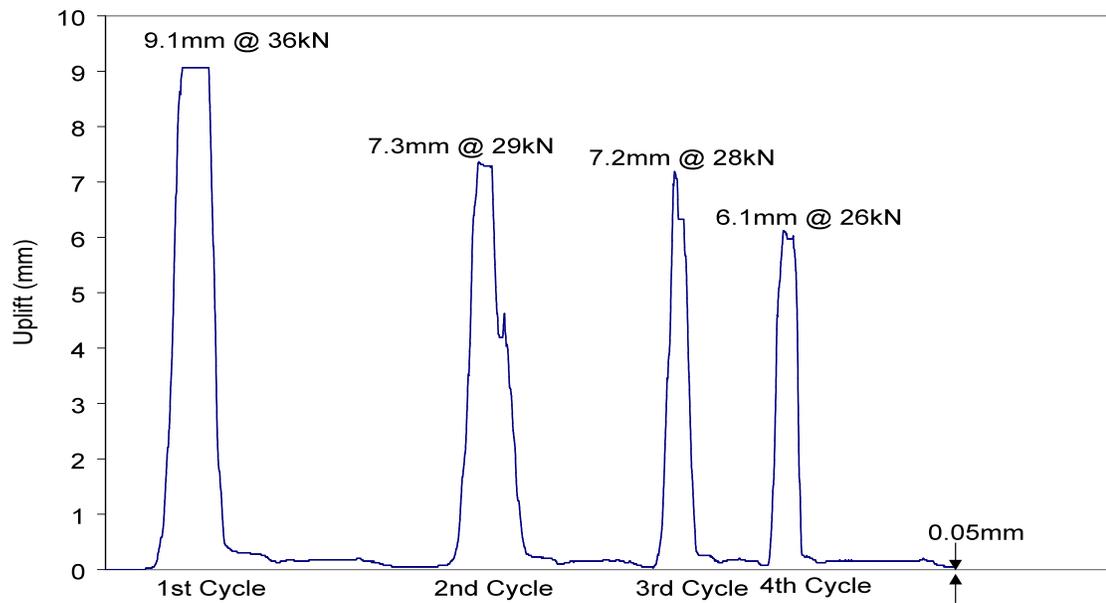
Figure 38: Uplift for Test Unit 1 at  $\pm 1.5$  to 2% Drift

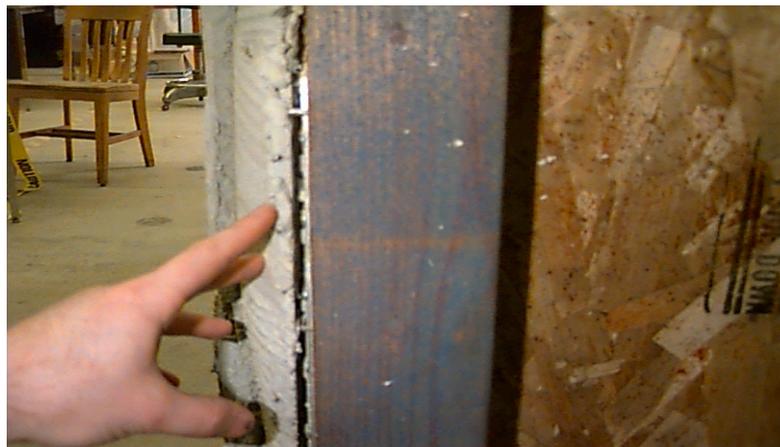
At a +3% drift, tension cracks did not visibly propagate further. The 4<sup>th</sup> set of cycles of the loading regime, Figure 24, Section 5.3, is associated with this drift level. Detachment of the facings from the straw-bales was visible, as shown in Figure 39. Further spalling continued on both facings, particularly on the plaster one. No further slip was observed at this drift level. The stroke capacity of the potentiometer (Potentiometer 7) used to measure uplift was exceeded, and maximum uplift recorded at the middle of the base box beam was 9.1mm, as shown in Figure 40.

Figure 39: Facing Separation at +3% Drift
