**CYCLIC IN-PLANE TESTING OF POST AND BEAM WALLS  
WITH STRAW-BALE IN-FILL AND STUCCO/PLASTER**

Master of Science in Civil Engineering

University of Washington

1999

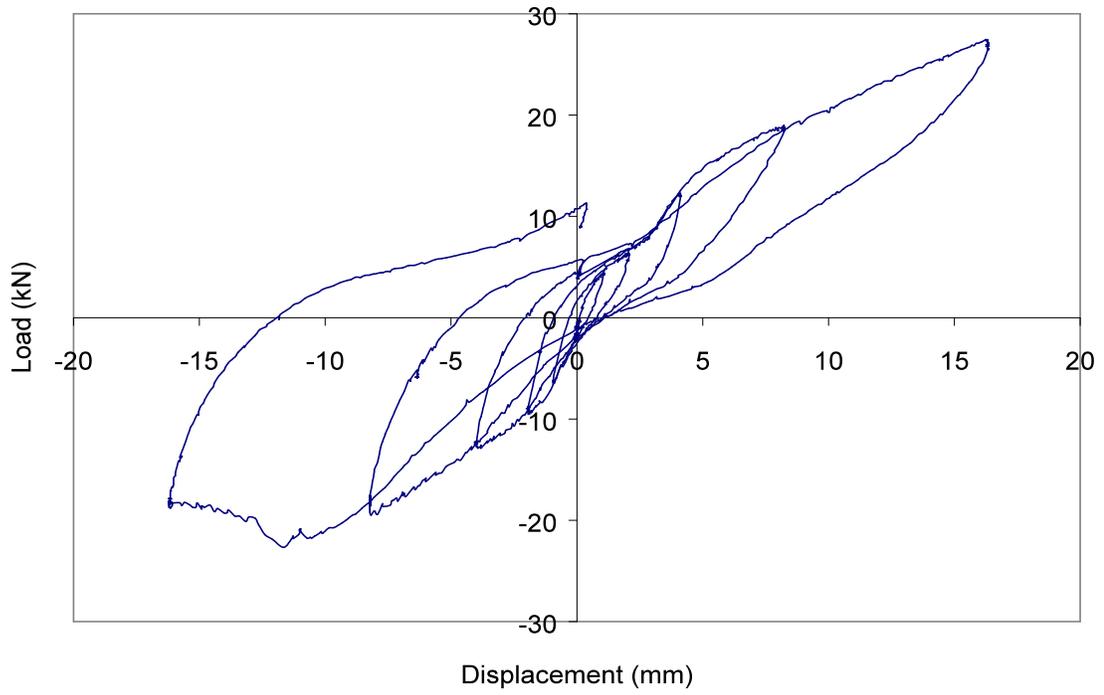
Figure 41: Hysteretic Load Displacement Loops for Test Unit 1 ( $\pm 0.75\%$  Drift)

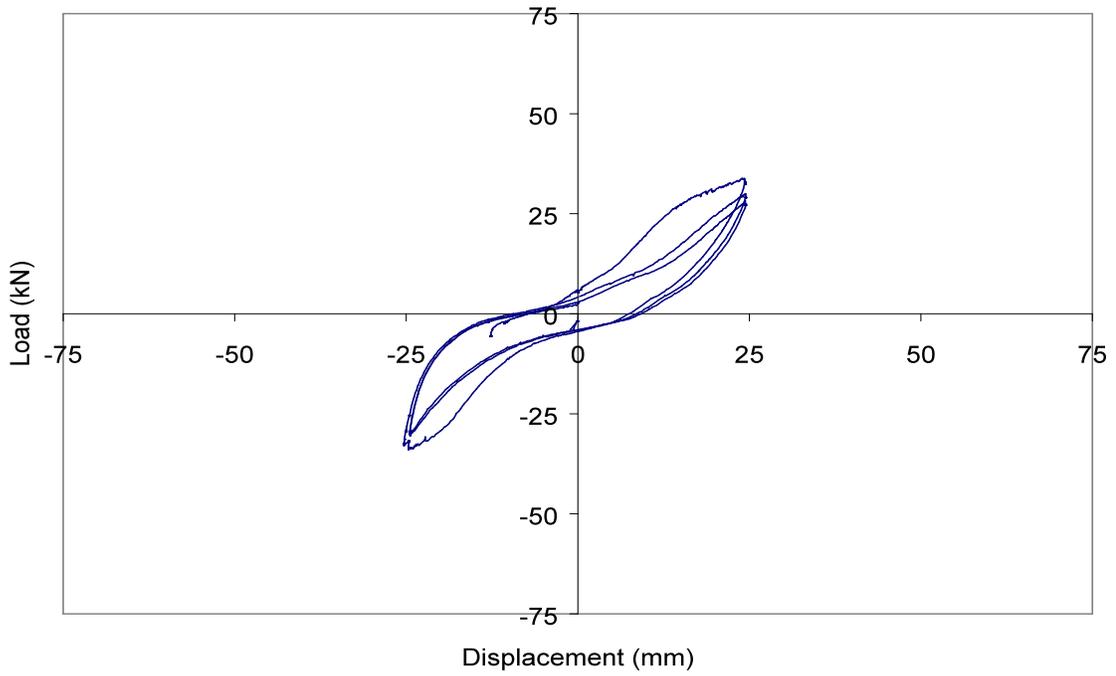
Figure 42: Hysteretic Load Displacement Loops for Test Unit 1 ( $\pm 1\%$  Drift)

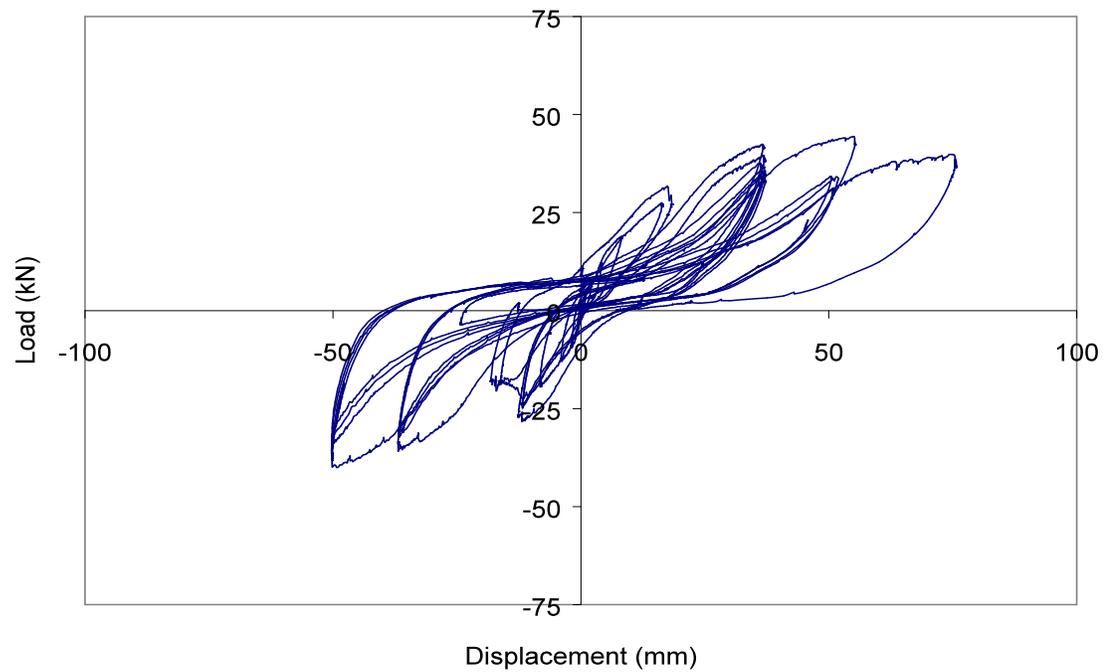
Envelope curves were generated for unit 1 from the complete set hysteretic load displacement loops as presented in Figures 46 and 47. The curves represent the capacity of unit 1 in opposite directions.

Figure 46: Complete Set of Hysteretic Load Displacement Loops for Test Unit 1

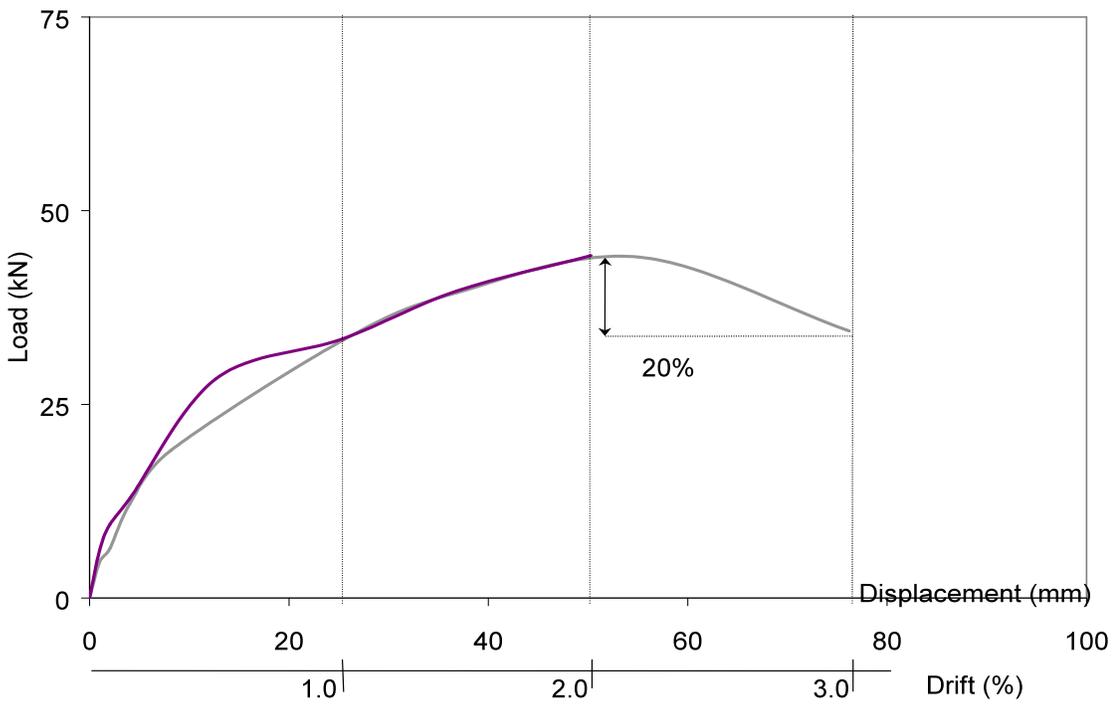
Figure 47: Envelope Curves for Test Unit 1

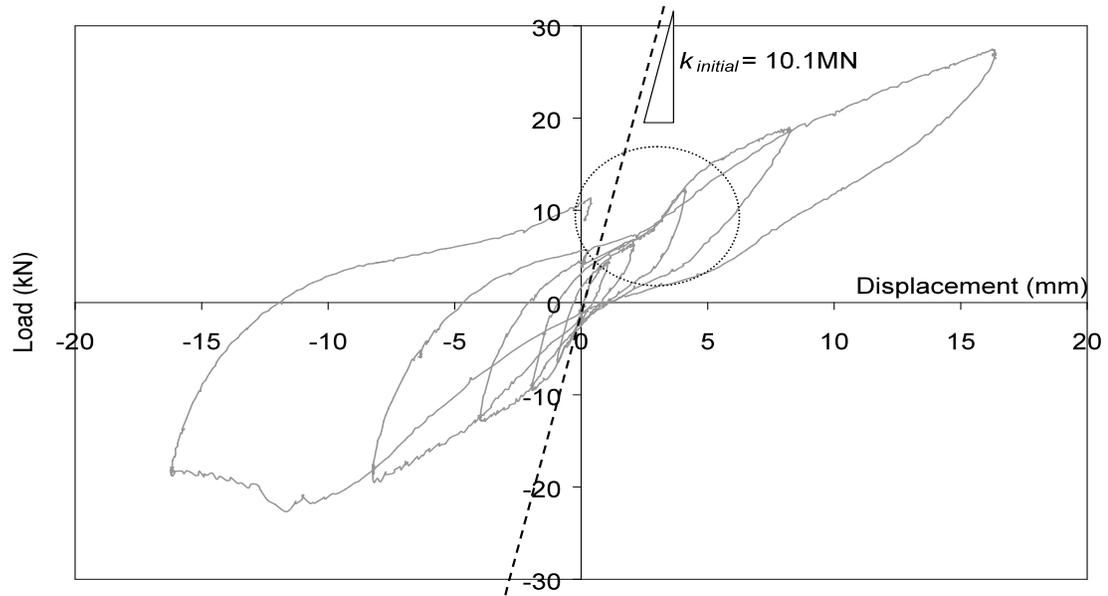
The initial stiffness of unit 1 was equal to approximately 10.1MN/m (57.7kips/in). The area enclosed in the dashed circle represents an unusual behavior, since the increasing slope of the loop represents stiffening of the system. This effect may be attributed to the slipping of the unit with respect to the floor slab and once slippage stopped, the unit was able to develop more lateral resistance, represented by the steepening of the curve slope. The phenomena may also be attributed to the excessive oversizing of the A325 bolt holes, as they were done with a manual drill. The unit may have moved, represented as the decreasing slope of the loops. When the bolts finally hit the oversized hole perimeter, the slope becoming very similar to the initial stiffness slope, stiffness continued degrading.

Figure 48: Initial Unit Stiffness, based on Force-Displacement Linear Relationship

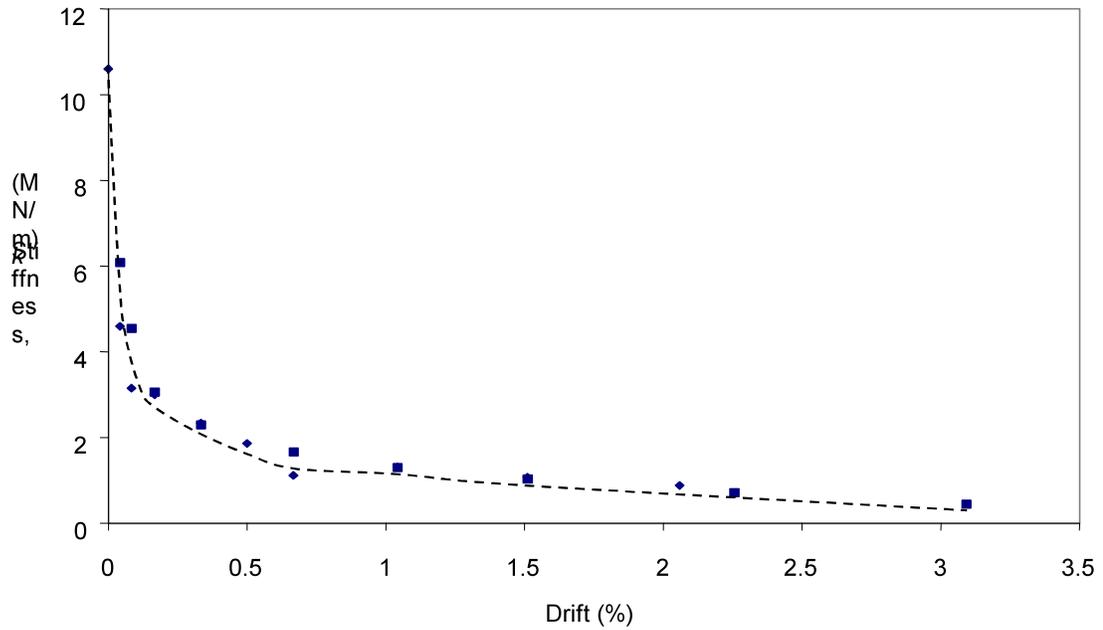
At 0.05% drift, the stiffness dropped to a value of approximately 4.6MN/m (26.25kips/ft) when taken as the secant to the unloading portion of the force-displacement loop. Subsequent loading degraded the unit stiffness approximately 95% to a final secant stiffness of 0.5MN/m (3.4kips/in) at a drift of 3.1%. The progression of lateral stiffness degradation,  $k$ , of unit 1 is plotted in Figure 49 as a function of drift.

Figure 49: Stiffness Degradation, Test Unit 1

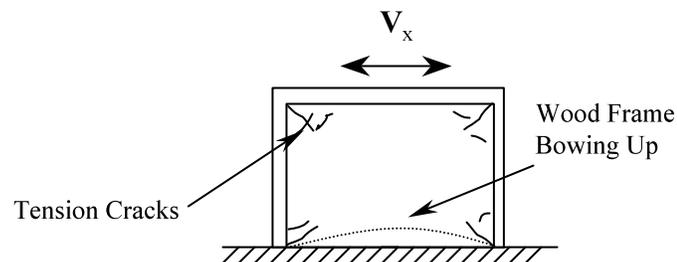
Test unit 2 was subjected to the repeated cyclic in-plane loading regime shown in Figure 25, Section 5.3. The load carrying mechanism was directed towards the facings, the material with the higher shear modulus,  $G$ . Tension cracks were observed only at the corners of the confined facings, with some measured uplift as the frame deformed throughout the test. Figure 50 shows a schematic of the observed behavior of test unit 2.

Figure 50: Schematic of Observed Behavior for Test Unit 2

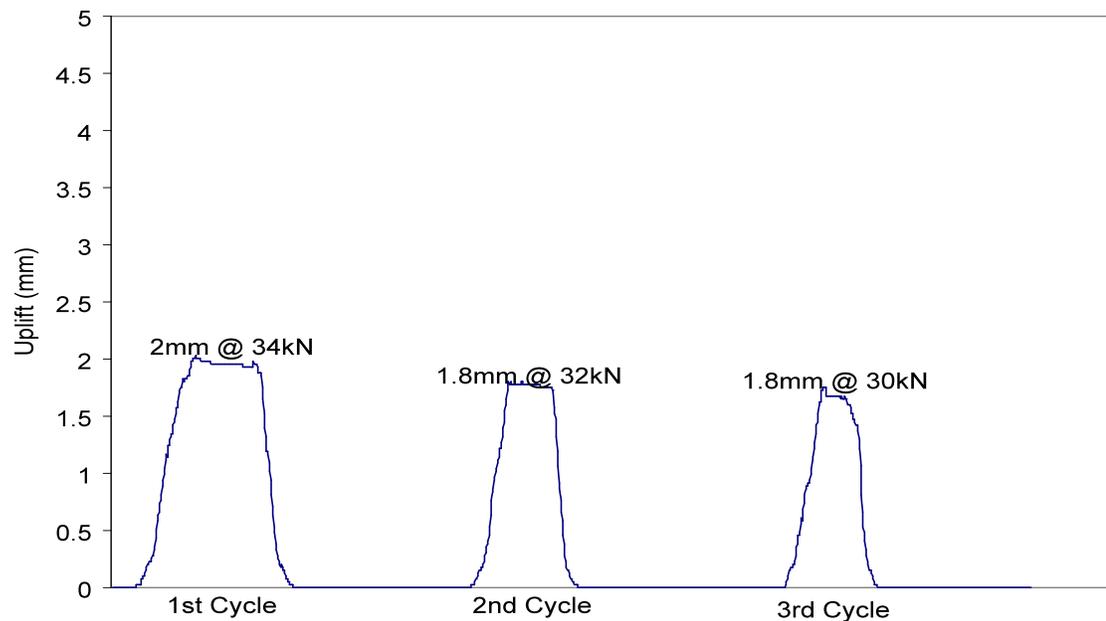
Figure 51: Uplift for Test Unit 1 at  $\pm 1.0\%$  Drift

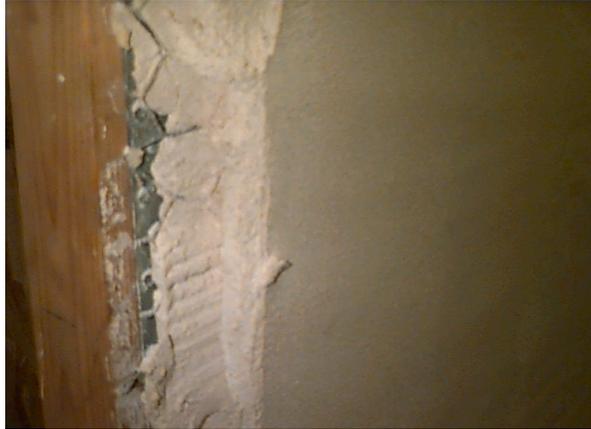
Figure 52: Damage to Plaster Facing, Test Unit 2, at  $\pm 1.5\%$  Drift

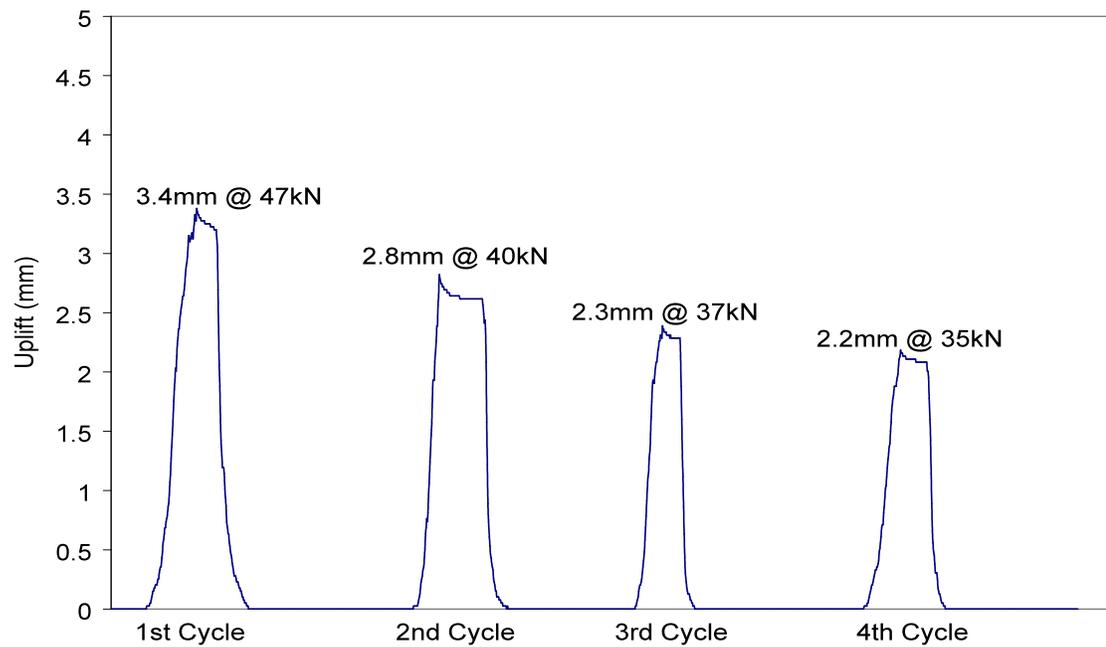
Figure 53: Uplift for Test Unit 1 at  $\pm 1.5\%$  Drift

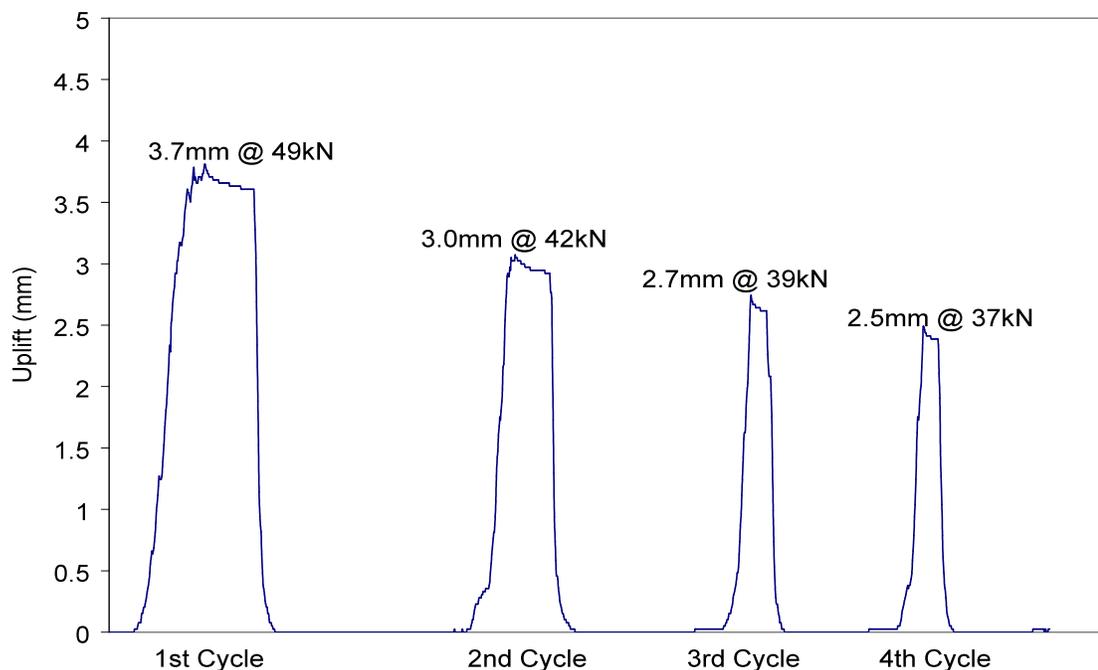
Figure 54: Uplift for Test Unit 2 at 2% Drift

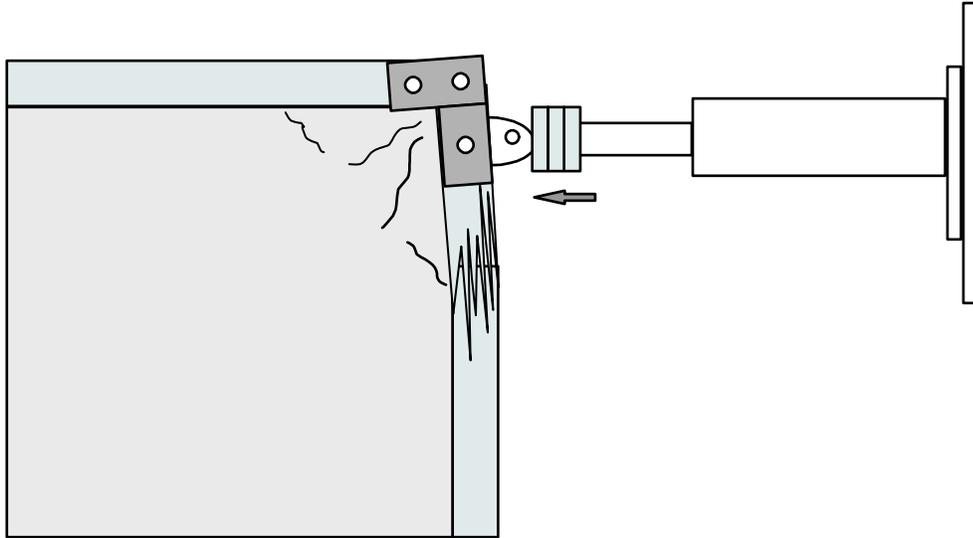
Figure 55: Schematic of Damage to Unit 2 at +3% Drift

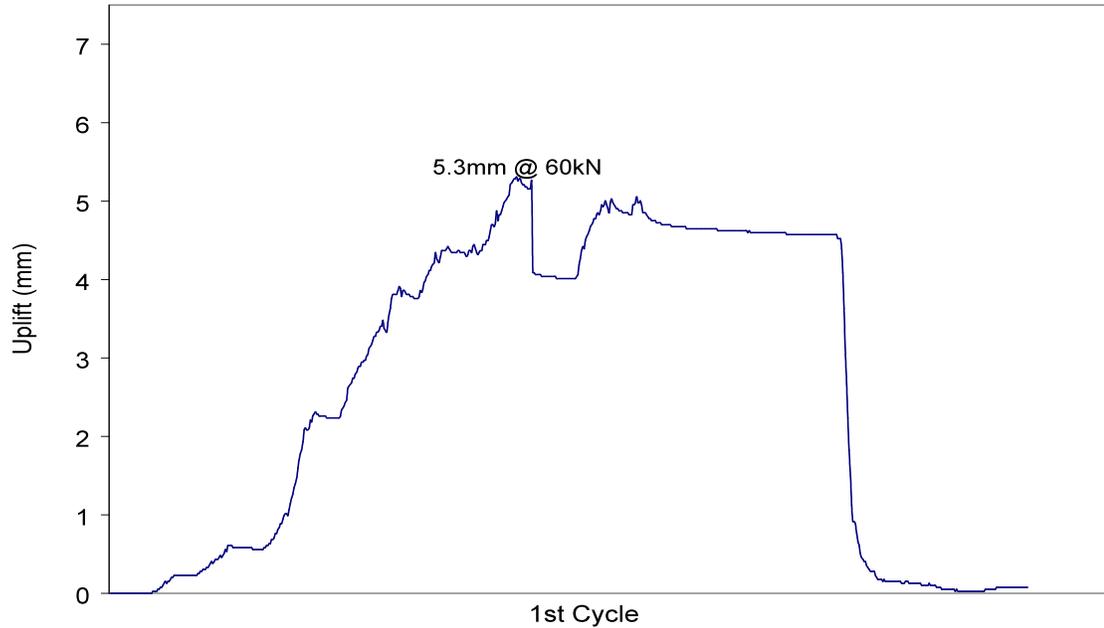
Figure 56: Uplift for Test Unit 2 at +3% Drift

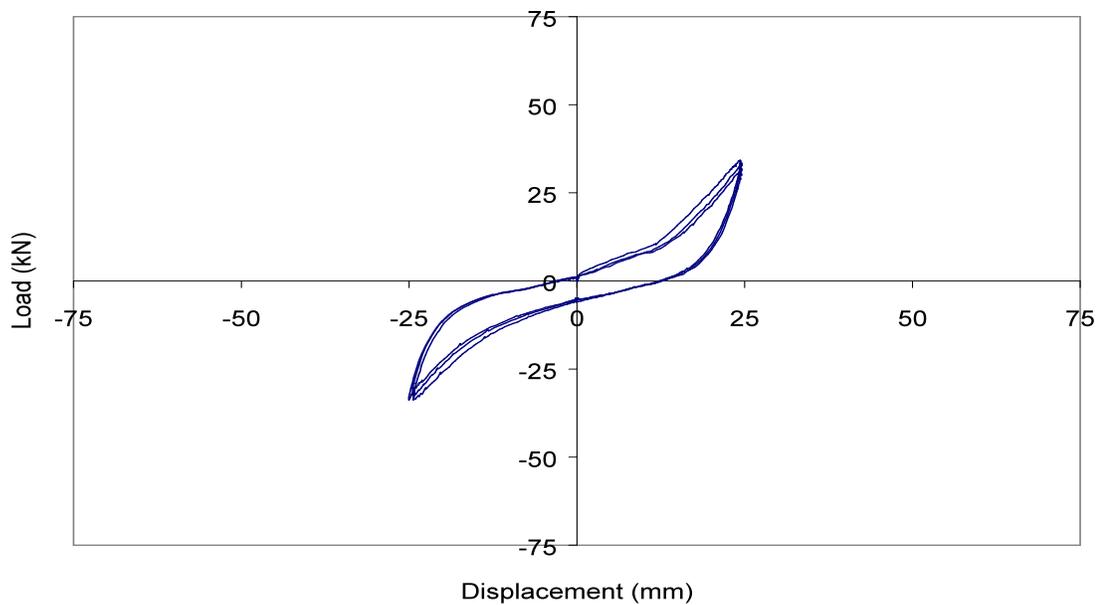
Figure 57: Hysteretic Load Displacement Loops for Test Unit 2 ( $\pm 1\%$  Drift)

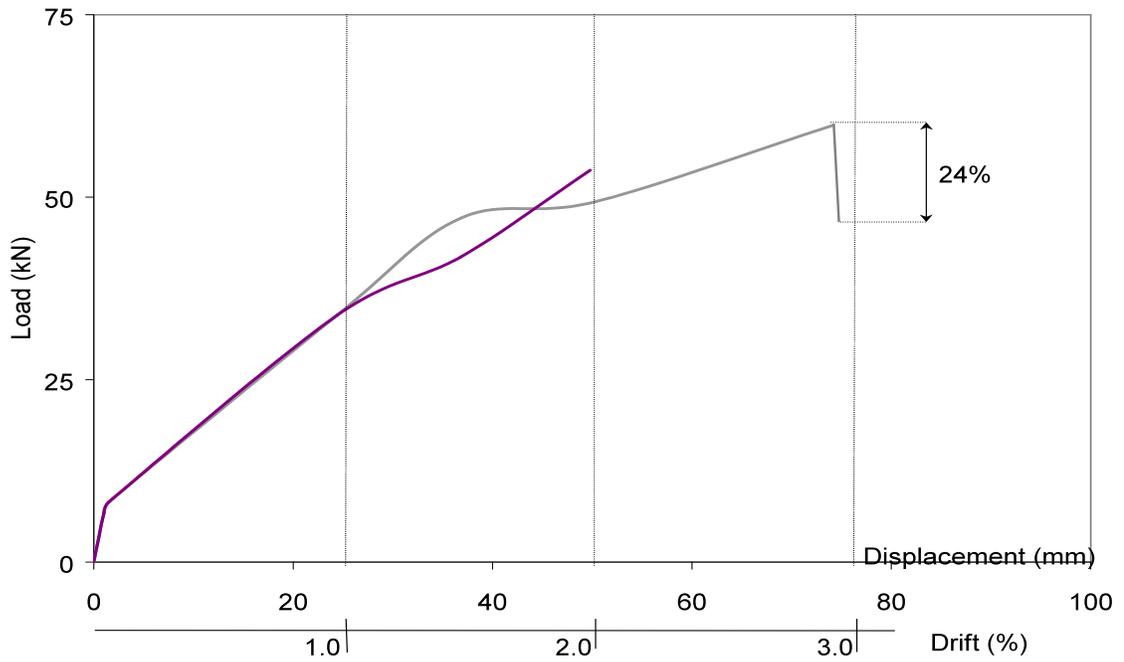
Figure 62: Envelope Curves for Test Unit 2

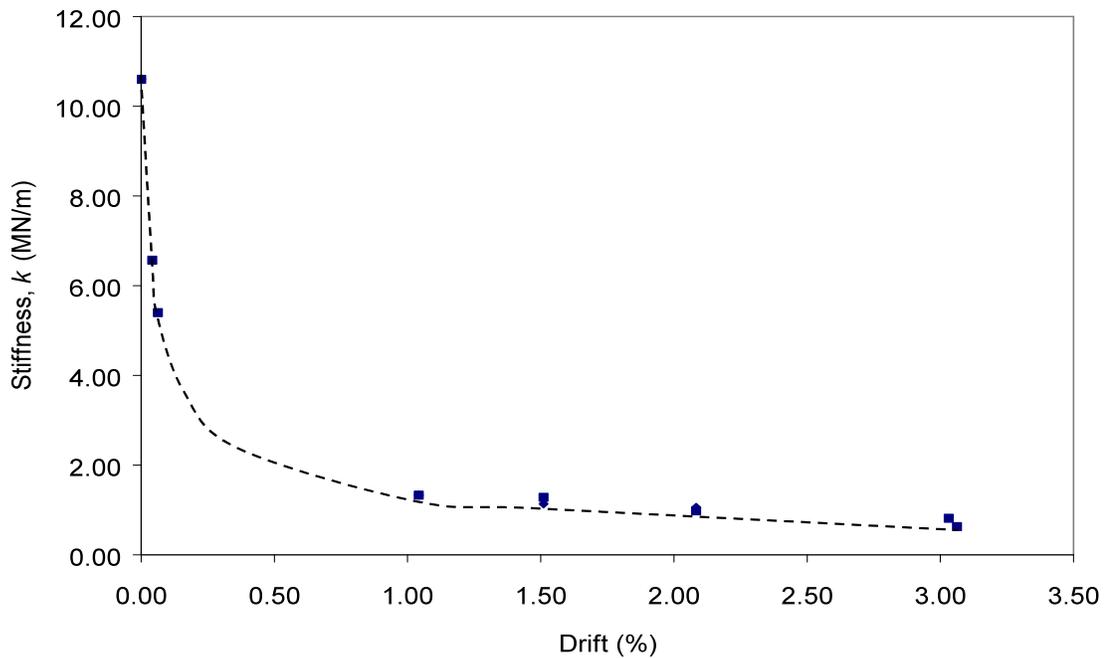
Figure 63: Stiffness Degradation, Test Unit 2

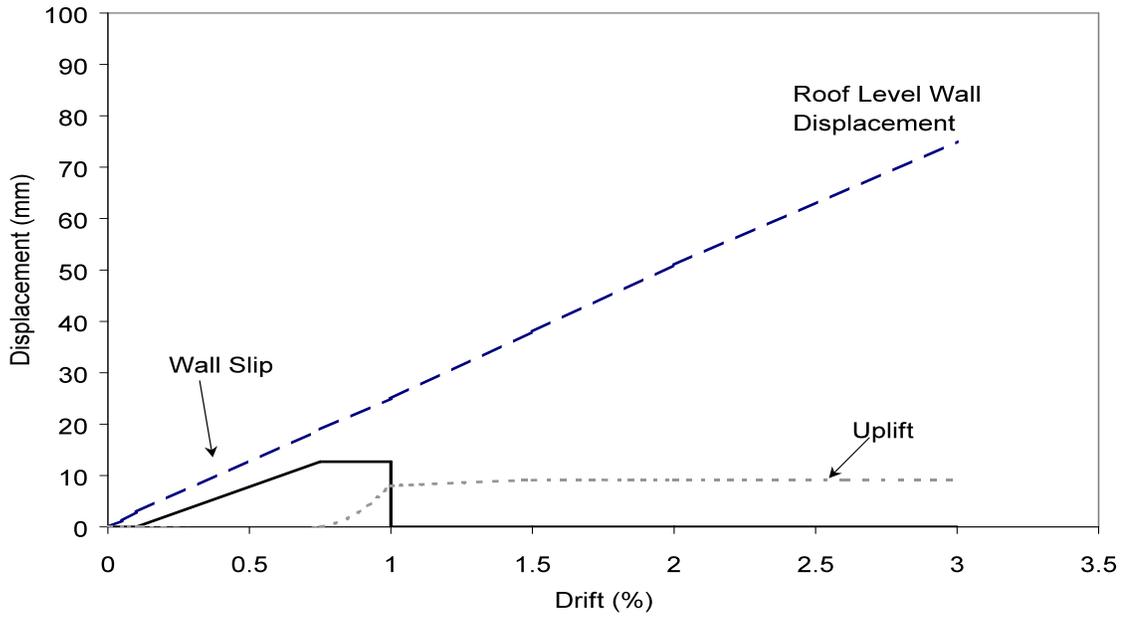
Figure 64: Uplift, Slip and Roof Level Displacement, Unit 1

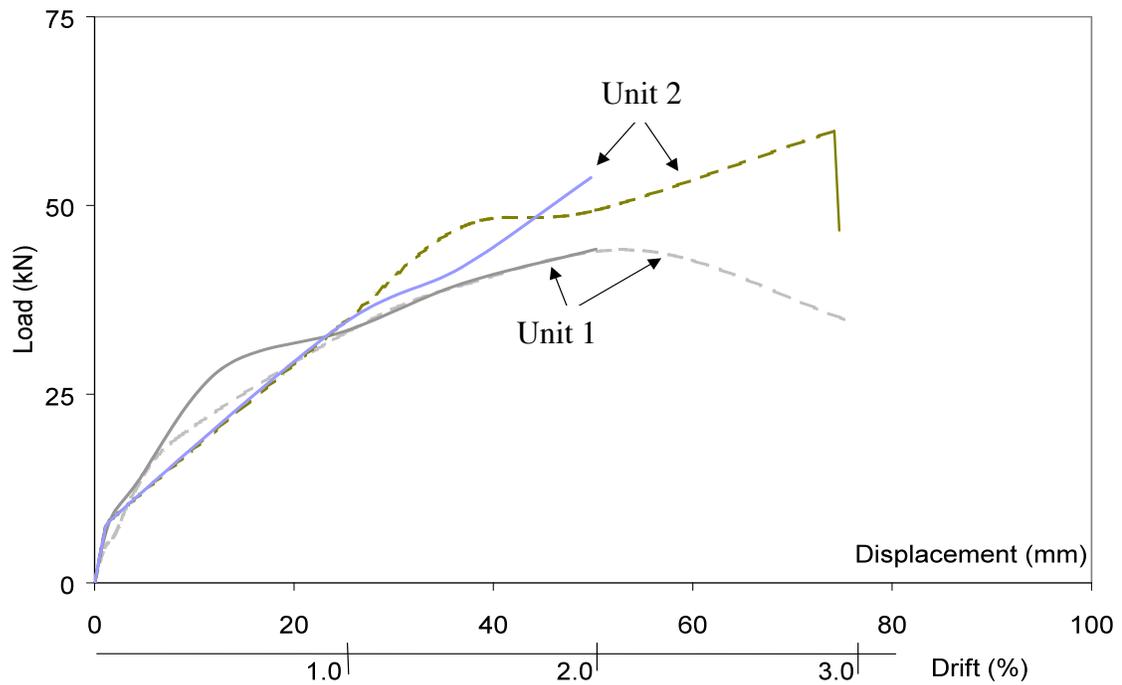
Figure 66: Envelope Curves for Units 1 and 2

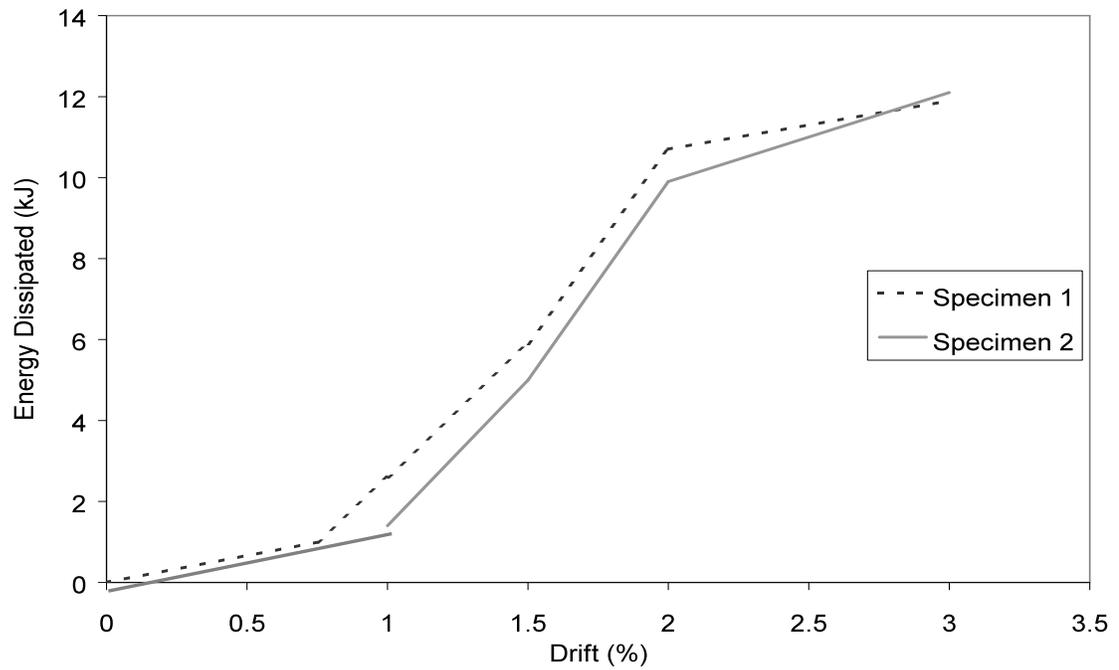
Figure 67: Energy Dissipation Capacity of Units 1 and 2

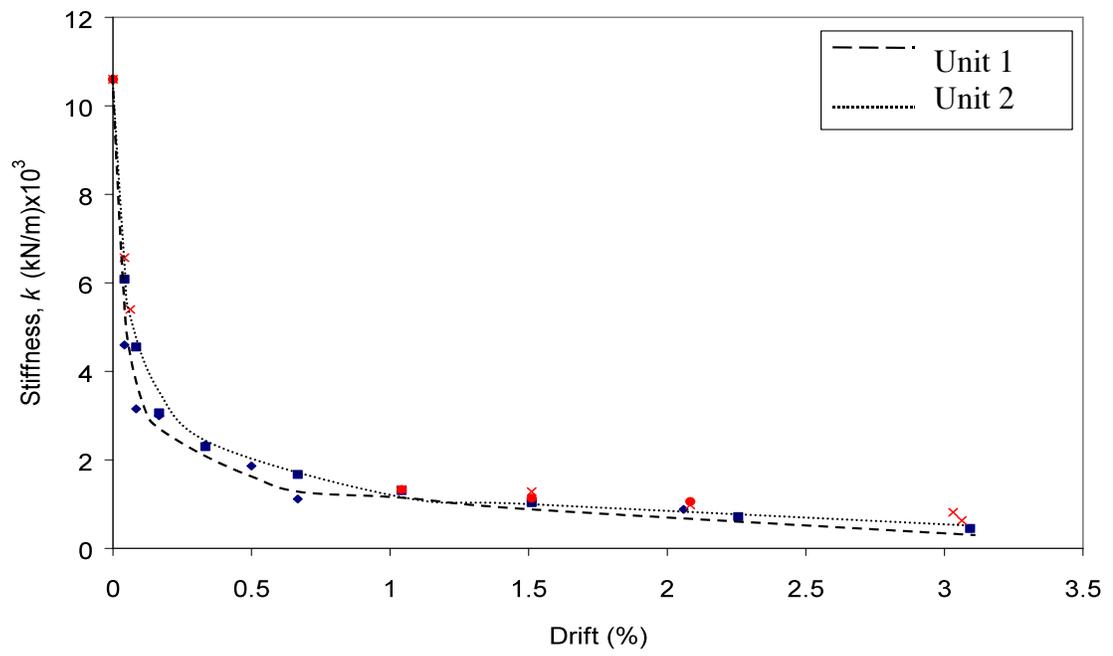
Figure 68: Stiffness Degradation for Units 1 and 2

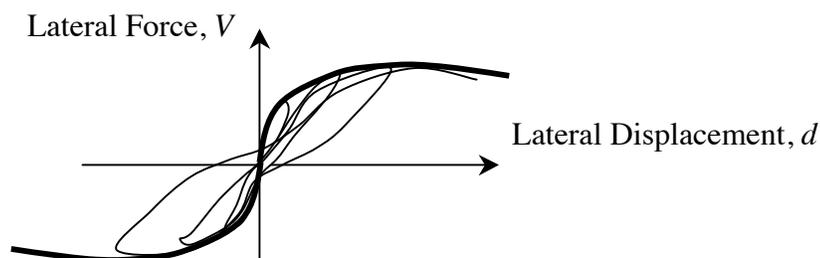
Figure 73: Generation of Envelope Curve based on Force Displacement Hysteretic Loops

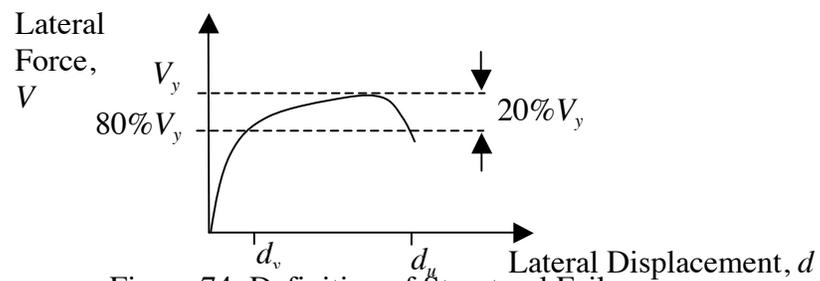
Figure 74: Definition of Structural Failure

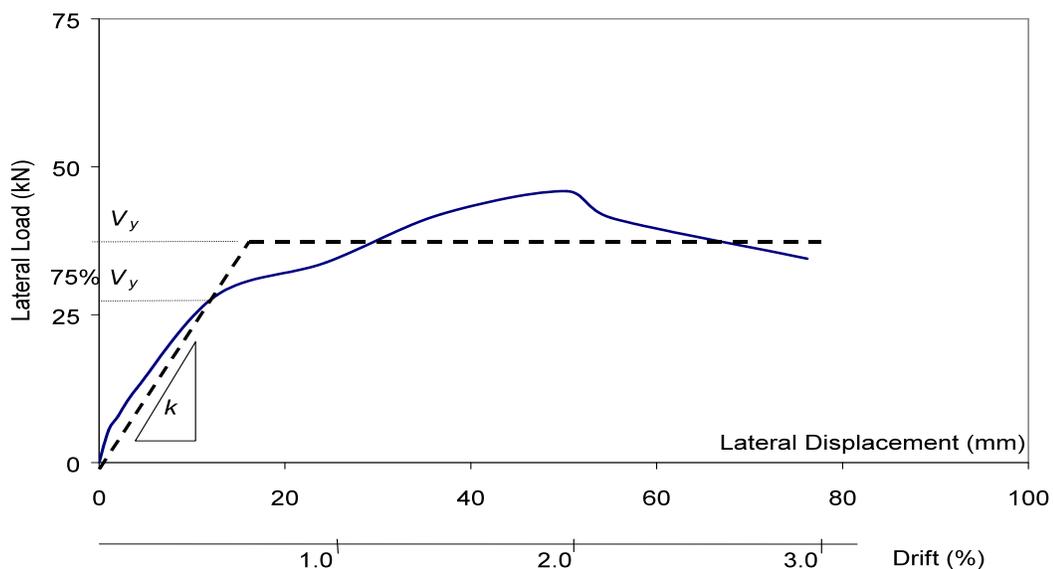
Figure 76: Schematic of Actual Load Curve and Linear Approximation

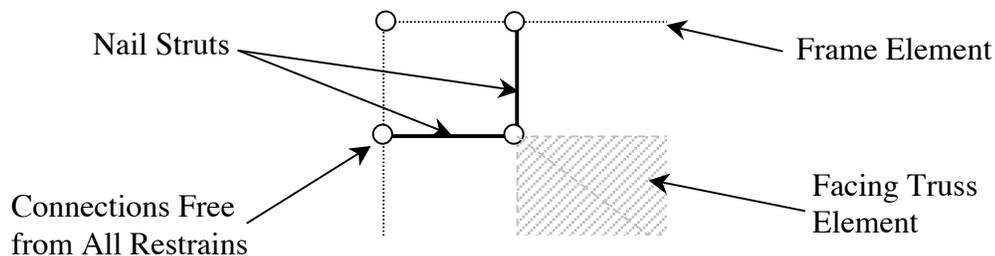
Figure 79: Nail Strut Model Connections

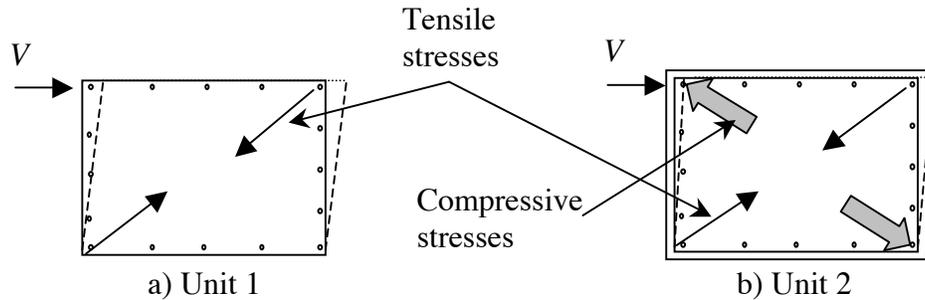
Figure 80: Deformations of Test Units

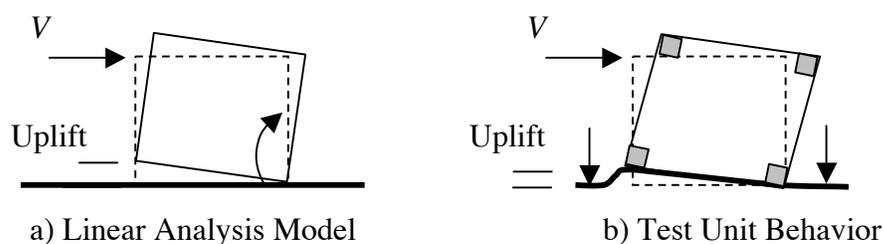
Figure 81: Comparison of Model Behavior vs. Observed Test Unit Behavior

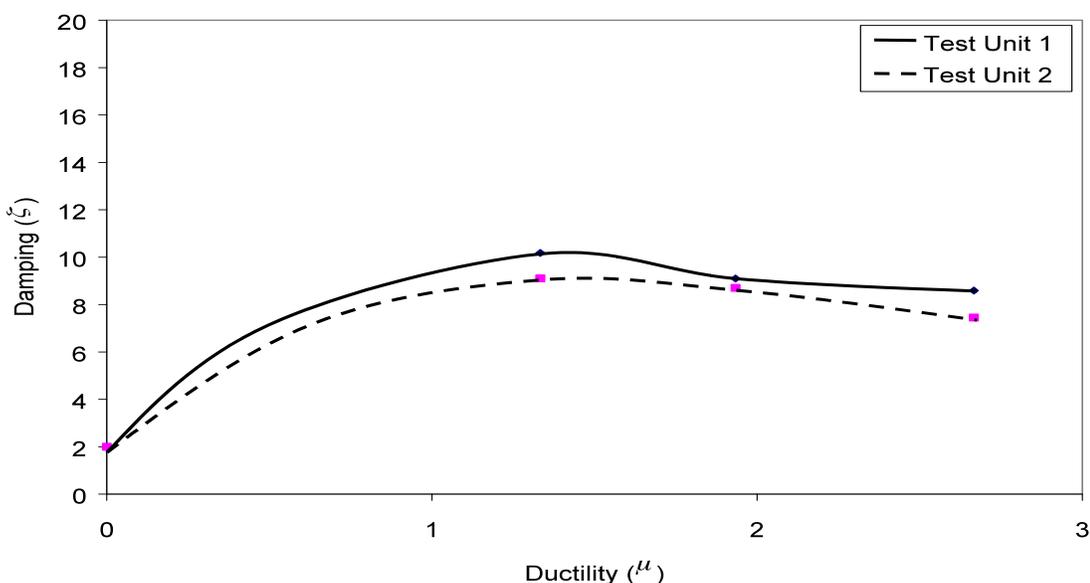
Figure 82: Equivalent Test Unit Damping Ratios,  $\xi$ , and Ductility,  $\mu$

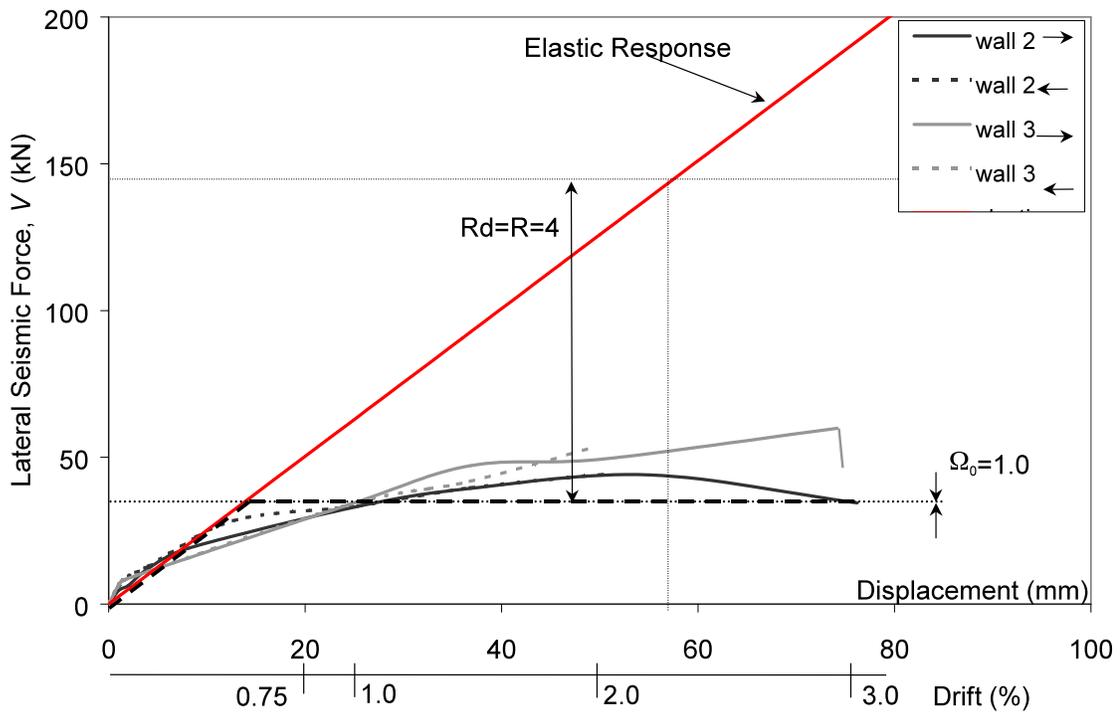
Figure 83: Elastic Response and Envelope Curves for Units 1 and 2 versus Drift

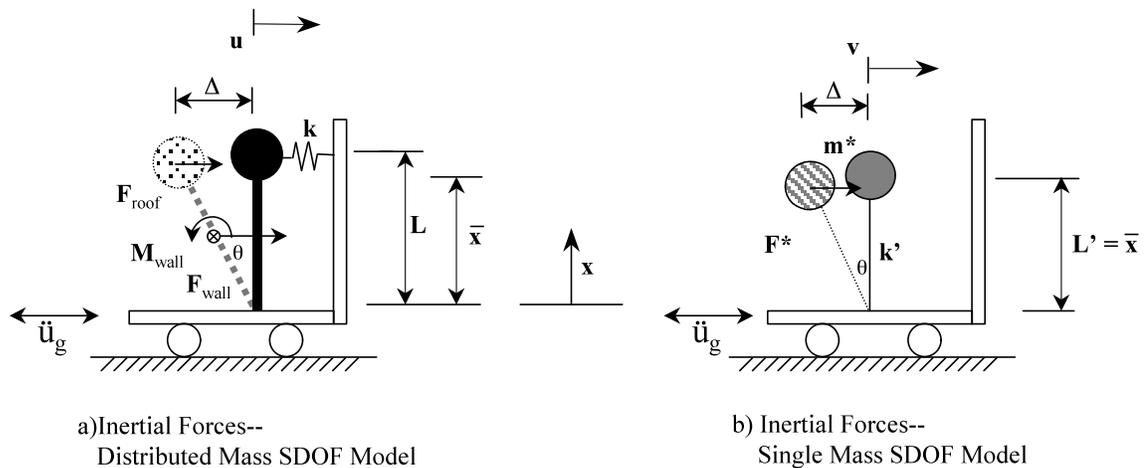
Figure 85: Inertial Forces Acting on Oscillators

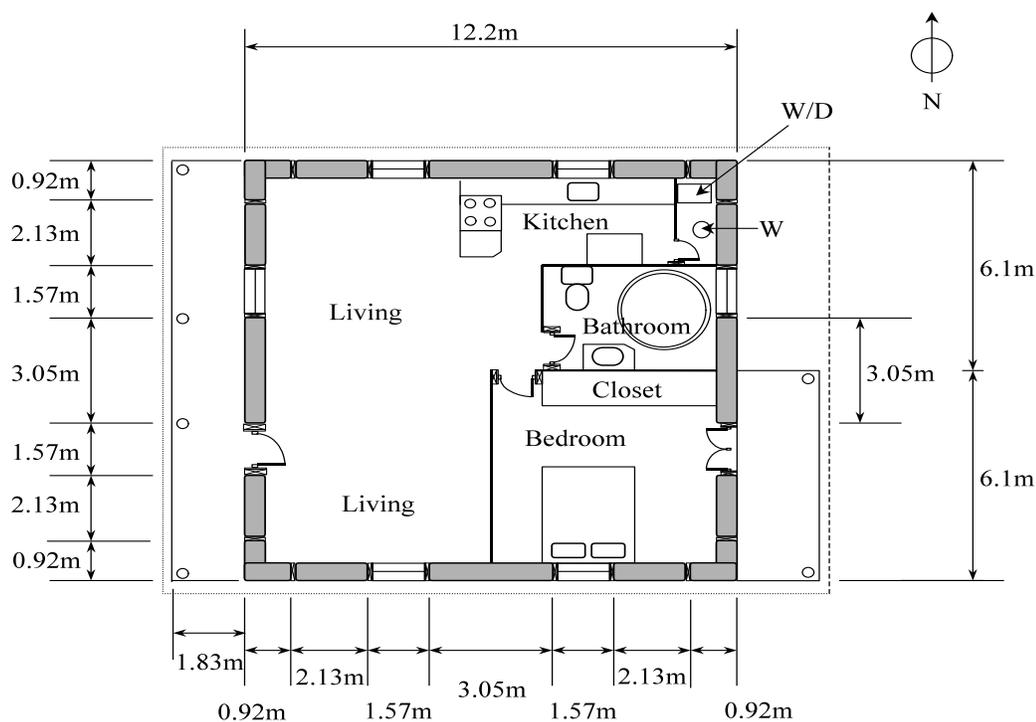
Figure 87: Plan Drawing of Model Structure

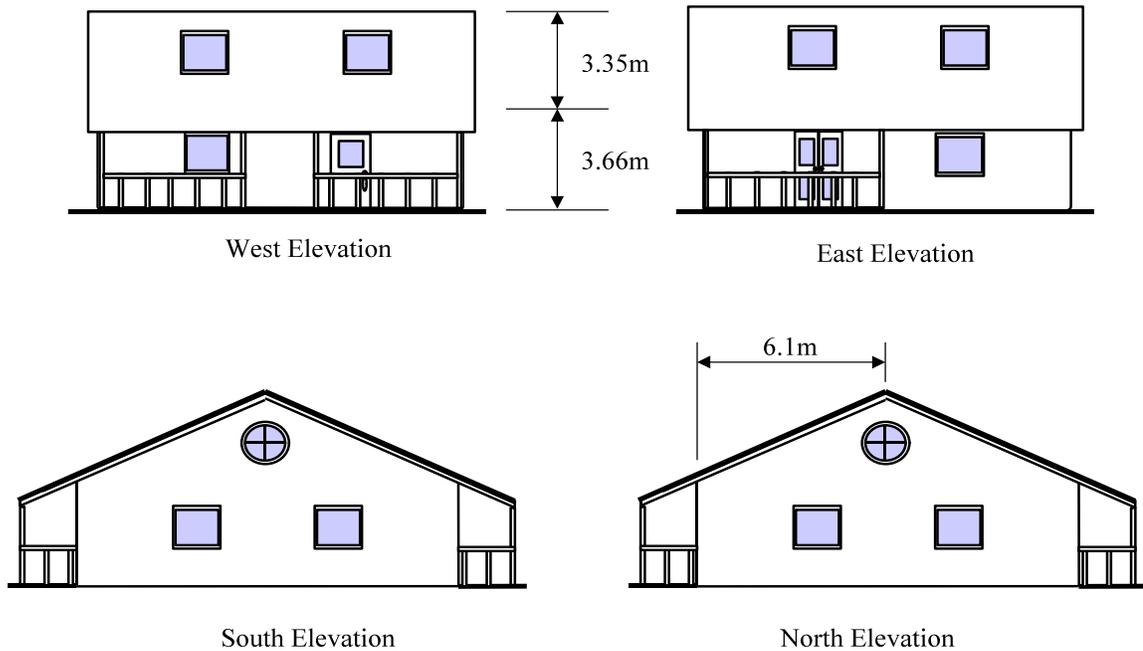
Figure 88: Elevation Drawings of Model Structure

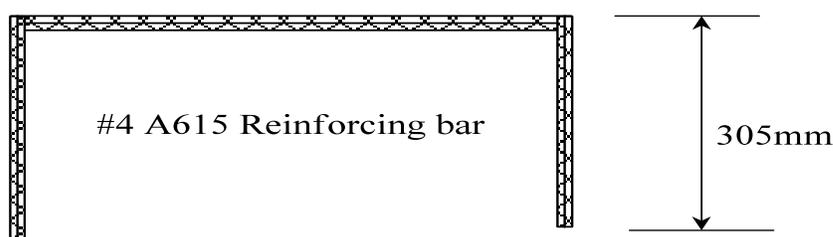
Figure 89: Staple for Corners in Straw-Bale Construction

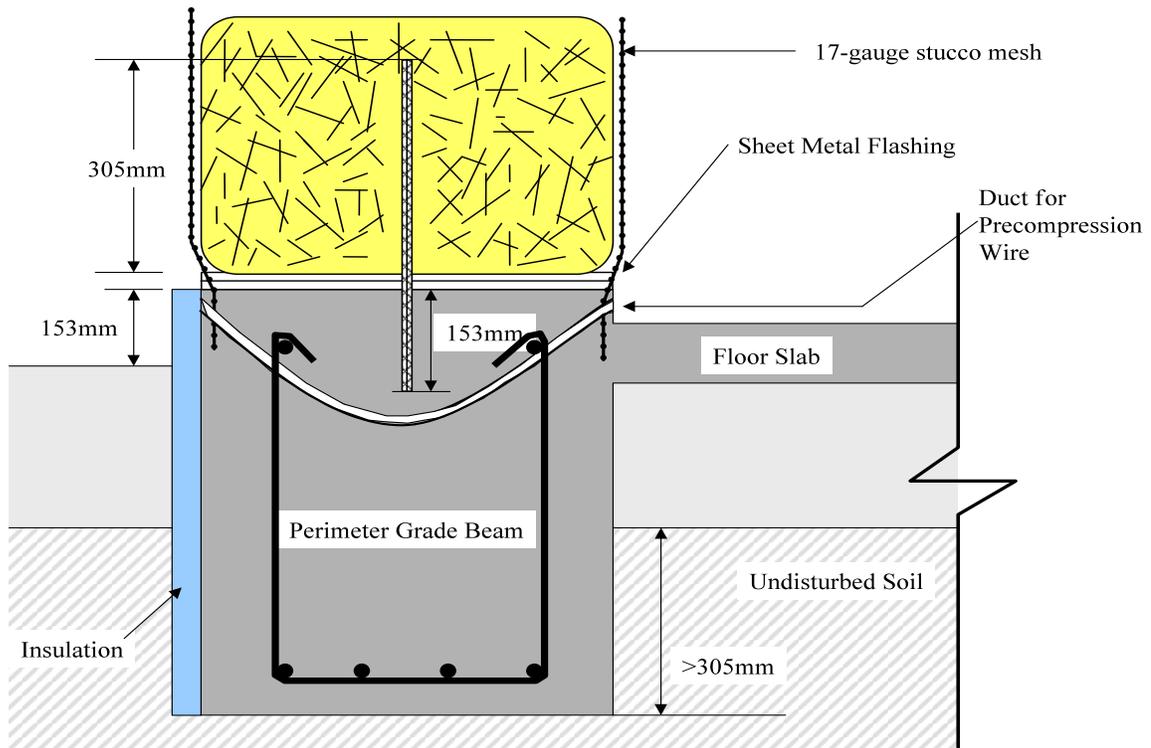
Figure 91: Foundation/Flooring System Cross-Section

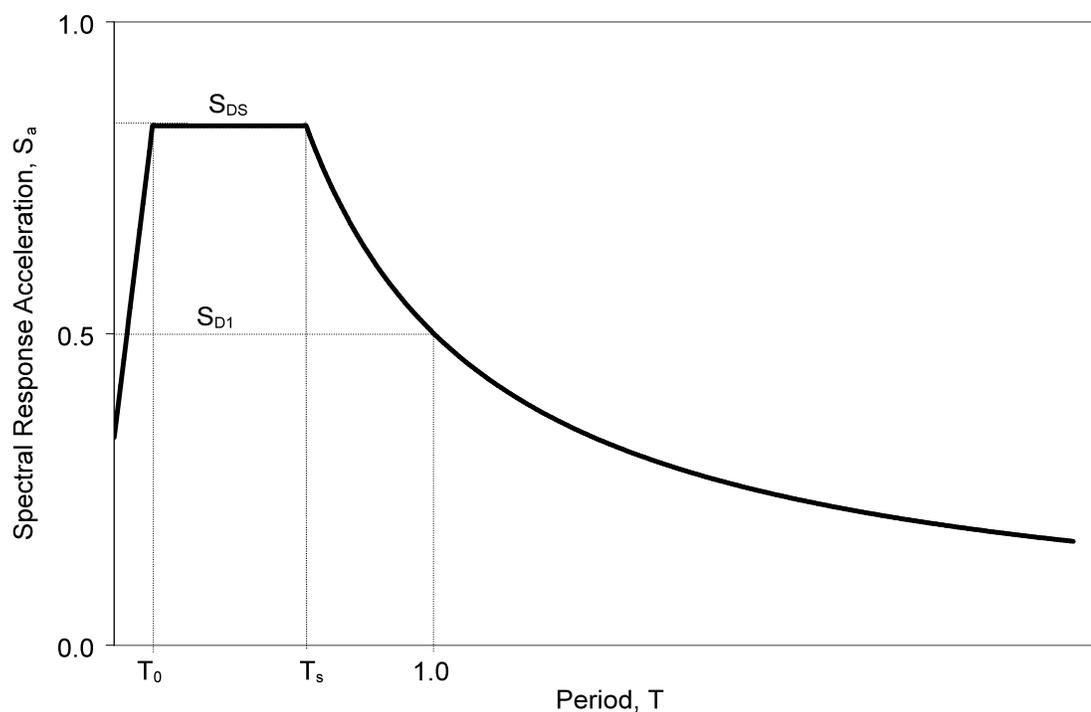
Figure 92: Design Response Spectrum

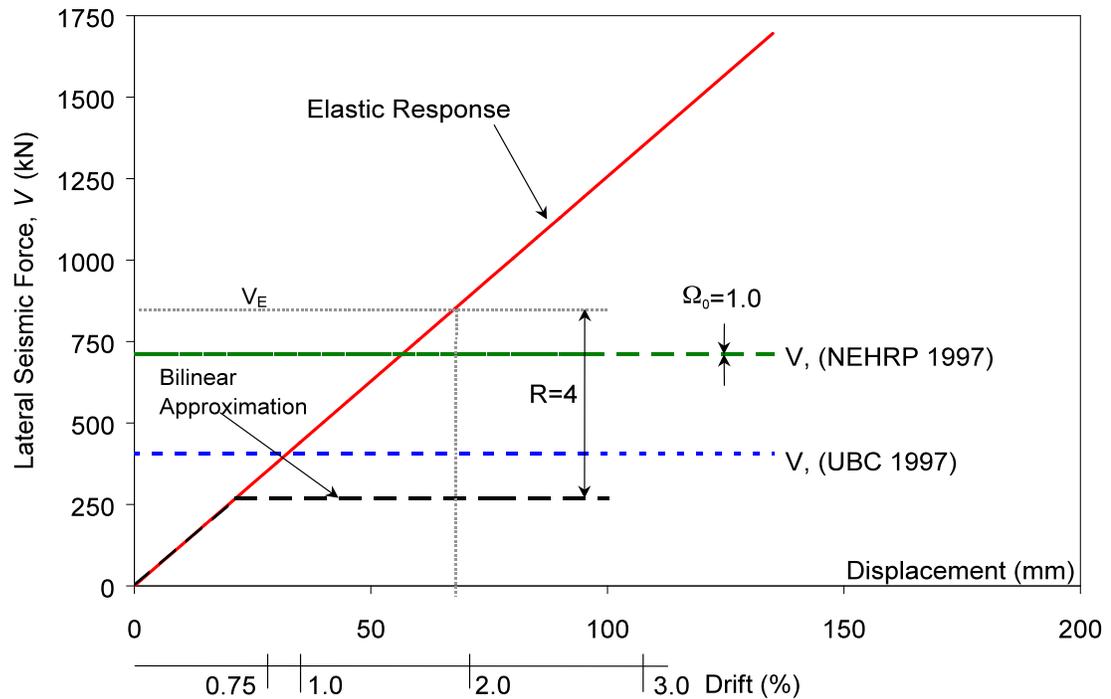
Figure 93: Expected Structural Envelope Curves and Calculated Base Shear Demand for Proposed Structure

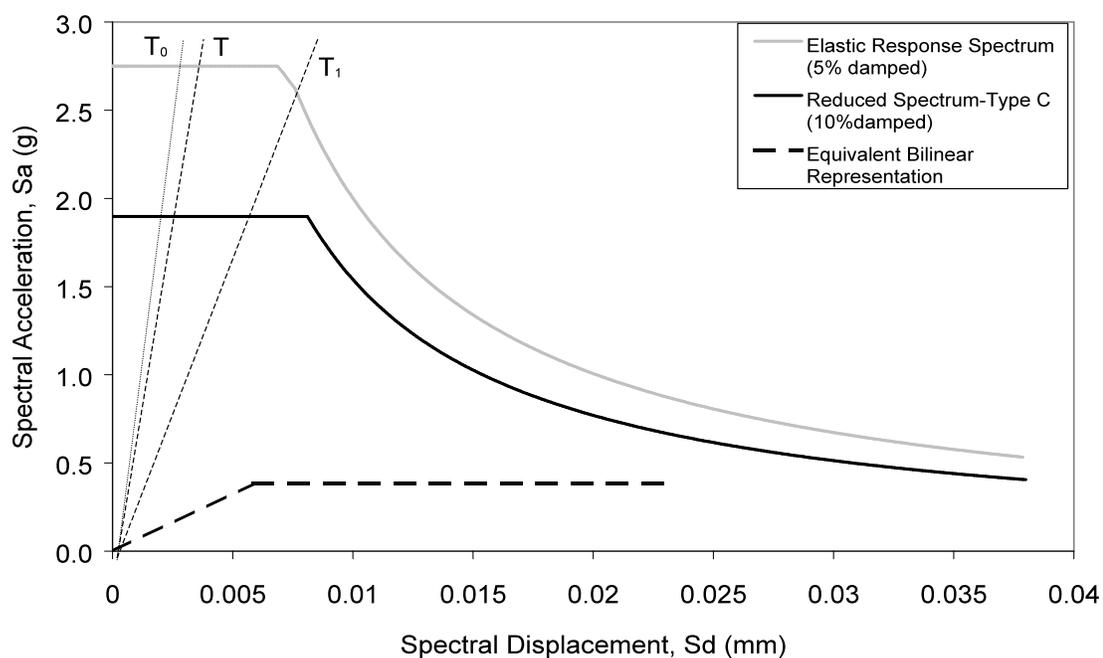
Figure 94: Acceleration-Displacement Response Spectrum (ADRS) for Model Structure
