**CYCLIC IN-PLANE TESTING OF POST AND BEAM WALLS  
WITH STRAW-BALE IN-FILL AND STUCCO/PLASTER**

Master of Science in Civil Engineering

University of Washington

1999

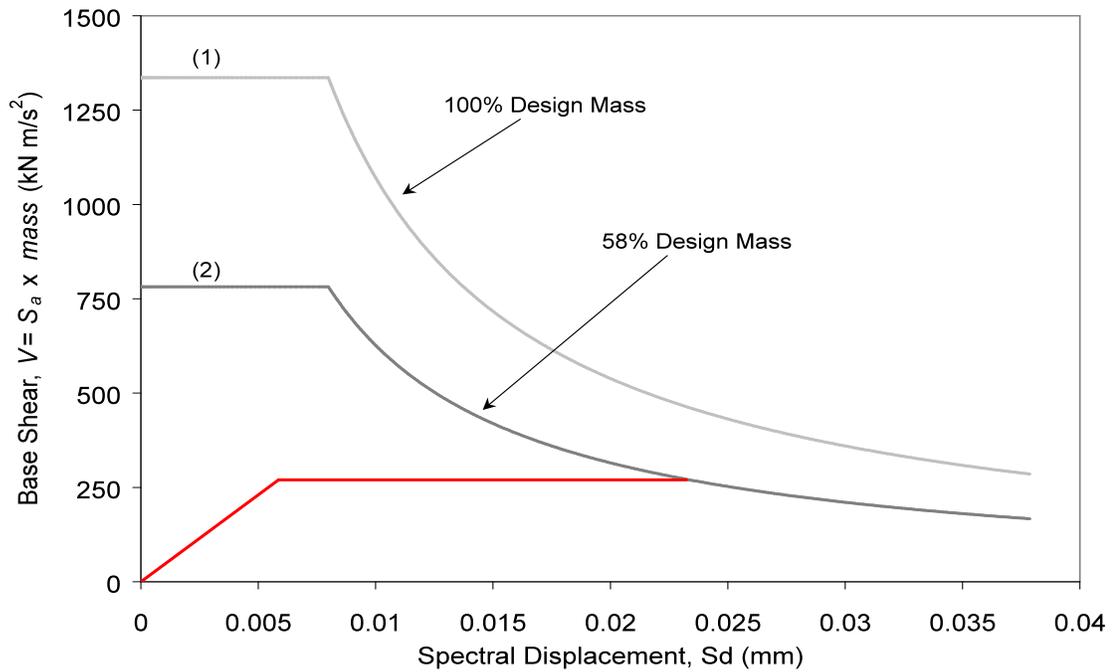
Figure 95: 10% Damped Base Shear Demand versus Spectral Displacement
