Monitoring the Hygrothermal Performance of Strawbale Walls

John Straube and Chris Schumacher

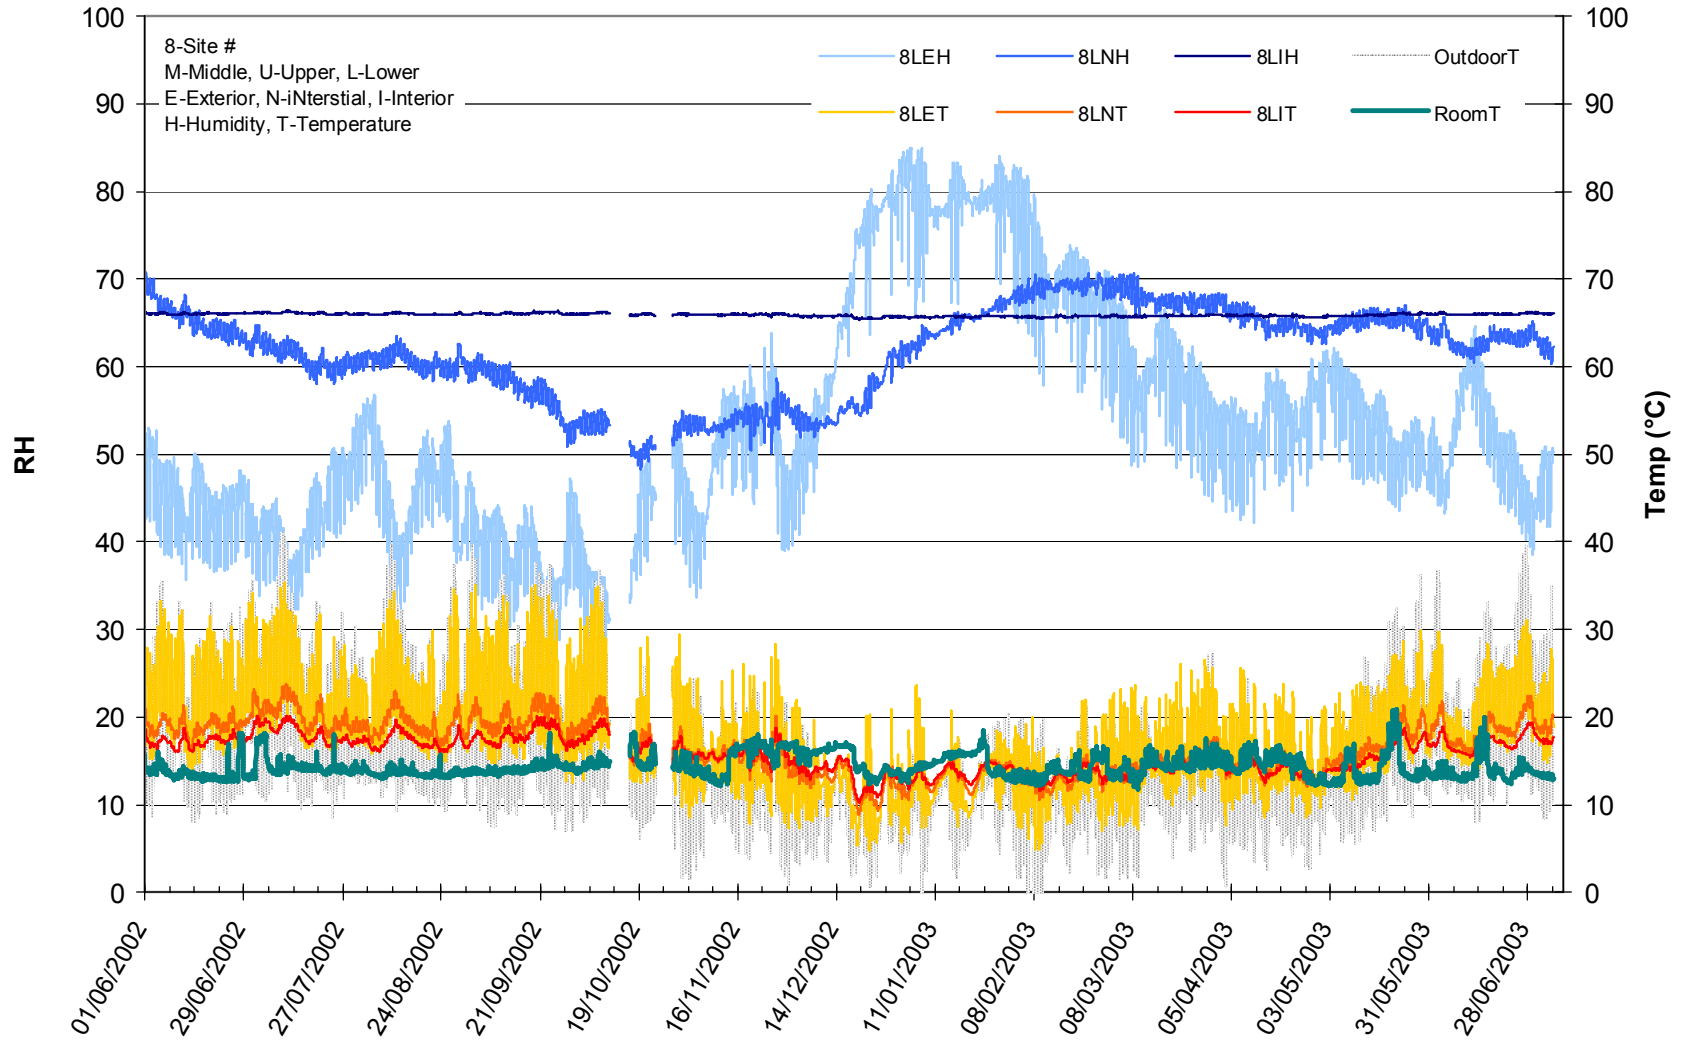
Site 8- East Wall of Barrel Room: Midheight Temp & RH

The temperature behind the exterior stucco of the wall (8MET = MiddleExteriorTemp) at mid-height often rises quickly in the morning, peaking at around 40 °C at 11:00 am. This is clearly caused by the morning sun, which is shaded on this wall by noon. The exterior temperature peaks later in the day (4 or 5 pm) and is usually lower. The temperature at the interior plaster (MIT) is much cooler and more stable, hovering near 20 °C (68 F) and varying by only about 3 °C over the period. Daily variations of the interior plaster is only on the order of 1°C. The middle-of-bale temperature tends to

vary between 20 and 25 °C. The wall remains above the exterior and interior temperatures because of solar exposure.
