Straw Bale House Moisture Research

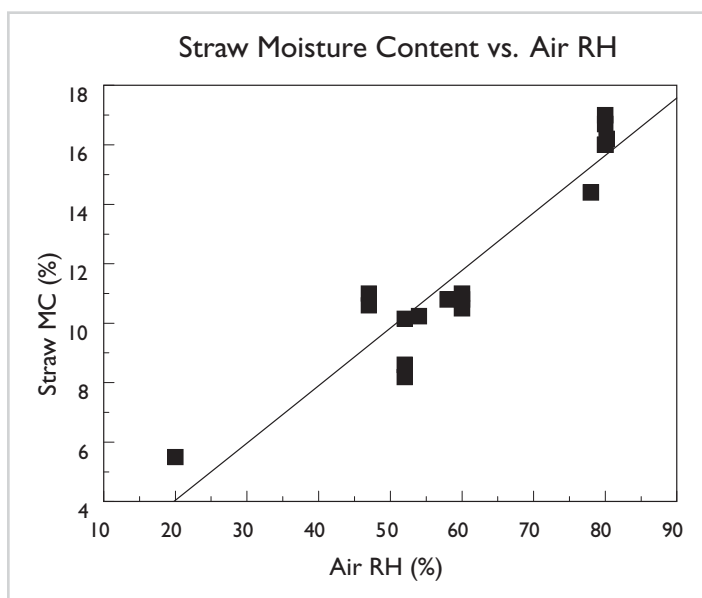
The September readings were generally lower than those at midsummer, at around 11 per cent. These wood moisture contracts in Nova Scotia are roughly the same as the air relative humidities as measured in Alberta. See the graph below for a conversion.

averaged 10 per cent wood moisture content in May and 12 per cent in July, with a few excursions above 15 per cent.
